**FIRE RISK ASSESSMENT
1-3 BRINKBURN CLOSE,
BYKER, NEWCASTLE UPON TYNE,
TYNE & WEAR**

NOVEMBER 2016

STORM TEMPEST
PROPERTY CONSULTANCY

Reference: JR – 3159-10-16

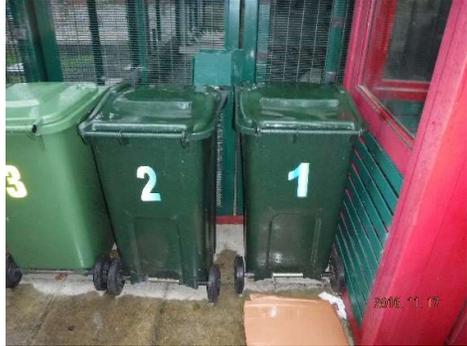
MEDIUM		1

At the time of the survey the external wheelie bins were being stored up against the stairwell lobby area's walls. We recommend the bins are relocated away from the buildings elevations.

<p>Assessors Observations:</p> <p>At the time of the survey the external wheelie bins were being stored up against the stairwell lobby area's walls.</p>
<p>Date of FRA: 17/11/2016</p> <p>Action by: 6 Months</p>		<p>Recommended Action:</p> <p>We recommend the external wheelie bins are relocated away from the buildings elevations.</p>
<p>Action</p> <p>Actioned by:</p> <p>Date:</p>		
<p>Review:</p> <p>Reviewed by:</p> <p>Date:</p>		
<p>Date:</p>		
LOW		2

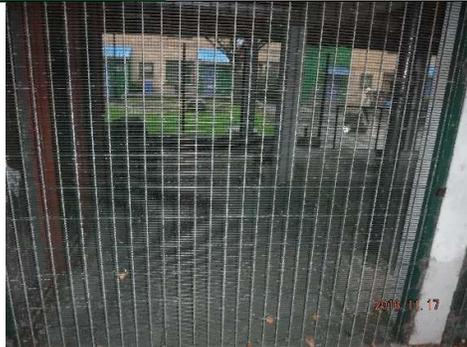
At the time of the survey we were unable to gain access into the ground floor undercroft area. We noted discarded household furniture in the undercroft. We recommend the items in the undercroft are identified and tenants are instructed to keep flammable and easily combustible items away from the perimeter of the undercroft to reduce the risk of arson.

<p>Assessors Observations:</p> <p>At the time of the survey we were unable to gain access into the ground floor storage area. We noted stored household goods in the undercroft.</p>
<p>Date of FRA: 17/11/2016</p> <p>Action by: 12 Months</p>		<p>Recommended Action:</p> <p>Flammable and easily combustible items should not be stored close to the perimeter of the store. We recommend the items in the undercroft are identified and tenants are instructed to keep flammable and easily combustible items away from the perimeter of the undercroft to reduce the risk of arson.</p>

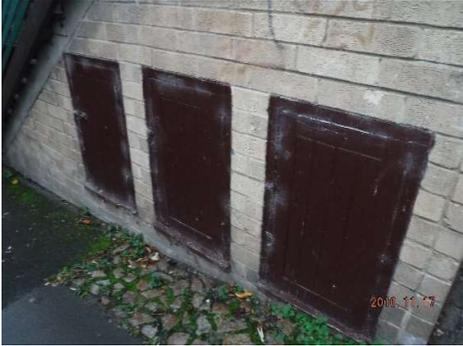
LOW	3

At the time of the survey we were unable to gain access into cupboards located under the external communal staircase. We believe the cupboards are likely to contain the electric meters and therefore should be kept free from stored goods. We recommend the under stairs cupboards are inspected and cleared of any stored sources of fuel.

<p>Assessors Observations:</p> <p>At the time of the survey we were unable to gain access into cupboards located under the external communal staircase. We believe the cupboards are likely to contain the electric meters and therefore should be kept free from stored goods.</p>
<p>Date of FRA: 17/11/2016</p> <p>Action by: 12 Months</p>		<p>Recommended Action:</p> <p>We recommend the under stairs cupboards are inspected and cleared of any stored sources of fuel.</p>
<p>Action</p> <p>Actioned by:</p> <p>Date:</p>		
<p>Review:</p> <p>Reviewed by:</p> <p>Date:</p>

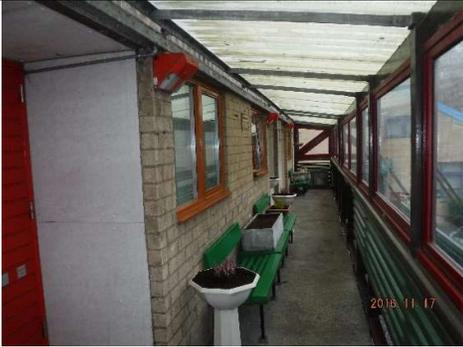
LOW	4

4.3 Fire
Compartmentation Due to building's construction we believe the fire compartmentation is generally sufficient. The communal balcony is semi-enclosed, windows opening onto the balcony/walkway do not appear to have fire rated glazed units. Under normal circumstances, it would be advised to upgrade the kitchen windows to provide 60-minute fire resistance. However, as these windows are softwood

framed, openable and are part of the Listed Building status, it would require a complete redesign of the windows and connecting to the fire alarm with an automatic closer fitted. We believe that it is not reasonably practicable to upgrade these windows.

<p>Assessors Observations:</p> <p>The communal balcony is semi-enclosed, windows opening onto the balcony/walkway do not appear to be fire rated.</p>
<p>Date of FRA: 17/11/2016</p> <p>Action by: None</p>		<p>Recommended Action:</p> <p>Under normal circumstances, it would be advised to upgrade the kitchen windows to provide 60-minute fire resistance. However, as these windows are softwood framed, openable and are part of the Listed Building status, it would require a complete redesign of the windows and connecting to the fire alarm with an automatic closer fitted. We believe that it is not reasonably practicable to upgrade these windows.</p>
<p>Action</p> <p>Actioned by:</p> <p>Date:</p>		
<p>Review:</p> <p>Reviewed by:</p> <p>Date:</p>
