**FIRE RISK ASSESSMENT  
HEADLAM GREEN (No's 14-19)  
HEADLAM STREET  
BYKER  
TYNE & WEAR**

**AUGUST 2017**

**STORM TEMPEST  
PROPERTY CONSULTANCY**

**Reference:** MH – 3293–07–17

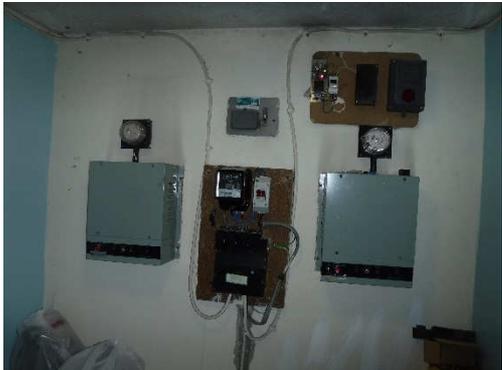
<b>LOW</b>		<b>1</b>

<b>Assessors Observations:</b>  The notice on the distribution board within the electric meter cupboard indicates that it was last inspected in 2016 and that it is next due to be serviced in ten years from that date (2026).
Date of FRA:	23/08/2017	<b>Recommended Action:</b>  We recommend that the electrical distribution is tested every 5 years (next due 2021) to satisfy compliance of the Electricity at Work Act 1989.
Action by:	12 Months	
<b>Action</b> Actioned by:		
Date:		
<b>Review:</b> Reviewed by:		
Date:

Electrical distribution boards should be tested every five years by a registered NICEIC contractor to satisfy compliance with the requirements of the Electricity at Work Act 1989. The notice on the distribution board within the electric meter cupboard indicates that it was last inspected in 2016 and that it is next due to be serviced in ten years from that date (2026). We recommend that the electrical distribution is tested every 5 years (next due 2021) to satisfy compliance of the Electricity at Work Act 1989.

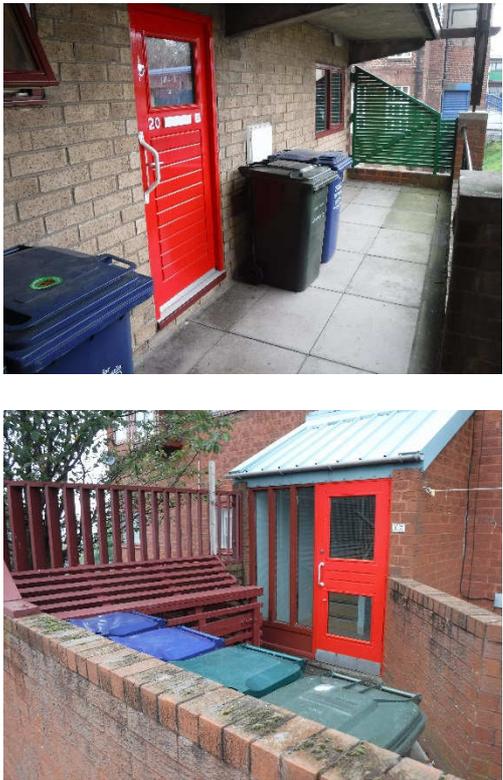
LOW		2

<p><b>Assessors Observations:</b></p> <p>Currently the bins are store either side of the entrance to flat 20 on the first floor, which is also outside the entrance to the communal stairs. The bins are also stored outside the rear ground floor entrance door.</p>
Date of FRA:	23/08/2017	<p><b>Recommended Action:</b></p> <p>We recommend that the bins are stored away from the entrance doors to the building.</p>	
<b>Action</b> Actioned by:	12 Months		
Date:			
<b>Review:</b> Reviewed by:			
Date:

Unlike other buildings on the estate, there are no internal bin stores to this property. There are timber framed bin stores located outside the rear ground floor entrance and running down the side of the steps leading to the front first floor entrance. Neither of these stores are currently used, as modern bins do not fit within the stores. Currently the bins are store either side of the entrance to flat 20 on the first floor, which is also outside the entrance to the communal stairs. The bins are also stored outside the rear ground floor entrance door. We recommend that the bins are stored away from the entrance doors to the building.

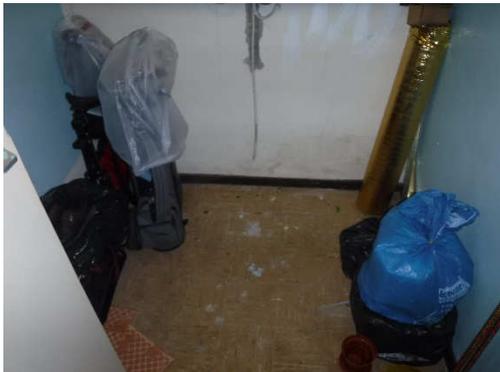
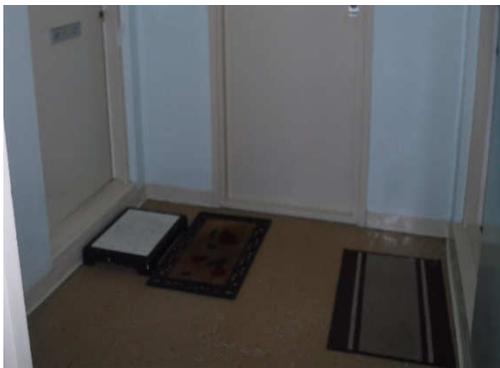
<b>MEDIUM</b>		<b>4</b>

<p><b>Assessors Observations:</b></p> <p>There are combustible household items stored within the electrical service room and small items, such as door mats, plant pots and a portable low level step located within the communal areas.</p>
Date of FRA:	23/08/2017	<p><b>Recommended Action:</b></p> <p>We recommend that the items are removed and that escape routes are kept clear and sources of fuel are stored suitably.</p>
Action by:	1 Month	
<b>Action</b> Actioned by:		
Date:		
<b>Review:</b> Reviewed by:		
Date:

The electric meter room on the ground floor, which is locked shut and houses the electric meters for the 2 adjacent flats, as well as the meter and main fuse board for the building, plus the emergency light battery backups, is currently used by the adjacent flat residents who have a key, to store household goods. We recommend that the items are removed and that the residents do not have access to this room.

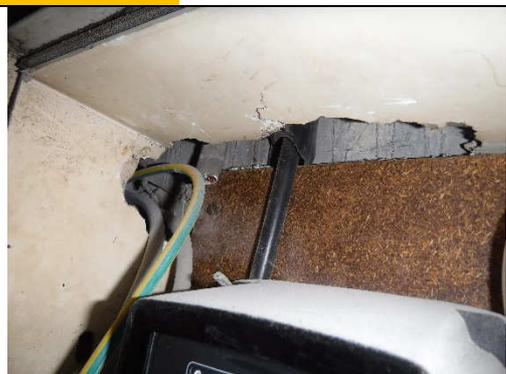
<b>MEDIUM</b>		5

<b>Assessors Observations:</b>  There is an electric meter box built in to the walls of the stair landings, adjacent to each flat front door. Gaps were noted behind the meter boxes, with no fire stopping.	
Date of FRA: 23/08/2017	<b>Recommended Action:</b>  We recommend that the holes within the building structure around the meter boxes are blocked up with appropriate fire stopping material.	
Action by: 6 Months		
<b>Action</b> Actioned by:  Date:		
<b>Review:</b> Reviewed by:  Date:		
<b>LOW</b>		6

There is an electricity meter box built in to the walls of the stair landings, adjacent to the front doors to Flats 15, 16, 18 and 19. Gaps were noted behind the meter boxes, with no fire stopping. We recommend that the holes within the building structure around the meter boxes are suitably fire stopped by a Third Party Accredited company.

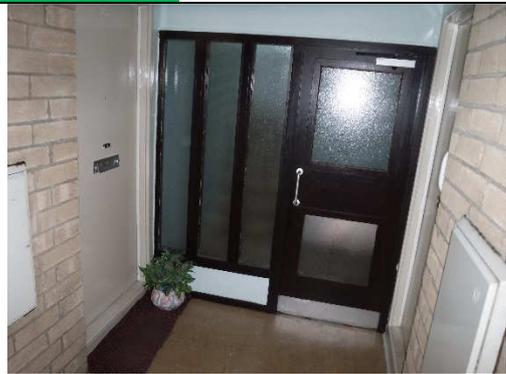
<b>Assessors Observations:</b>  There are timber framed, Georgian wired, glazed partitions with fire doors, located to the first floor front entrance, second floor walkway access, rear ground floor entrance door and first lobby access to the communal staircase, all with a plasterboard panel above.	
Date of FRA: 23/08/2017	<b>Recommended Action:</b>  We recommend that the partitions and panels above are upgraded to 60-minute fire resistance.

Action by: 12 Months		
<b>Action</b> Actioned by:  Date:		
<b>Review:</b> Reviewed by:  Date:

6	We recommend that the partitions and panels above are upgraded to 60-minute fire resistance.	Low	12 Months		£750
7	We recommend that the cable penetrations within the ground floor meter room are suitably fire stopped.	High	1 Month		£120
<b>Means of Escape</b>					
8	We recommend that the internal flat entrance doors are upgraded with intumescent strips and cold smoke seals, fire rated ironmongery, including handles, locks, hinges, letterbox and overhead door closer.	Medium	6 Months		£2100

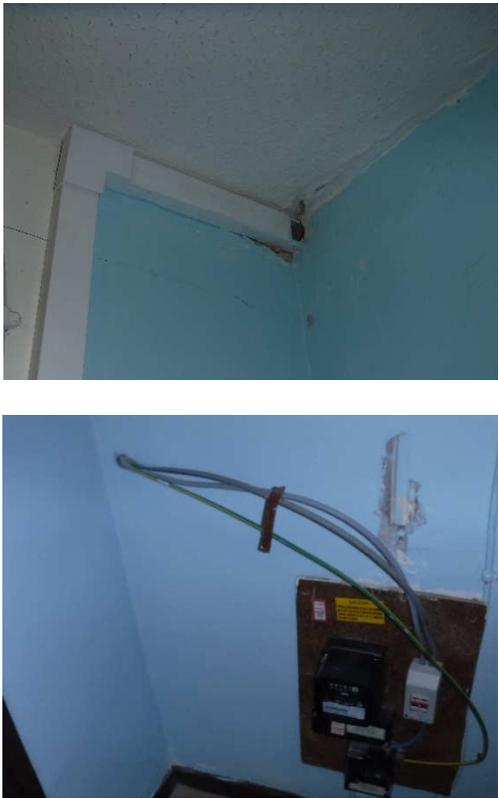
<b>HIGH</b>		<b>7</b>

<p><b>Assessors Observations:</b></p> <p>Where the cables for the various electrical supplies enter, and leave the ground floor meter room there are holes around the cables penetrating the compartmentation.</p>
Date of FRA:	23/08/2017	<p><b>Recommended Action:</b></p> <p>We recommend that the cable penetrations are suitably fire stopped by a Third Party Accredited company.</p>
Action by:	1 Month	
<b>Action</b> Actioned by:		
Date:		
<b>Review:</b> Reviewed by:		
Date:

The electricity meters for Flat 14 and 17 are located within the electricity meter room on the ground floor, along with the electricity meter for the communal areas of the building and the battery backup for the emergency lights. Where the cables for the various electrical supplies enter, and leave the ground floor meter room there are holes around the cables penetrating the compartmentation. We recommend that the penetrations are suitably fire stopped by a Third Party Accredited company.

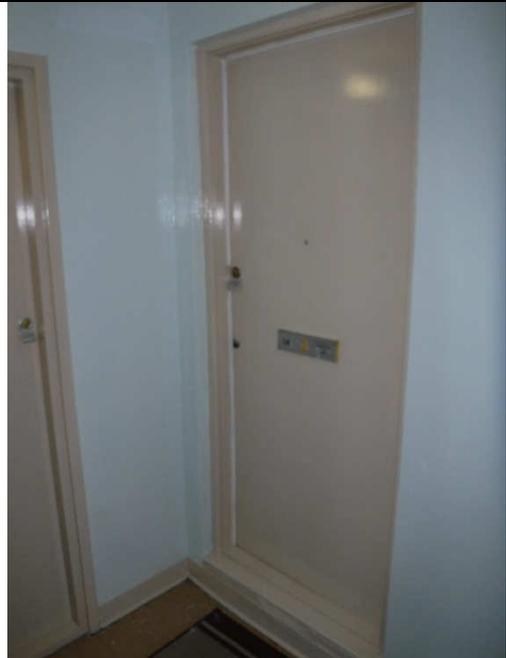
<b>MEDIUM</b>		<b>8</b>

The internal flat entrance doors are solid timber fire doors, with an integrated Perko type door closer and all appear to be original to the building. The doors are generally in a poor condition, with no intumescent strips and smoke seals. It was not possible to determine whether the 1½ pairs of hinges were fire rated. The doors are fitted with a letter box flap, standard lever handle and separate latch lock at eye level. We recommend that the internal flat entrance doors are upgraded to provide intumescent/cold smoke seals, intumescent letterbox and overhead door closer. The client may wish to consider replacing the flat entrance doors as part of a planned maintenance scheme.

<b>Assessors Observations:</b>  Internal flat entrance doors are original to the building.
Date of FRA:	23/08/2017	<b>Recommended Action:</b>  We recommend that the internal flat entrance doors are upgraded with intumescent strips and cold smoke seals, fire rated ironmongery, including handles, locks, hinges, intumescent letterbox and overhead door closer.
Action by:	6 Months	
<b>Action</b> Actioned by:		
Date:		
<b>Review:</b> Reviewed by:		
Date:

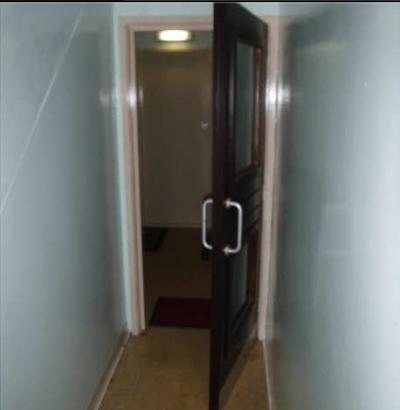
<b>HIGH</b>		<b>9</b>

<b>Assessors Observations:</b>  The ground floor lobby fire door does not have a door closer fitted.	
Date of FRA: 23/08/2017	<b>Recommended Action:</b>  We recommend that a door closer is fitted.	
Action by: 2 Weeks		
<b>Action</b> Actioned by:		
Date:		
<b>Review:</b> Reviewed by:		
Date:

9	We recommend that a door closer is fitted to the ground floor lobby fire door.	High	2 Weeks		£145
10	We recommend that the ground floor meter room door is upgraded with intumescent strips and cold smoke seals, fire rated ironmongery, including handles, locks, hinges and overhead door closer.	Medium	6 Months		£300
<b>Management Procedures</b>					
11	We recommend that a Fire Action Notice is provided.	Medium	1 Month		£25
12	We recommend that 'No Smoking' signage is provided to the communal areas.	Low	3 Months		£25
<b>TOTAL:</b>					<b>£3,695.00</b>

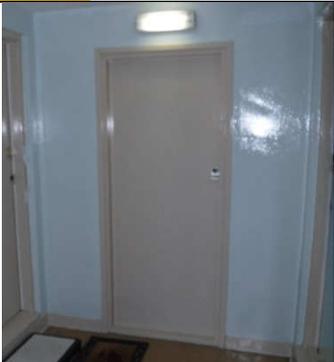
<b>MEDIUM</b>		<b>10</b>

The internal door to the ground floor service cupboard is a solid timber door, with 2 integrated Perko type door closers fitted and appears to be original to the building. The doors are generally in a poor condition, with no intumescent strips and smoke seals. It was not possible to determine whether the 1½ pairs of hinges were fire rated. We recommend that the door is upgraded with intumescent strips and cold smoke seals, fire rated ironmongery, including handles, lock, hinges and overhead door closer. The client may wish to consider replacing the service cupboard door as part of a planned maintenance scheme.

<b>Assessors Observations:</b>  The internal door to the ground floor service cupboard is a solid timber door, with 2 integrated Perko type door closers fitted and appears to be original to the building. The doors are generally in a poor condition, with no intumescent strips and smoke seals. It was not possible to determine whether the 1½ pairs of hinges were fire rated.	
Date of FRA: 23/08/2017	<b>Recommended Action:</b>  We recommend that the door is upgraded with intumescent strips and cold smoke seals, fire rated ironmongery, including handles, locks, hinges and overhead door closer.	
Action by: 6 Months		
<b>Action</b> Actioned by:		
Date:		
<b>Review:</b> Reviewed by:		
Date:
