**FIRE RISK ASSESSMENT
THE BROW (No's 9-14)
ST PETERS ROAD
BYKER
TYNE & WEAR**

AUGUST 2017

Reference: MH – 3293–07–17

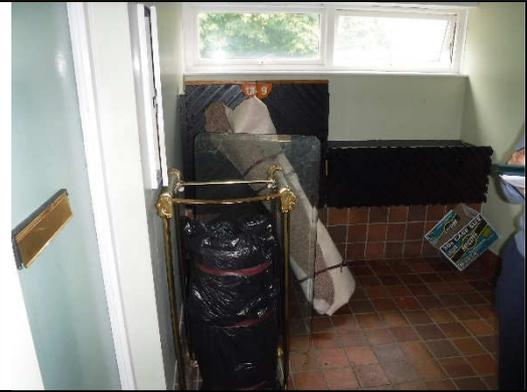
Medium		1

The means of escape route via the communal stairs within the property is good, however we did note a glass topped table and a roll of carpet stored on the first-floor landing, which may cause an obstruction in an emergency situation. The communal areas should remain a sterile environment to ensure the escape route remains clear. We recommend that the items are removed and that escape routes are kept clear and sources of fuel are stored suitably.

Assessors Observations: The means of escape route via the communal stairs within the property is good, however we did note glass topped coffee table and a roll of carpet stored on the first-floor landing, which may cause an obstruction in an emergency situation. The communal areas should remain a sterile environment to ensure the escape route remains clear.	
Date of FRA: 23/08/2017	Recommended Action: We recommend that the items are removed that escape routes are kept clear and sources of fuel are stored suitably.	
Action by: 1 Month		
Action Actioned by: Date:		
Review: Reviewed by: Date:

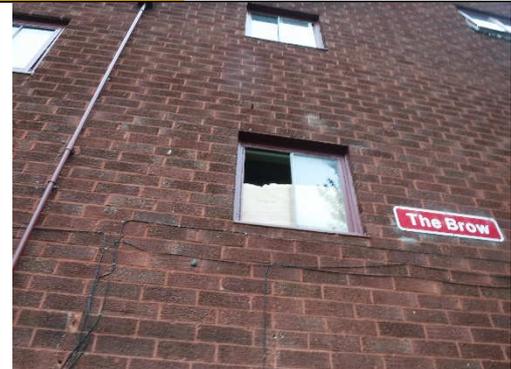
MEDIUM		2

The window to the ground floor stairs mid-landing has a pane of glass missing. This could be used to throw flammable items through the window. We recommend that the glass is replaced.

Assessors Observations: The window to the ground floor stairs mid-landing has a pane of glass missing. This could be used to throw flammable items through the window.	
Date of FRA: 23/08/2017	Recommended Action: We recommend that the glass is replaced.	
Action by: 1 Month		
Action Actioned by: Date:		
Review: Reviewed by: Date:

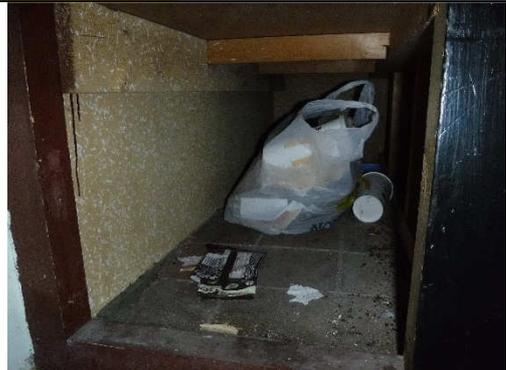
MEDIUM		3

<p>Assessors Observations:</p> <p>To the side of the bin store is a matching, all-be-it lower level, box. The purpose of the box was unclear, as access to it could only be gained via the inside of the bin store at low level. One of the boxes was found to contain a bag of rubbish.</p>
Date of FRA:	23/08/2017	<p>Recommended Action:</p> <p>We recommend that the bin stores and box to the side are emptied of uncontrolled waste.</p>
Action by:	1 Month	
Action Actioned by:		
Date:		
Review: Reviewed by:		
Date:

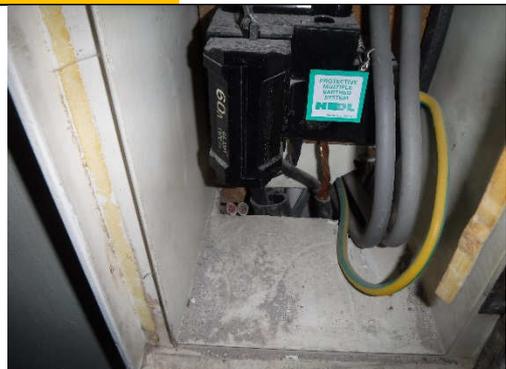
MEDIUM		4

There is an electric meter box built in to the walls of the stair landings, adjacent to each flat front door. Gaps were noted behind the meter boxes, with no fire stopping. We recommend that the holes within the building structure around the meter boxes are blocked up with appropriate fire stopping material.

<p>Assessors Observations:</p> <p>There is an electric meter box built in to the walls of the stair landings, adjacent to each flat front door. Gaps were noted behind the meter boxes, with no fire stopping.</p>
Date of FRA:	23/08/2017	<p>Recommended Action:</p> <p>We recommend that the holes within the building structure around the meter boxes are blocked up with appropriate fire stopping material.</p>
Action by:	6 Months	
Action Actioned by:		
Date:		
Review: Reviewed by:		
Date:

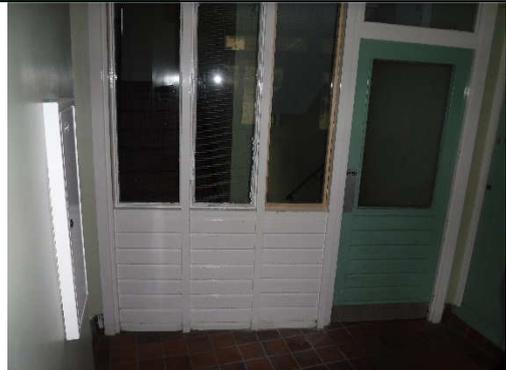
LOW	5

There are timber framed, half Georgian wired glazed partitions to each of the floors, between the landing area with the flat doors on and the communal staircase. These partitions are not required under current fire regulations, however as they are in place, we recommend that the doors to the screens are upgraded to FD30S doors with fire rated ironmongery, intumescent smoke seals and overhead door closers.

<p>Assessors Observations:</p> <p>There are timber framed, half Georgian wired glazed partitions to each of the 3 floors, between the landing area with the flat doors on and the communal staircase.</p>
<p>Date of FRA: 23/08/2017</p> <p>Action by: 12 Months</p>	<p>Recommended Action:</p> <p>We recommend that the doors are replaced with a new FD30S doors, with intumescent strips and cold smoke seals, fire rated ironmongery, including handles, hinges, and overhead door closer, plus a "Fire Door Keep Shut" sign.</p>
<p>Action</p> <p>Actioned by:</p> <p>Date:</p>	
<p>Review:</p> <p>Reviewed by:</p> <p>Date:</p>

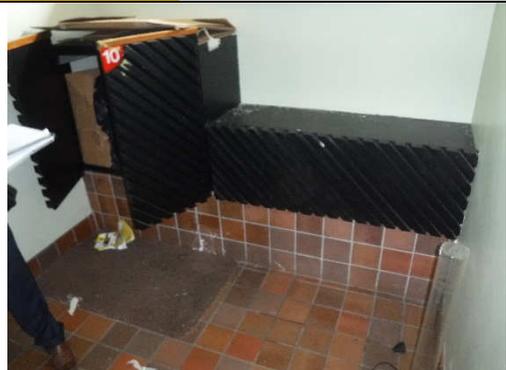
MEDIUM	5

There is a tiled raised plinth, across the width of the first and second floor landings, approximately 450mm high. On top of this plinth is a timber framed and lined bin store cupboard. To the side of the bin store is a matching, all-be-it lower level, box. The purpose of the box was unclear, as access to it could only be gained via the inside of the bin store at low level. One of the boxes was found to contain a bag of rubbish. We recommend that the bin stores and box to the side are emptied of uncontrolled waste and are upgraded with fire resistant walls and new fire doors with smoke seals.

<p>Assessors Observations:</p> <p>There is a tiled raised plinth, across the width of the first and second floor landings, approximately 450mm high. On top of this plinth is a timber framed and lined bin store cupboard. To the side of the bin store is a matching, all-be-it lower level, box.</p>
<p>Date of FRA: 23/08/2017</p> <p>Action by: 6 Months</p>	<p>Recommended Action:</p> <p>We recommend that the bin stores and box to the side are upgraded with fire resistant walls and new fire doors with smoke seals.</p>
<p>Action</p> <p>Actioned by:</p> <p>Date:</p>	
<p>Review:</p> <p>Reviewed by:</p> <p>Date:</p>

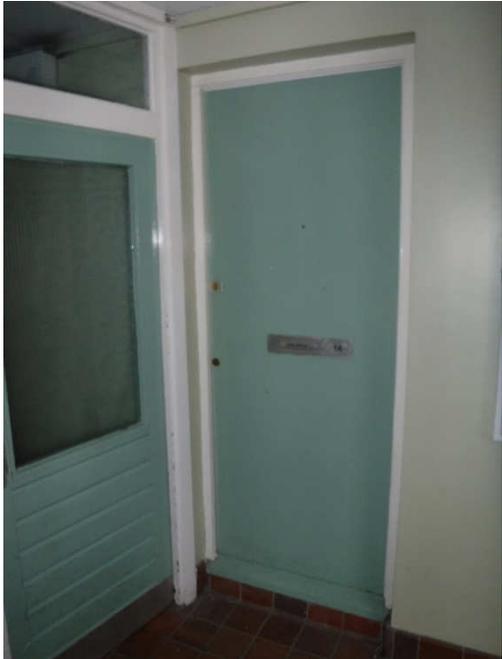
MEDIUM		6

The internal flat entrance doors are solid timber fire doors, with a mixture of integrated Perko type door closer and overhead door closers and all appear to be original to the building. The doors are generally in a poor condition, with no intumescent strips and smoke seals. It was not possible to determine whether the 1½ pairs of hinges were fire rated. The doors are fitted with a letter box flap, standard lever handle and separate latch lock at eye level. We recommend that the internal flat entrance doors are upgraded with intumescent strips and cold smoke seals, fire rated ironmongery, including handles, locks, hinges, letterbox and overhead door closer. The client may wish to consider replacing the flat entrance doors as part of a planned maintenance scheme.

Assessors Observations: Internal flat entrance doors are original to the building.
Date of FRA:	23/08/2017	Recommended Action: We recommend that the internal flat entrance doors are upgraded with intumescent strips and cold smoke seals, fire rated ironmongery, including handles, locks, hinges, letterbox and overhead door closer.
Action by:	6 Months	
Action Actioned by:		
Date:		
Review: Reviewed by:		
Date:

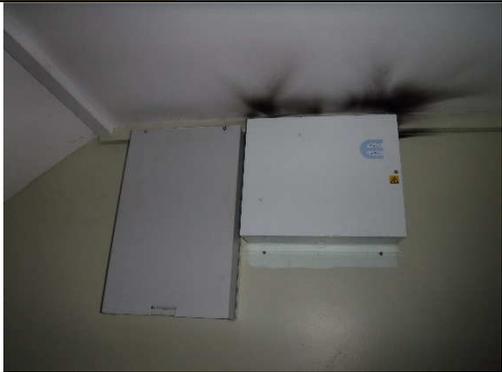
MEDIUM		7

There is an electrical box located to the rear door exit staircase of the ground floor landing, which at the time of the survey appeared

to be operating correctly. However, there was soot/burn marks to the wall and ceiling above the unit. This indicated that the unit has recently been faulty. We recommend an investigation is carried out to see what happened, why and what repairs were carried out to prevent it from happening again. We also recommend that the wall and ceiling are cleaned and redecorated where necessary to show if this happens again and to prevent residents from being concerned.

Assessors Observations: There is an electrical box located to the rear door exit staircase of the ground floor landing, which at the time of the survey appeared to be operating correctly. However, there was soot/burn marks to the wall and ceiling above the unit.
Date of FRA:	23/08/2017	Recommended Action: We recommend an investigation is carried out to see what happened, why and what repairs were carried out to prevent it from happening again. We also recommend that the wall and ceiling are cleaned and redecorated where necessary to show if this happens again and to prevent residents from being concerned.
Action by:	3 Months	
Action Actioned by:		
Date:		
Review: Reviewed by:		
Date:
