FIRE RISK ASSESSMENT
THORNBOROUGH HOUSE (No's 1-7)
SPIRES LANE
BYKER
TYNE & WEAR

AUGUST 2017

Reference: MH – 3293–07–17

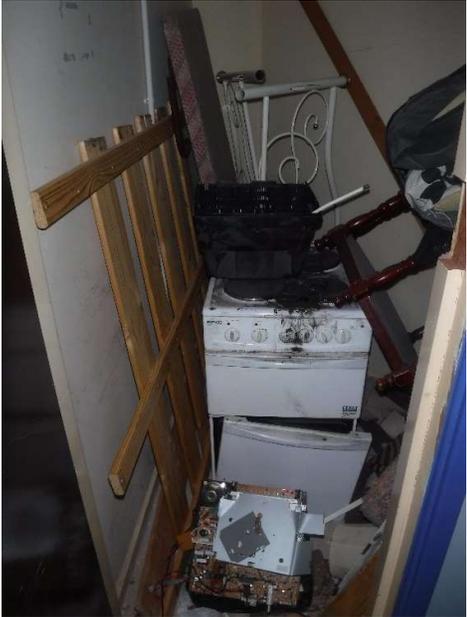
Medium	1

- Combustible household items stored in the first-floor store room.
- Combustible household items stored in the second-floor bin store.

The escape routes were free from obstruction at the time of the inspection with exception to the various household goods stored within the store room off the first-floor landing. The escape routes should remain free from combustible items to reduce the risk of a fire starting in the communal areas and to ensure a clear escape route. The travel distances were assessed as being compliant with the Building Regulations Approved Document B.

<p>Assessors Observations:</p> <p>Various household goods stored within the store room off the first-floor landing.</p>		
Date of FRA: 23/08/2017	Recommended Action:		
Action by: 1 Month	We recommend that the items are removed and that		
Action Actioned by:	escape routes are kept clear and sources of fuel are stored suitably.		
Date:			
Review: Reviewed by:			
Date:

The means of escape route via the communal stairs within the property is good, with no items stored in the stair landings or lobby which could have caused an obstruction in an emergency situation. The communal areas should remain a sterile environment to ensure the escape route remains clear. We recommend that the items within the first-floor store room are removed and that escape routes are kept clear and sources of fuel are stored suitably.

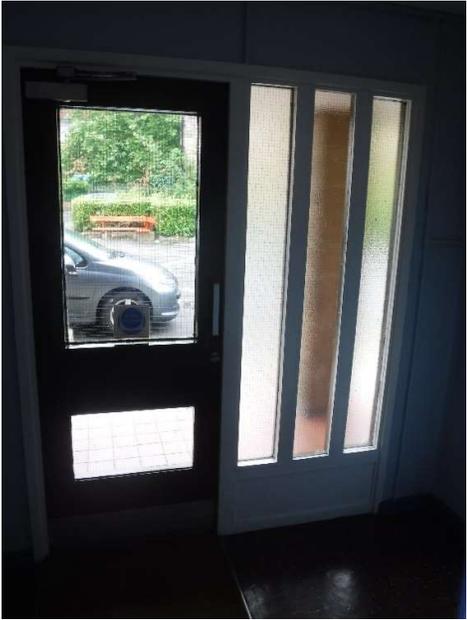
Low	2

The external doors to the top and bottom of the communal staircase are glazed timber fire doors, with Georgian wired glazing in reasonable condition, hung on 1½ pairs of hinges, an overhead door closer device, pull handles and a thumb turn to the internal face of the door. We recommend that the doors are upgraded with

<p>Assessors Observations:</p> <p>The external doors to the top and bottom of the communal staircase are glazed timber fire doors, with Georgian wired glazing in reasonable condition, hung on 1½ pairs of hinges, an overhead door closer device, pull handles and a thumb turn to the internal face of the door.</p>	
Date of FRA: 23/08/2017	<p>Recommended Action:</p> <p>We recommend that the doors are upgraded with intumescent strips and cold smoke seals, fire rated ironmongery, including handles, hinges, door lock with thumb turn, overhead door closer and fire resistant glazing.</p>	
Action by: 12 Months		
<p>Action</p> <p>Actioned by:</p> <p>Date:</p>		
<p>Review:</p> <p>Reviewed by:</p> <p>Date:</p>

intumescent strips and cold smoke seals, fire rated ironmongery, including handles, hinges, door lock with thumb turn, overhead door closer and fire resistant glazing, plus "Keep Fire Door Shut" signs. The client may wish to consider replacing the doors as part of a planned maintenance scheme.

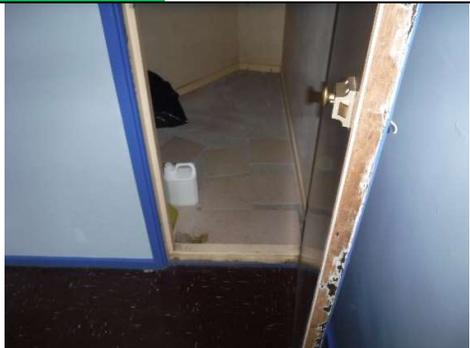
LOW		3

Assessors Observations: The doors to the internal 4 nr store rooms accessed off the staircase landings and lobbies are timber fire doors in reasonable condition, hung on 1½ pairs of hinges, with handles and integrated Perko type door closer devices.	
Date of FRA: 23/08/2017	Recommended Action: We recommend that the internal store doors are upgraded with intumescent strips and cold smoke seals, fire rated ironmongery, including handles, locks where necessary, hinges and overhead door closers.	
Action by: 12 Months		
Action Actioned by: Date:		
Review: Reviewed by: Date:

The doors to the internal 4 nr store rooms accessed off the staircase landings and lobbies are timber fire doors in reasonable condition, hung on 1½ pairs of hinges, with handles and integrated Perko type door closer devices. We recommend that the internal store doors are upgraded with intumescent strips and cold smoke seals, fire rated ironmongery, including handles, locks where necessary, hinges and overhead door closers, plus "Keep Fire Door Shut" signs. The client may wish to consider replacing the doors as part of a planned maintenance scheme.

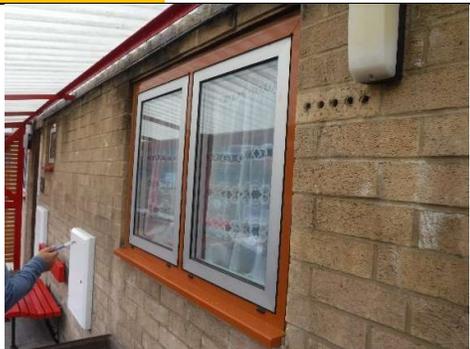
MEDIUM		4

Assessors Observations: Flat 6 is internally arranged so that the kitchen window is overlooking the external walkway fire escape.	
Date of FRA: 23/08/2017	Recommended Action: Under normal circumstances, it would be advised to upgrade the kitchen windows to provide 60-minute fire resistance. However, as these windows are aluminium framed, openable and are part of the Listed Building status, it would require a complete redesign of the windows and connecting to the fire alarm with an automatic closer fitted. We believe that it is not reasonably practicable to upgrade these windows.	
Action by: None		
Action Actioned by: Date:		
Review: Reviewed by: Date:

Flat 6 is internally arranged so that the kitchen window is overlooking the external walkway fire escape. Under normal circumstances, it would be advised to upgrade the kitchen windows to provide 60-minute fire resistance. However, as these windows are aluminium framed, openable and are part of the Listed Building status, it would require a complete redesign of the windows and connecting to the fire alarm with an automatic closer fitted. We believe that it is not reasonably practicable to upgrade these windows.
