**FIRE RISK ASSESSMENT
AVONDALE HOUSE,
50 RABY WAY, BYKER,
NEWCASTLE UPON TYNE, NE6 2FR**

26 OCTOBER 2018

Reference: IR-3474-05-18

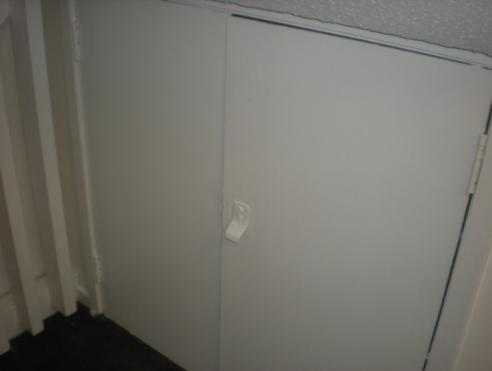
MEDIUM	1

Assessors Observations: The door to the hall storage space below the main stairs is not locked. In addition, there is a breach to its ceiling inside from the passing of services through the fire compartment barrier ceiling.
Date First Identified:	26/10/18	Recommended Action: Ensure that the ceiling in the entrance foyer under stair storage cupboard is fire stopped in order to secure and maintain the compartment ceiling. In addition, this store must be kept locked and fitted with signage indicating 'fire door, keep locked'. Ensure that the door is a fire door rated (FD30)
Rectify Within: (months)	6	
Budget Cost:	£300

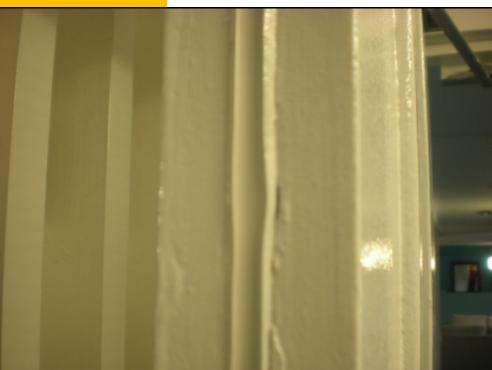
MEDIUM	2

Assessors Observations: The cold smoke seals to the entrance door from lobby to communal lounge are painted over and as a result would fail to operate to their full potential.
Date First Identified:	26/10/18	Recommended Action: Replace the cold smoke seals in the entrance door from lobby to communal lounge.
Rectify Within: (months)	6	
Budget Cost:	£35

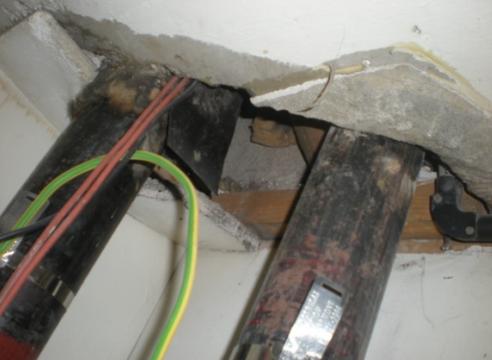
MEDIUM	9

Assessors Observations: There is a breach of compartmentation in the ceiling of the server room from passing services.	
Date First Identified:	26/10/18	Recommended Action: Ensure that the fire compartmentation is maintained by fire stopping the passing of all services through compartment walls and ceilings in order to maintain the fire resistant rating of the barrier.
Rectify Within: (months)	6	
Budget Cost:	£50

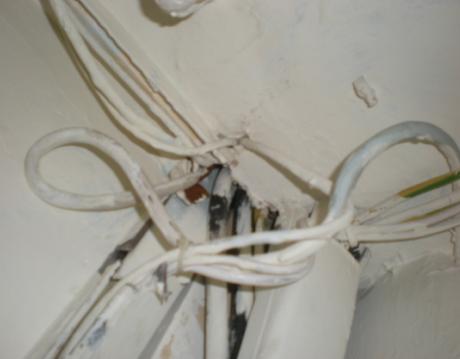
MEDIUM	10

Assessors Observations: There are several breaches of the compartmentation in the ceiling of the first floor stores next to the door into the training room from passing services.	
Date First Identified:	26/10/18	Recommended Action: Ensure that the fire compartmentation is maintained by fire stopping the passing of all services through compartment walls and ceilings in order to maintain the fire resistant rating of the barrier.
Rectify Within: (months)	6	
Budget Cost:	£50
