**FIRE RISK ASSESSMENT
1-52 RABYGATE, BYKER,
NEWCASTLE UPON TYNE,
NE6 2EF**

6 MARCH 2019

Reference: 3660-01-19-IR

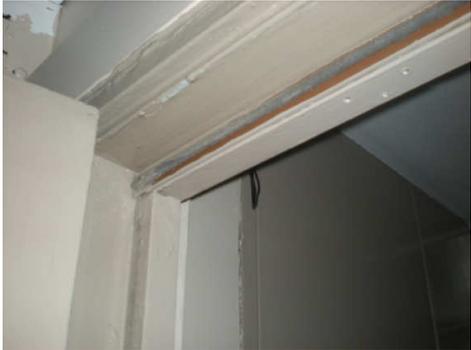
MEDIUM		1

<p>Assessors Observations:</p> <p>The following Service cupboards are fitted with fire doors (FD60) however; they are not fitted with intumescent strips and cold smoke seals;</p> <ul style="list-style-type: none"> • Refuse store on 7th floor (stair15) partial. • 5th floor refuse store near apartment 31 (stair 15) • 4th floor refuse store near apartment 30 (stair 15) • Ground floor communications room (stair 15) • Ground floor refuse store next to apartment 9 (stair 16) • 4th floor refuse store next to apartment 12
Date First Identified:	06/03/2019	<p>Recommended Action:</p> <p>Fit intumescent strips and cold smoke seals to the fire doors listed above.</p> <p>In addition, we would recommend a full survey of the standard and compliance of all fire doors opening onto the protected stairs means of escape.</p>
Rectify Within: (months)	6	
Budget Cost:	£210

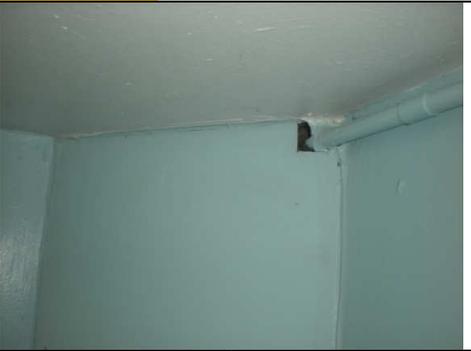
MEDIUM		2

<p>Assessors Observations:</p> <p>The presence of what appear to be asbestos panels in addition to some timber panels that have replaced damaged panels has the potential to conceal significant breaches in compartmentation from within the protected stairs.</p>
Date First Identified:	06/03/2019	<p>Recommended Action:</p> <p>We recommend that the breaches are fire stopped to provide the same level of fire resistance as the wall and/or ceiling.</p> <p>In addition, due to the consistent evidence of compartmentation breaches within this block in addition to other sections of the Byker wall, we would strongly recommend a full compartment survey.</p>
Rectify Within: (months)	6	
Budget Cost:	£250

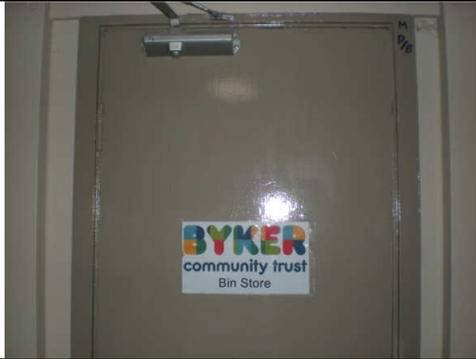
MEDIUM		3

Assessors Observations: The following fire doors are not fitted with signage indicating 'fire door, keep locked'; <ul style="list-style-type: none"> • The refuse store near apartment 30 in stair 15 • The communications room on stair 16
		Recommended Action: Ensure that signage indicating 'fire door, keep locked' is fitted to the above fire doors in compliance with BS 5499.
Date First Identified:	06/03/2019	
Rectify Within: (months)	6	
Budget Cost:	£20

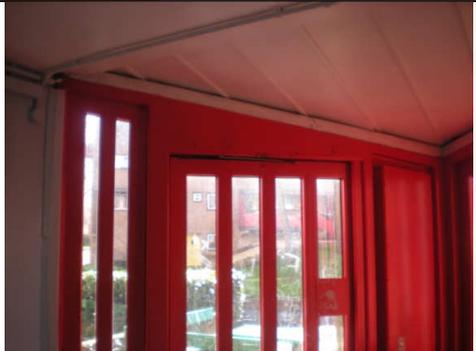
MEDIUM		4

Assessors Observations: The following final exits are not fitted with fire exit signs; <ul style="list-style-type: none"> • Exit 15 • Exit 16
		Recommended Action: Fit fire exits signs which conform with BS5499 to the following fire exit doors; <ul style="list-style-type: none"> • Exits 15 & 16
Date First Identified:	06/03/2019	
Rectify Within: (months)	6	
Budget Cost:	£20
