**FIRE RISK ASSESSMENT
1-55 SHIPLEY RISE, BYKER,
NEWCASTLE UPON TYNE,
NE6 2DF**

6 MARCH 2019

STORM TEMPEST
PROPERTY CONSULTANCY

Reference: 3660-01-19-IR

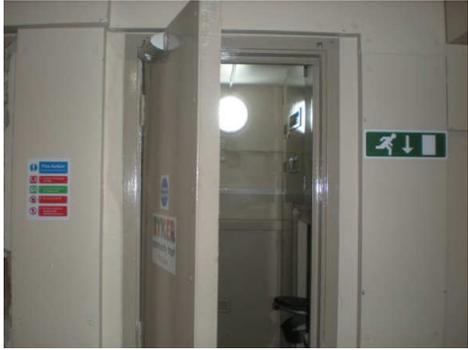
MEDIUM		1

<p>Assessors Observations:</p> <p>The following Service cupboards are fitted with fire doors (FD60) however; they are not fitted with intumescent strips and cold smoke seals;</p> <ul style="list-style-type: none"> • 1st floor service store (stair14) • 3rd floor refuse store (stair 14) • 3rd floor service store next to refuse (stair 14) • 4th floor, both store next to 22 Apt (stair 14) • Ground floor store opposite lift (stair 13) • 2nd floor refuse store (stair 13) • 3rd floor refuse store (stair 12)
Date First Identified:	06/03/2019	<p>Recommended Action:</p> <p>Fit intumescent strips and cold smoke seals to the fire doors listed above.</p> <p>In addition, we would recommend a full survey of the standard and compliance of all fire doors opening onto the protected stairs means of escape.</p>
Rectify Within: (months)	6	
Budget Cost:	£245

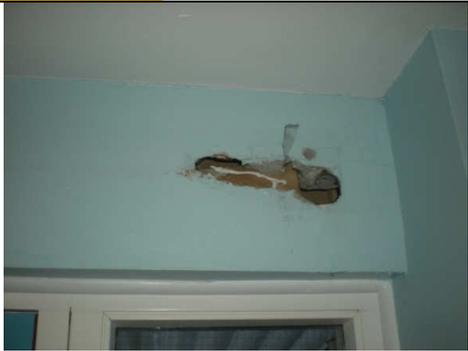
MEDIUM		2

<p>Assessors Observations:</p> <p>There are several visible breaches of compartmentation and fire stopping within the protected staircases in the following locations;</p> <ul style="list-style-type: none"> • Within the 3rd floor refuse store in stair 14 • Within the 2nd floor refuse store in stair 13 • 4th floor lobby above door (photo opposite) <p>Note; we are aware of the potential for more hidden breaches due to evidence within previous blocks.</p>
Date First Identified:	06/03/2019	<p>Recommended Action:</p> <p>We recommend that the breaches are fire stopped to provide the same level of fire resistance as the wall and/or ceiling.</p> <p>In addition, due to the consistent evidence of compartmentation breaches within this block in addition to other sections of the Byker wall, we would strongly recommend a full compartment survey.</p>
Rectify Within: (months)	6	
Budget Cost:	£250

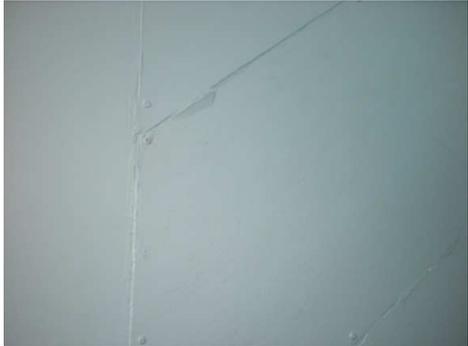
MEDIUM		3

<p>Assessors Observations:</p> <p>The presence of what appear to be asbestos panels in addition to some timber panels that have replaced damaged panels has the potential to conceal significant breaches in compartmentation from within the protected stairs.</p>
Date First Identified:	06/03/2019	<p>Recommended Action:</p> <p>We recommend that the breaches are fire stopped to provide the same level of fire resistance as the wall and/or ceiling.</p> <p>In addition, due to the consistent evidence of compartmentation breaches within this block in addition to other sections of the Byker wall, we would strongly recommend a full compartment survey.</p>
Rectify Within: (months)	6	
Budget Cost:	£250

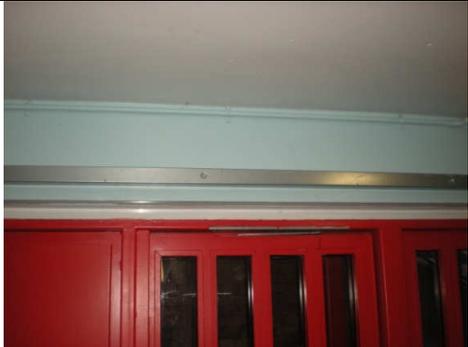
MEDIUM		4

<p>Assessors Observations:</p> <p>The following fire exits are not fitted with fire exit signage;</p> <ul style="list-style-type: none"> • All three final exits at ground floor level at entrances 12, 13 and 14. • The fire exit from the upper floor balcony into stair 12.
Date First Identified:	06/03/2019	<p>Recommended Action:</p> <p>Ensure that signage indicating 'fire door, keep locked' is fitted to the above fire doors in compliance with BS 5499.</p>
Rectify Within: (months)	6	
Budget Cost:	£40
