**FIRE RISK ASSESSMENT**  
**76-88 & 91 TOM COLLINS HOUSE,**  
**BYKER, NEWCASTLE UPON TYNE,**  
**TYNE & WEAR**

NOVEMBER 2016

**Reference:** JR – 3159-10-16

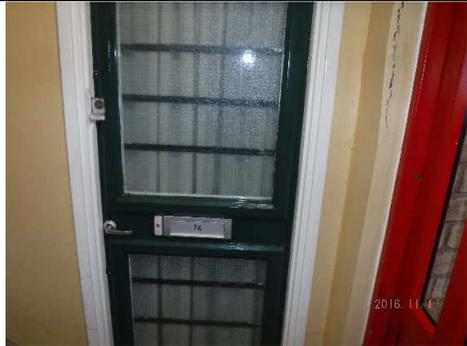
LOW		1

<p><b>Assessors Observations:</b></p> <p>At the time of the survey we were unable to gain access into any of the flats on the enclosed stairwell.</p>
Date of FRA:	17/11/2016	<p><b>Recommended Action:</b></p> <p>We recommend the Flat entrance doors to 76, 80, 85 &amp; 91 are inspected and upgraded if necessary to meet the requirements of a FD30S fire doors fitted with self-closing devices and fire rated letter boxes.</p>
Action by:	12 Months	
<p><b>Action</b></p> <p>Actioned by:</p> <p>Date:</p>		
<p><b>Review:</b></p> <p>Reviewed by:</p> <p>Date:</p>		
<p>Date:</p>		
LOW		2

At the time of the survey we were unable to gain access into any of the flats on the enclosed stairwell. We recommend the Flat entrance doors to 76, 80, 85 & 91 are inspected and upgraded if necessary to meet the requirements of a FD30S fire doors fitted with self-closing devices and fire rated letter boxes.

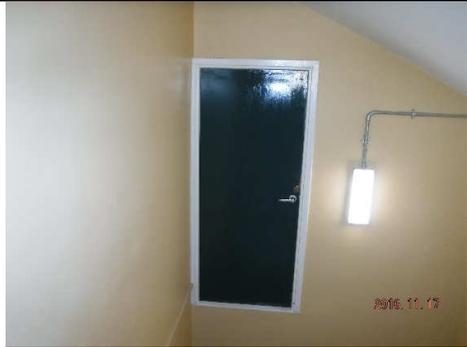
The cupboard door on the stairwell is believed to be a solid core fire door, the door is however without intumescent strips, cold smoke seals and hung on only one pair of hinges. We recommend the cupboard door is fitted with intumescent strips, cold smoke seals, suitable lock, hung on 1½ pairs of fire rated hinges and labelled with a sign reading 'Fire door keep shut'.

<p><b>Assessors Observations:</b></p> <p>The cupboard door on the stairwell is believed to be a solid core fire door, the door is however without intumescent strips, cold smoke seals and hung on only one pair of hinges.</p>
Date of FRA:	17/11/2016	<p><b>Recommended Action:</b></p> <p>We recommend the cupboard door is fitted with intumescent strips, cold smoke seals, suitable lock, hung on 1½ pairs of fire rated hinges and labelled with a sign reading 'Fire door keep shut'.</p>

Action by:	12 Months	
<p><b>Action</b></p> <p>Actioned by:</p> <p>Date:</p>		
<p><b>Review:</b></p> <p>Reviewed by:</p> <p>Date:</p>		
<p>Date:</p>

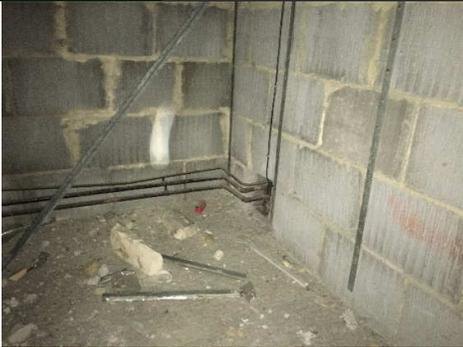
<b>LOW</b>	<b>3</b>

<p><b>Assessors Observations:</b></p> <p>At the time of the survey several service penetrations were found in compartmenting walls between the stairwell cupboard and flats.</p>
<p>Date of FRA: 17/11/2016</p> <p>Action by: 12 Months</p>		<p><b>Recommended Action:</b></p> <p>We recommend the penetrations in the cupboard compartmenting walls are blocked up with fire rated materials.</p>
<p><b>Action</b></p> <p>Actioned by:</p> <p>Date:</p>		
<p><b>Review:</b></p> <p>Reviewed by:</p> <p>Date:</p>

4.3 Fire Compartmentation	Due to building's construction we believe the fire compartmentation is generally good.
	Most of the escape routes are open air and do not require compartmentation. The enclosed communal stairwell requires good compartmentation to ensure a safe escape route. We recommend doors on the enclosed stairwell are upgraded as per recommendations in Item 4.2.
	At the time of the survey several service penetrations were found in compartmenting walls between the stairwell cupboard and flats. We recommend the penetrations in the cupboard compartmenting walls are blocked up with fire rated materials.

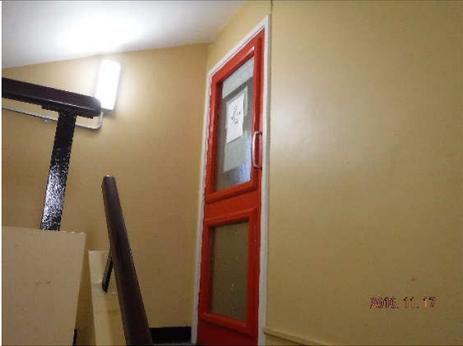
<b>LOW</b>	<b>4</b>

<p><b>Assessors Observations:</b></p> <p>At the time of the survey we were unable to identify if the bulk head light units were emergency lights. We assume the existing wall mounted lights in communal areas are not emergency light units.</p>
<p>Date of FRA: 17/11/2016</p> <p>Action by: 12 Months</p>		<p><b>Recommended Action:</b></p> <p>We recommend the light units in the enclosed stairwell are either replaced with emergency light units or additional emergency lighting are installed to the areas. Light units should be installed in accordance with BS5266.</p>
<p><b>Action</b></p> <p>Actioned by:</p> <p>Date:</p>		
<p><b>Review:</b></p> <p>Reviewed by:</p> <p>Date:</p>

4.5 Emergency Lighting	The communal escape routes are covered by wall mounted bulk head light units. At the time of the survey we were unable to identify if the bulk head light units were emergency lights. We assume the existing wall mounted lights in communal areas are not emergency light units. We recommend the light units in the enclosed stairwell are either replaced with emergency light units or additional emergency lighting are installed to the areas. Light units should be installed in accordance with BS5266.

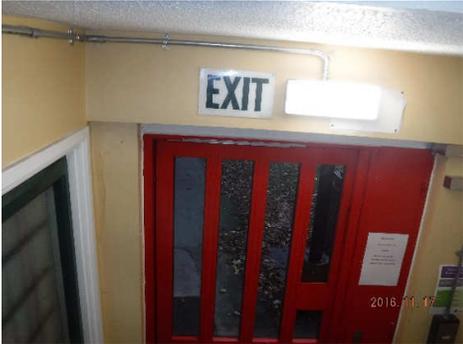
LOW	5

<p><b>Assessors Observations:</b></p> <p>The escape signage above the final exit door on the lower ground floor is an old sign.</p>	
<p>Date of FRA: 17/11/2016</p> <p>Action by: 12 Months</p> <p><b>Action</b></p> <p>Actioned by:</p> <p>Date:</p> <p><b>Review:</b></p> <p>Reviewed by:</p> <p>Date:</p>	<p><b>Recommended Action:</b></p> <p>We recommend the sign above the final exit door on the lower ground floor is replaced with a new fire exit sign.</p>

The escape signage above the final exit door on the lower ground floor is an old sign. We recommend the sign above the final exit door on the lower ground floor is replaced with a new fire exit sign.
