**FIRE RISK ASSESSMENT
AVONDALE HOUSE,
50 RABY WAY, BYKER,
NEWCASTLE UPON TYNE NE6 2FR**

31 OCTOBER 2019

STORM TEMPEST
PROPERTY CONSULTANCY

Reference: IR-3660-01-19

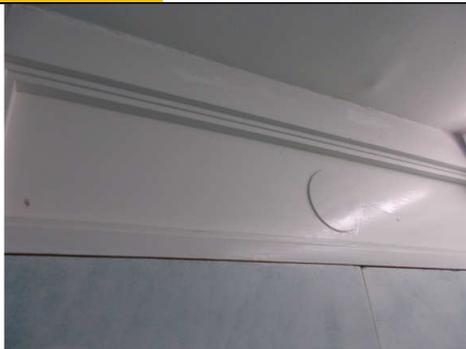
| MEDIUM | | 1 |

In addition, the cupboards outside apartments 5 and 16 are fitted with plywood timber transoms which will not provide a minimum of 30 minutes fire resistance (This is not as vital as would normally be due to the cupboards not being in use as previously described however; the matter should still be addressed within a suitable time frame).

| MEDIUM | | 1 |
|---|---|--|
| | | <p>Assessors Observations:</p> <p>The storage cupboards next to apartments 5 & 16 have plywood transoms above the doors which do not provide a minimum of 30 minutes fire resistance.</p> |

| MEDIUM | | 1 |
|---|---|--|
| Date First Identified: | 31/10/2019 | <p>Recommended Action:</p> <p>Replace the timber transom panels above the doors with fire resistant material that will provide a minimum of 30 minutes fire resistance.</p> |

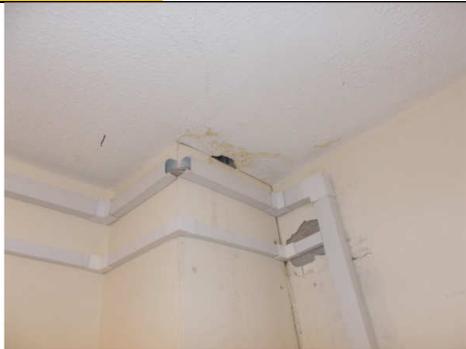
| MEDIUM | | 2 |

No breaches of fire compartmentation were noted with the exception of those identified within the schedule of observations inside the server room. In addition, the server room is fitted with a window onto the means of escape which does not appear to be fire resistant and therefore, could compromise the means of escape.

| MEDIUM | | 2 |
|---|---|--|
| | | <p>Assessors Observations:</p> <p>There are still minor breaches of compartmentation from passing services within the server room.</p> <p>In addition, the glazed panel window in the server room does not appear to be fire resistant?</p> |

| MEDIUM | | 2 |
|---|---|--|
| Date First Identified: | 31/10/2019 | <p>Recommended Action:</p> <p>Ensure that within the server room, the breaches of compartmentation are fire stopped and sealed in order to provide a minimum of 30 minutes fire resistance. In addition, either; confirm that the glazing will provide a minimum of 30 minutes fire resistance, replace the window with glazing that offers a minimum of 30 minutes fire resistance or block the window to provide a minimum of 30 minutes fire resistance.</p> |

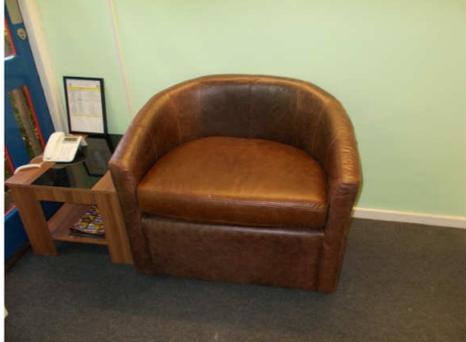
| MEDIUM | | 3 | |

| | | Assessors Observations: | There is furniture located within the means of escape which do not conform to the Furniture and furnishings (fire safety) regulations 1988. |

| Date First Identified: | 31/10/2019 | Recommended Action: | All items of furniture located upon means of escape should be carefully managed in order not to pose an obstruction in an evacuation. In addition, they must conform to the Furniture and furnishings (fire safety) regulations 1988. |

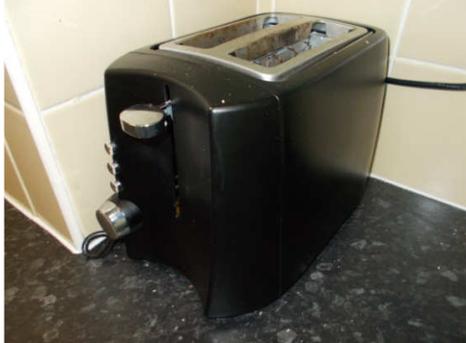
| MEDIUM | | 4 | |

There is no record of PAT testing for portable electrical equipment which is the responsibility of the Armed Forces and Veterans Launch Pad organisation.

| | | Assessors Observations: | Portable electrical equipment has not been made the subject of routine inspection or testing. |

| Date First Identified: | 31/10/2019 | Recommended Action: | Ensure that all portable electrical equipment is made subject to a routine inspection and testing regime. This could be achieved by PAT testing or a similar method. The results must be recorded for inspection. |
