FIRE RISK ASSESSMENT
1 – 3 BRINKBURN CLOSE, BYKER,
NEWCASTLE UPON TYNE
NE6 2HW

JANUARY 2020

STORM TEMPEST
PROPERTY CONSULTANCY

Reference: 3660-01-19-IC

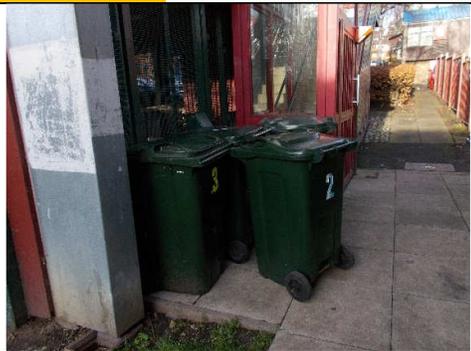
MEDIUM		1

It was noted the external wheelie bins were being stored adjacent to the entrance door to the stair. Should these become accidentally or deliberately ignited, the resultant fire may compromise the exit door for the premises. We recommend the bins are relocated away from the building.

Assessors Observations:			
		<p>The external wheelie bins were being stored adjacent to the entrance door to the stair. Should these become accidentally or deliberately ignited, the resultant fire may compromise the exit door for the premises.</p>			
		Date First Identified:	10/01/20	Recommended Action:	
		Rectify Within: (months)	6	<p>We recommend the bins are relocated away from the building.</p>	
Budget Cost:	No Cost

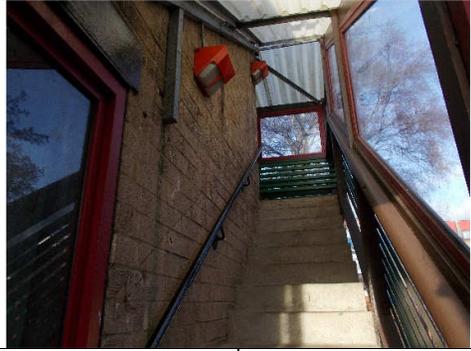
LOW		2

There are five bulk head style light fittings installed to illuminate the common means of escape. We understand these are connected to a separate electrical supply for the building. We recommend the client confirms this electrical installation has been subject to a five-year fixed wiring inspection by a competent engineer, and if not, arrange for this to be carried out as soon as practicable.

Assessors Observations:			
		<p>There are five bulk head style light fittings installed to illuminate the common means of escape. We understand these are connected to a separate electrical supply for the building.</p>			
		Date First Identified:	10/01/20	Recommended Action:	
		Rectify Within: (months)	12	<p>We recommend the client confirms this electrical installation has been subject to a five-year fixed wiring inspection by a competent engineer, and if not, arrange for this to be carried out as soon as practicable.</p>	
Budget Cost:	No Cost

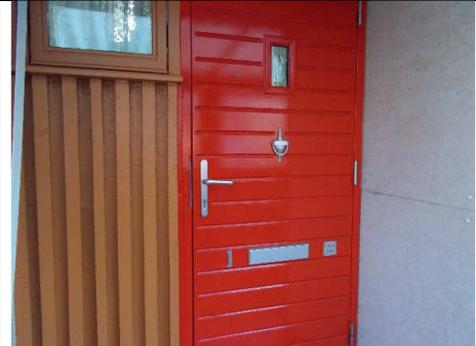
MEDIUM		4

4.2 Fire Doors The flat entrance doors to the property are off the 1st floor semi enclosed balcony. We were able to gain access to apartment 2 in order to inspect the specification of its entrance door. The entrance doors are good quality timber doors with timber clad side panel, timber framed window, and open with the direction of travel in an evacuation. However, it was noted that the flat entrance doors do not appear to be fire doors. We recommend the flat entrance doors to the first two apartments (flat numbers 1+2) opening onto the common walkway /balcony should be FD30S doors with a self-closing device fitted. This will ensure residents can evacuate their apartments and be able to pass a fire within an adjoining flat and reach the stairway/final exit. (LGG Fire Safety in Purpose Built Blocks of Flats Sec 59.5).

Assessors Observations:		
		The flat entrance doors do not appear to be fire doors.		
		Date First Identified:	10/01/20	Recommended Action:
		Rectify Within: (months)	6	We recommend the flat entrance doors to the first two apartments (flat numbers 1+2) opening onto the common walkway /balcony should be FD30S doors with a self-closing device fitted. This will ensure residents can evacuate their apartments and be able to pass a fire within an adjoining flat and reach the stairway/final exit. (LGG Fire Safety in Purpose Built Blocks of Flats Sec 59.5).
Budget Cost:	£2,000
