**FIRE RISK ASSESSMENT
10 – 14 RABY CROSS, BYKER,
NEWCASTLE UPON TYNE
NE6 2AL**

FEBRUARY 2020

Reference: 3660-01-19-IC

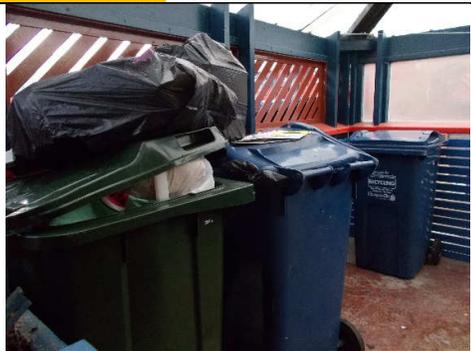
MEDIUM		1

It was noted the residents wheeled bins are being stored adjacent to the top of the stair leading to the apartments. Should these become accidentally or deliberately ignited, the resultant fire will compromise the exit stair for the premises and is likely to spread to the timber on the balcony walkway. We recommend these bins are relocated to a secure area away from the means of escape.

As previously mentioned above, there are three wheeled bins as well as additional refuse at the head of the stair adjacent apartment 10. Not only do these partially obstruct the means of escape but these are also a fire hazard.

Assessors Observations: The residents wheeled bins are being stored adjacent to the top of the stair leading to the apartments. Should these become accidentally or deliberately ignited, the resultant fire will compromise the exit stair for the premises and is likely to spread to the timber on the balcony walkway.	
Date First Identified:	18/02/20	Recommended Action: We recommend these bins are relocated to a secure area away from the means of escape.	
Rectify Within: (months)	4		
Budget Cost:	No Cost

The risk of an arson attack is considered medium. The premises have secure access, however, as previously mentioned, the wheeled bins are currently being stored on the means of escape and should be relocated to a secure area away from the building.

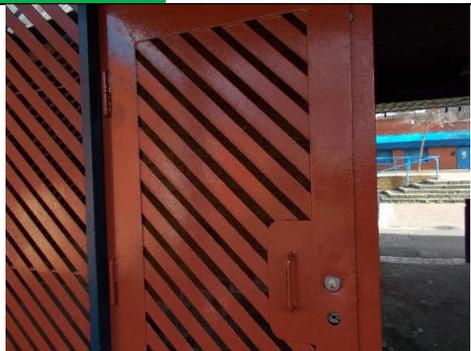
LOW		4

It was noted there is no "Fire Exit Keep Clear" sign attached to the external side of the final exit door at the foot of the stair. We recommend this is attached.

Assessors Observations:		
		There is no "Fire Exit Keep Clear" sign attached to the external side of the final exit door at the foot of the stair.		
		Date First Identified:	18/02/20	Recommended Action:
		Rectify Within: (months)	12	
Budget Cost:	£10			
		We recommend this is attached.
