**FIRE RISK ASSESSMENT
1-5 THE CHEVRON, BYKER,
NEWCASTLE UPON TYNE
NE6 1RP**

28 FEBRUARY 2020

Reference: 3660-01-19-IR

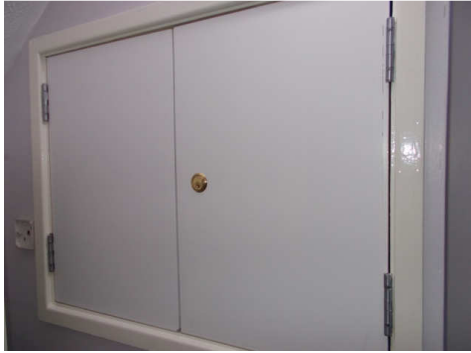
MEDIUM		1

The mains electrical supply and distribution equipment are located within the ground floor hall timber cupboard however; the structure would appear to be constructed of plywood and therefore is unlikely to be fire resistant.

<p>Assessors Observations:</p> <p>There is a timber electrical cupboard located in the ground floor hall of this single staircase means of escape.</p>
Date First Identified:	28/02/2020	<p>Recommended Action:</p> <p>Confirm that the electrical cupboard affords a minimum of 30 minutes fire resistance or, alternatively, install storage within the ground floor hall (which could affect both fire exits) which does provide a minimum of 30 minutes fire resistance.</p>
Rectify Within: (months)	6	
Budget Cost:	No cost if compliant (£500 if not)

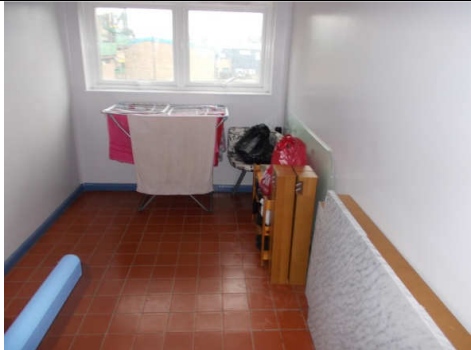
MEDIUM		2

The means of escape are sterile and clear with the exception of the timber electrical cupboard within the ground floor hall and the laundry and furnishings on the first floor landing.

<p>Assessors Observations:</p> <p>There are combustibile items and potential obstructions stored on the means or escape first floor landing.</p>
Date First Identified:	28/02/2020	<p>Recommended Action:</p> <p>All items must be removed from the means of escape landings. Residents must be reminded that all means of escape must be clear at all times.</p>
Rectify Within: (months)	6	
Budget Cost:	No cost
