**FIRE RISK ASSESSMENT
6-14 THE CHEVRON, BYKER,
NEWCASTLE UPON TYNE
NE6 1RP**

28 FEBRUARY 2020

Reference: 3660-01-19-IR

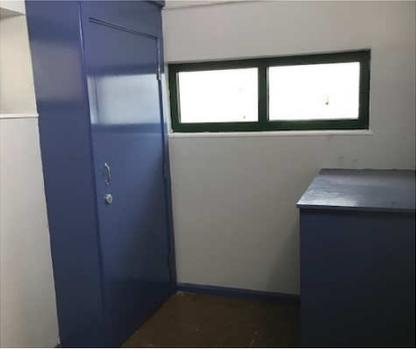
MEDIUM		1

located within the ground floor hall timber cupboard which is fitted with a fire door however; the structure would appear to be constructed of plywood and therefore is unlikely to be fire resistant.

The means of escape are sterile and clear with the exception of the timber refuse cabinet and electrical cupboard within the ground floor hall.

<p>Assessors Observations:</p> <p>There is a timber refuse store and a timber electrical cupboard located in the ground floor hall of this single staircase means of escape.</p>
Date First Identified:	28/02/2020	<p>Recommended Action:</p> <p>Confirm that the refuse store and electrical cupboard afford a minimum of 30 minutes fire resistance or, alternatively, install storage within the ground floor hall (which could affect both fire exits) which does provide a minimum of 30 minutes fire resistance.</p>
Rectify Within: (months)	6	
Budget Cost:	No cost if compliant (£1000 if not)

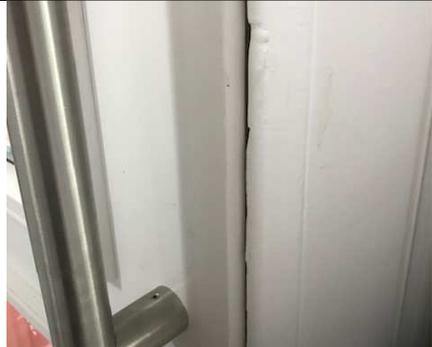
MEDIUM		2

<p>Assessors Observations:</p> <p>The fire door to the second floor balcony is not closing fully onto the rebate under its own weight.</p>
Date First Identified:	28/02/2020	<p>Recommended Action:</p> <p>Adjust the self closing device to enable the fire door to close fully onto the rebate under its own weight.</p>
Rectify Within: (months)	6	
Budget Cost:	£35

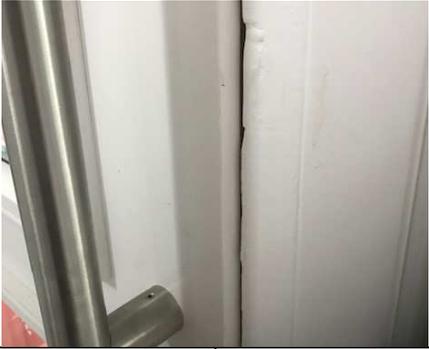
MEDIUM		3

4.2 Fire Doors Within the staircase, all balcony doors would appear to be fire doors however; they are not complete with intumescent strips and smoke seals. In addition, the second floor balcony door is not closing fully onto the rebate under its own weight. The apartment doors would also appear to be fire doors (FD30S) complete with intumescent strips and smoke seals however; they are fitted with what appear to be standard letterboxes. Therefore, it should be confirmed that the letterboxes are fitted with intumescent seals? (Note; apartments 12 and 13 were inspected).

<p>Assessors Observations:</p> <p>The fire doors to the balconies are not fitted with intumescent strips and smoke seals.</p>
Date First Identified:	28/02/2020	<p>Recommended Action:</p> <p>Install intumescent strips and smoke seals to the balcony fire doors.</p>
Rectify Within: (months)	6	
Budget Cost:	£300
