**FIRE RISK ASSESSMENT
9-14 THE BROW, BYKER,
NEWCASTLE UPON TYNE,
NE6 2FL**

28 FEBRUARY 2020

Reference: 3660-01-19-IR

FIRE RISK ASSESSMENT
14-19 HEADLAM GREEN, BYKER,
NEWCASTLE UPON TYNE
NE6 2NZ

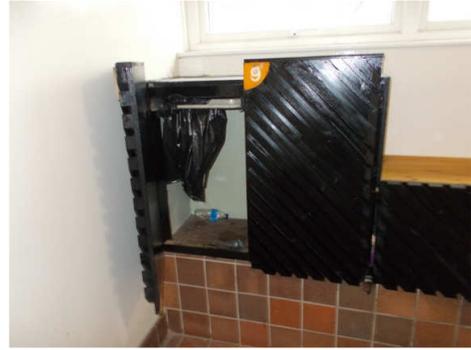
MEDIUM		1

Assessors Observations: There is refuse stored on the landings in the means of escape within timber units which pose a risk from an arson attack.	
Date First Identified:	28/02/2020	Recommended Action: While it is accepted that access is secure and restricted to residents and bona-fide guests, the procedure of storing refuse on the landings should cease as this is a single access stair case only and the only means of escape for all residents.	
Rectify Within: (months)	6		
Budget Cost:	No cost

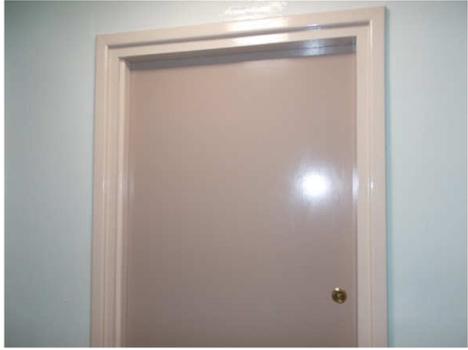
MEDIUM		1

Assessors Observations: There is no sign indicating 'fire door keep locked' fitted to the ground floor electrical cupboard.	
Date First Identified:	28/02/2020	Recommended Action: Fit a sign indicating 'fire door keep locked' fitted to the ground floor electrical cupboard.	
Rectify Within: (months)	6		
Budget Cost:	£50
