**FIRE RISK ASSESSMENT
AVONDALE HOUSE,
50 RABY WAY, BYKER,
NEWCASTLE UPON TYNE NE6 2FR**

OCTOBER 2020

Reference: 3888-06-20-PD

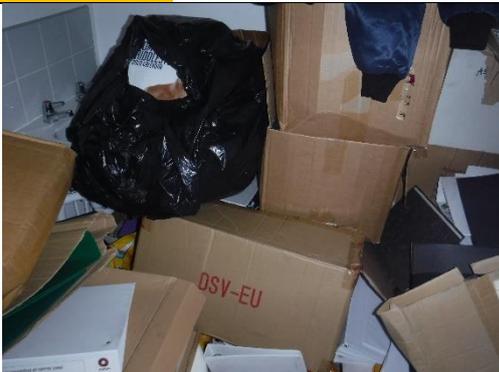
MEDIUM		1

A large amount of waste paper and cardboard was stored in a redundant WC adjacent to flat 10. We recommend that this combustible waste is removed from this location.

Assessors Observations: A large amount of waste paper and cardboard was stored in a redundant WC adjacent to flat 10.	
Date First Identified:	28/10/20	Recommended Action: We recommend that this combustible waste is removed from this location.	
Date of FRA:	28/10/20		
Rectify Within: (months)	6		
Budget Cost:	No Cost

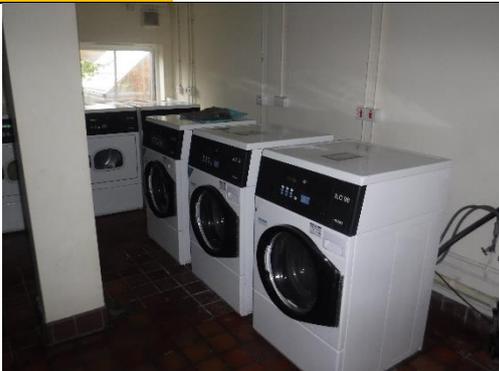
MEDIUM		2

At the time of the visit there was no evidence to show that the

laundry equipment is subject to regular maintenance. We recommend the client considers the introduction of a maintenance contract for this equipment which includes the cleaning of the drier ductwork.

Assessors Observations: At the time of the visit there was no evidence to show that the laundry equipment is subject to regular maintenance.	
Date First Identified:	28/10/20	Recommended Action: We recommend the client considers the introduction of a maintenance contract for this equipment which includes the cleaning of the drier ductwork.	
Date of FRA:	28/10/20		
Rectify Within: (months)	6		
Budget Cost:	No Cost

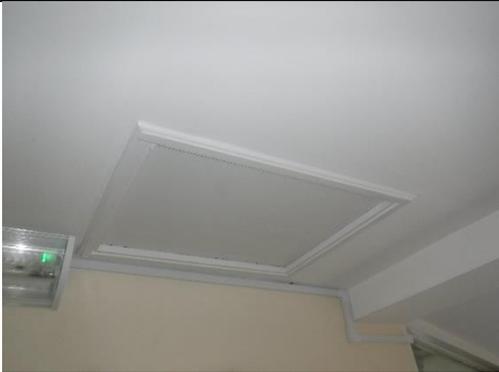
MEDIUM		3

Timber push up type loft access panels are located within the means of escape routes x3. We recommend that the hatches are replaced with a fire rated hatch with a fire resistance of 60 minutes.

Assessors Observations: Timber push up type loft access panels are located within the means of escape routes x3.	
Date First Identified:	28/10/20	Recommended Action: We recommend that the hatches are replaced with a fire rated hatch with a fire resistance of 60 minutes.	
Date of FRA:	28/10/20		
Rectify Within: (months)	6		
Budget Cost:	£375

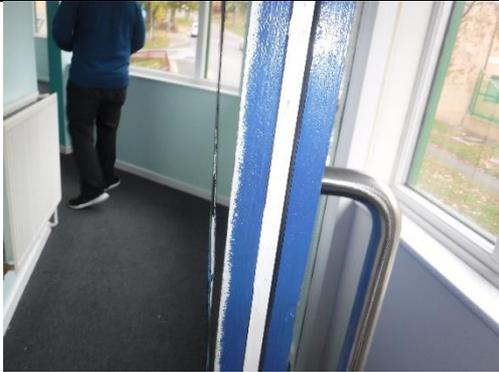
MEDIUM		4

We noted that the “rubber fin” type cold smoke seals on the flat entrance doors and doors within the common areas had started to degrade. We recommend that the fire doors are inspected and that the cold smoke seals are replaced as required.

Assessors Observations: We noted that the "rubber fin" type cold smoke seals on the flat entrance doors and doors within the common areas had started to degrade.	
Date First Identified:	28/10/20	Recommended Action: We recommend that the fire doors are inspected and that the cold smoke seals are replaced as required.	
Date of FRA:	28/10/20		
Rectify Within: (months)	6 Month		
Budget Cost:	£25 per door

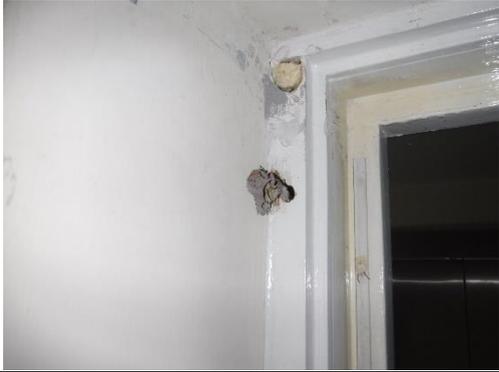
MEDIUM		5

The stairwell door outside flat 26 has damage to the frame where it has been drilled for services. We recommend that the hole in the door frame is fire stopped with suitable fire stopping materials.

Assessors Observations: The stairwell door outside flat 26 has damage to the frame where it has been drilled for services.	
Date First Identified:	28/1/020	Recommended Action: We recommend that the hole in the door frame is fire stopped with suitable fire stopping materials.	
Date of FRA:	28/10/20		
Rectify Within: (months)	6		
Budget Cost:	£20

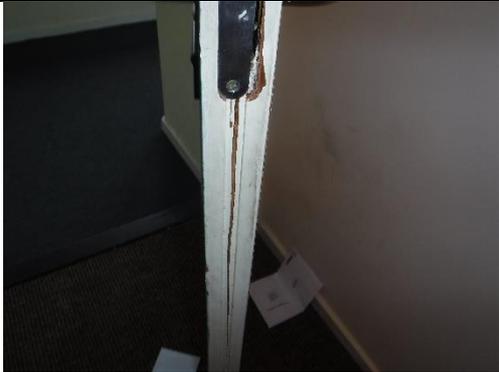
MEDIUM		6

Flat 30, the fire door is damaged beyond repair. We recommend that the fire door is replaced with a fire door set with a rating of FD30s.

Assessors Observations: Flat 30, the fire door is damaged beyond repair.	
Date First Identified:	28/10/20	Recommended Action: We recommend that the fire door is replaced with a fire door set with a rating of FD30s.	
Date of FRA:	28/10/20		
Rectify Within: (months)	6		
Budget Cost:	£400

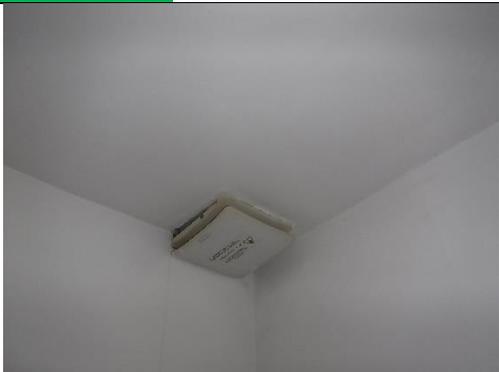
LOW		7

The flats have ceiling mounted extract fans that vent out within the ceiling void. We recommend the client ensure that the extract fans have intumescent collars or damper and appropriate ducting where penetrating through the fire compartmentation ceiling.

<p>Assessors Observations:</p> <p>The flats have ceiling mounted extract fans that vent out within the ceiling void or loft space.</p>
Date First Identified:	28/10/020	<p>Recommended Action:</p> <p>We recommend the client ensure that the extract fans have intumescent collars or damper and appropriate ducting where penetrating through the fire compartmentation ceiling.</p>
Date of FRA:	28/10/20	
Rectify Within: (months)	12	
Budget Cost:	No Cost

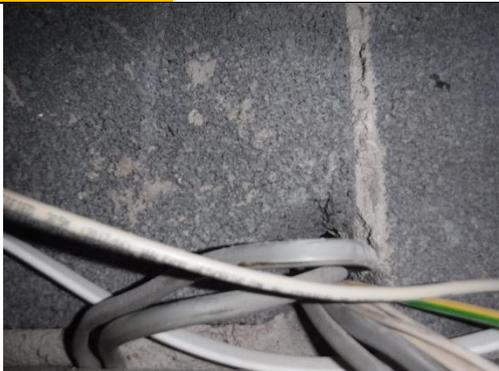
MEDIUM		8

Loft as accessed from landing outside flat 35 and loft above flat 30, we noted gaps around service penetrations that had not been fire stopped or sealed. We recommend that the service penetrations are fire stopped using suitable fire resistant materials. Fire stopping works to be carried out by a 3rd party accredited contractor.

<p>Assessors Observations:</p> <p>Loft as accessed from landing outside flat 35 and loft above flat 30, we noted gaps around service penetrations that had not been fire stopped or sealed.</p>
Date First Identified:	28/10/20	<p>Recommended Action:</p> <p>We recommend that the service penetrations are fire stopped using suitable fire resistant materials. Fire stopping works to be carried out by a 3rd party accredited contractor.</p> <p>We would recommend that a passive survey is undertaken to identify any breaches of compartmentation within the loft spaces.</p>
Date of FRA:	28/10/20	
Rectify Within: (months)	6	
Budget Cost:	£100

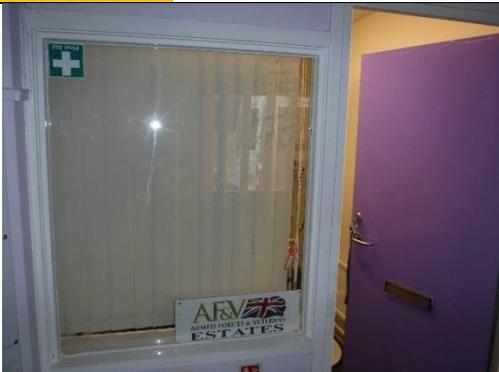
MEDIUM		9

The server room is fitted with a window onto the means of escape which does not appear to be fire resistant and therefore, could compromise the means of escape. We recommend that the glazing is replaced with fire resistant glass.

Assessors Observations: The server room is fitted with a window onto the means of escape which does not appear to be fire resistant and therefore, could compromise the means of escape.	
Date First Identified:	31/10/19	Recommended Action: We recommend that the glazing is replaced with fire resistant glass.	
Date of FRA:	28/10/20		
Rectify Within: (months)	6		
Budget Cost:	£100
