FIRE RISK ASSESSMENT
89-128 TOM COLLINS HOUSE,
DUNN TERRACE, BYKER,
NEWCASTLE UPON TYNE NE6 1DB

FEBRUARY 2021

STORM TEMPEST
PROPERTY CONSULTANCY

Reference: 3855-03-20-IC

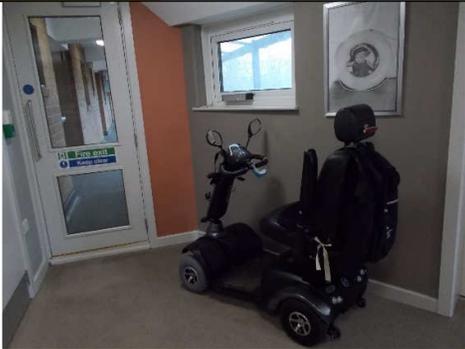
MEDIUM		1

The corridors are generally kept clear of scooters, as scooter stores have been provided on the 6th and 7th floors. At the time of the inspection, there was a scooter stored within the means of escape outside of flat 96. Should a fault and subsequent fire occur within the scooter, this would prevent the means of escape being safely used by residents. It could also hinder firefighters carrying out firefighting tasks elsewhere on the same floor. We recommend that

Assessors Observations:			
		<p>At the time of the inspection, there was a scooter stored within the means of escape outside of flat 96. Should a fault and subsequent fire occur within the scooter, this would prevent the means of escape being safely used by residents. It could also hinder firefighters carrying out firefighting tasks elsewhere on the same floor.</p>			
		Date First Identified:	01/02/21	Recommended Action:	
		Date of FRA	01/02/21	<p>We recommend that residents are reminded not to store scooters in the corridors and use the storage provided.</p>	
		Rectify Within: (months)	6		
Budget Cost:	No Cost

residents are reminded not to store scooters in the corridors and use the storage provided.

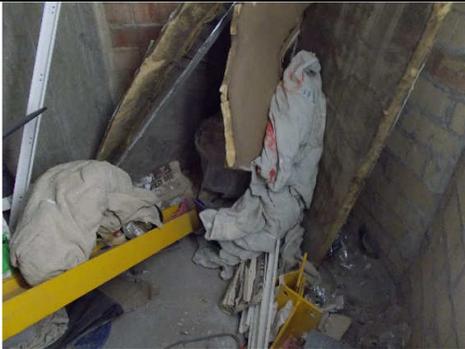
LOW		2

It was noted within the storage cupboard adjacent the comms room 11th floor, there are excessive combustible materials which appear to have been discarded. We recommend these are disposed of if they are no longer needed.

Assessors Observations:			
		<p>Within the storage cupboard adjacent the comms room 11th floor, there are excessive combustible materials which appear to have been discarded.</p>			
		Date First Identified:	01/02/21	Recommended Action:	
		Date of FRA	01/02/21	<p>We recommend these are disposed of if they are no longer needed.</p>	
		Rectify Within: (months)	12		
Budget Cost:	No Cost

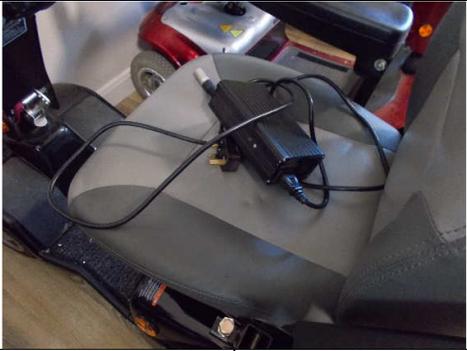
MEDIUM		4

The portable electrical equipment was last made the subject of PAT testing during March 2020. However, it was noted that some of the electrical charging equipment used for the mobility scooters have

Assessors Observations: Some of the electrical charging equipment used for the mobility scooters have not been subject to a PAT test.
Date First Identified:	01/02/21	Recommended Action: We recommend this policy is enforced.
Date of FRA	01/02/21	
Rectify Within: (months)	6	
Budget Cost:	No Cost

not been subject to a PAT test. We recommend this policy is enforced.

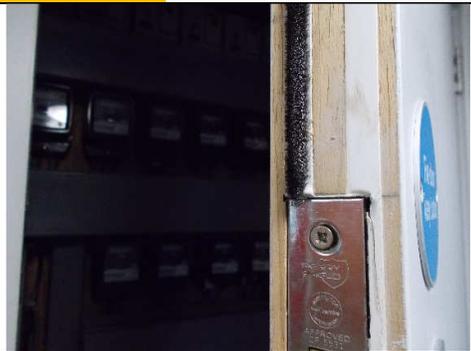
MEDIUM		5

It was noted the meter cupboard doors and the buildings aerial cupboard doors on the 2nd, 5th, 8th, and 10th floors respectively have been fitted with combined intumescent strips with cold smoke seals. Due to the associated electrical hazard and as there is no smoke detection within these cupboards, we recommend the cold smoke seals are removed, leaving the intumescent strips only.

<p>Assessors Observations:</p> <p>The meter cupboard doors and the buildings aerial cupboard doors on the 2nd, 5th, 8th, and 10th floors respectively have been fitted with combined intumescent strips with cold smoke seals.</p>
Date First Identified:	01/02/21	<p>Recommended Action:</p> <p>Due to the associated electrical hazard and as there is no smoke detection within these cupboards, we recommend the cold smoke seals are removed, leaving the intumescent strips only.</p>
Date of FRA	01/02/21	
Rectify Within: (months)	6	
Budget Cost:	£150

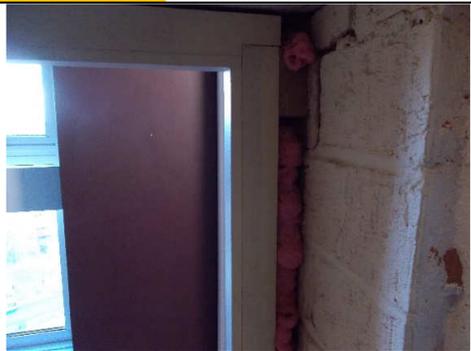
MEDIUM		6

The lift motor room (11th floor) has a FD30S door kept locked. However, the frame for the door is a poor fit with expanding foam being used to take up the excessive gap internally. In a fire situation within this compartment, it is unlikely that the fire will be contained as fire rated foam is only designed to fill very small apertures. We

<p>Assessors Observations:</p> <p>The lift motor room (11th floor) has a FD30S door kept locked. However, the frame for the door is a poor fit with expanding foam being used to take up the excessive gap internally. In a fire situation within this compartment, it is unlikely that the fire will be contained as fire rated foam is only designed to fill very small apertures.</p>
Date First Identified:	01/02/21	<p>Recommended Action:</p> <p>We recommend this foam is removed and the gap is filled with a suitable fire stopping material capable of providing a minimum 30 minutes fire resistance.</p>
Date of FRA	01/02/21	
Rectify Within: (months)	6	
Budget Cost:	£50

recommend this foam is removed and the gap is filled with a suitable fire stopping material capable of providing a minimum 30 minutes fire resistance.

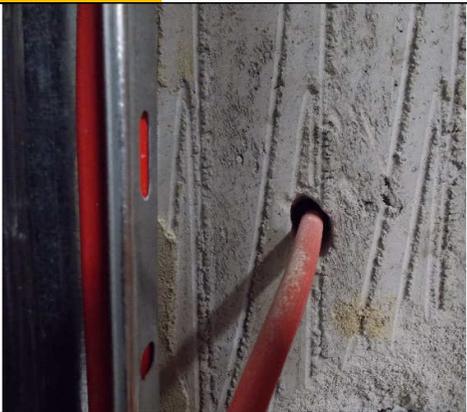
MEDIUM		7

It was noted there is a breach within the electrical cupboard inside the laundry where a cable penetrates into the adjacent cupboard. We recommend this breach is addressed using a suitable fire stopping material capable of providing a minimum 30 minutes fire resistance.

Assessors Observations: There is a breach within the electrical cupboard inside the laundry where a cable penetrates into the adjacent cupboard.
		Recommended Action: We recommend this breach is addressed using a suitable fire stopping material capable of providing a minimum 30 minutes fire resistance.
Date First Identified:	01/02/21	
Date of FRA	01/02/21	
Rectify Within: (months)	6	
Budget Cost:	£25

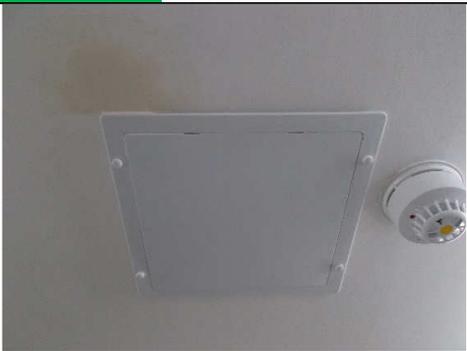
LOW		8

There is an inspection hatch on the ceiling within the laundry which is not fire rated. Due to the laundry being a high-risk room, we recommend this particular inspection hatch is replaced with a fire rated hatch to maintain the fire integrity of the ceiling (30 minutes).

Assessors Observations: There is an inspection hatch on the ceiling within the laundry which is not fire rated.
		Recommended Action: Due to the laundry being a high-risk room, we recommend this particular inspection hatch is replaced with a fire rated hatch to maintain the fire integrity of the ceiling (30 minutes).
Date First Identified:	01/02/21	
Date of FRA	01/02/21	
Rectify Within: (months)	12	
Budget Cost:	£125

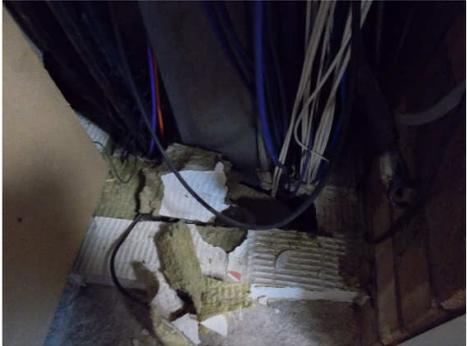
LOW		9

Within the meter cupboard 2nd floor adjacent flat 96, there is a breach at floor level where fire stopping material has been moved / cables penetrate. We recommend the fire stopping is reinstated.

Assessors Observations: Within the meter cupboard 2 nd floor adjacent flat 96, there is a breach at floor level where fire stopping material has been moved / cables penetrate.	
Date First Identified:	01/02/21	Recommended Action: We recommend the fire stopping is reinstated.	
Date of FRA	01/02/21		
Rectify Within: (months)	12		
Budget Cost:	£100

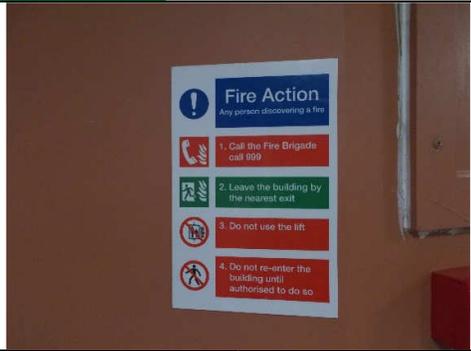
LOW		12

It was noted that the general fire action notices displayed give conflicting instructions to users of the building and should be replaced to clarify what is required by residents (i.e., Stay Put policy if in your apartment), and visitors/residents in the common areas (Full Evacuation).

<p>Assessors Observations:</p> <p>The general fire action notices displayed give conflicting instructions to users of the building and should be replaced to clarify what is required by residents (i.e., Stay Put policy if in your apartment), and visitors/residents in the common areas (Full Evacuation).</p>
Date First Identified:	01/02/21	<p>Recommended Action:</p> <p>As above.</p>
Date of FRA	01/02/21	
Rectify Within: (months)	12	
Budget Cost:	£100
