**FIRE RISK ASSESSMENT
MOUNT PLEASANT HOUSE,
98 HEADLAM STREET, BYKER,
NEWCASTLE UPON TYNE NE6 1EB**

JUNE 2021

STORM TEMPEST
PROPERTY CONSULTANCY

Reference: 4005-04-21-DS

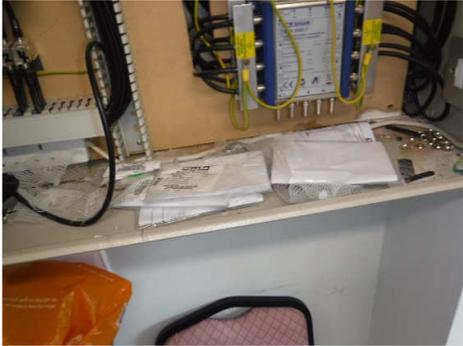
MEDIUM		1

Within the laundry there an electrical cupboard, housing the communications equipment, which had combustible items stored to the bottom of the cupboard. We recommend that the combustible items are removed from the electrical communications cupboard in the laundry and the cupboard is kept clear at all times.

Assessors Observations: Within the laundry there an electrical cupboard, housing the communications equipment, which had combustible items stored to the bottom of the cupboard.
Date First Identified:	05/06/2020	Recommended Action: We recommend that the combustible items are removed from the electrical communications cupboard in the laundry and the cupboard is kept clear at all times.
Date of FRA	29/06/2021	
Rectify Within: (months)	6	
Budget Cost:	No cost

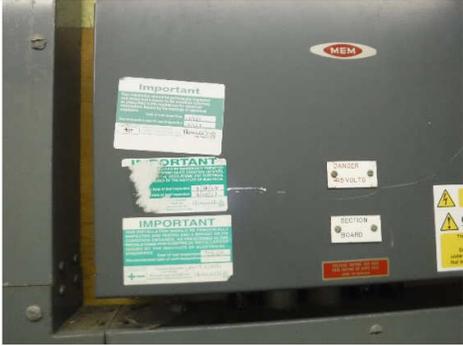
MEDIUM		2

We inspected various electrical distribution panels throughout the communal areas of the premises and within the three flats inspected. We noted some did not have any record of testing and some which were tested over 5 years ago. The landlord's electrical distribution within the building is modern wiring. All electrical installations are required to be tested regularly to the standards defined by the IET Wiring Regulations (BS 7671). The mains electrical supply and distribution installation and wiring should be

Assessors Observations: We inspected various electrical distribution panels throughout the communal areas of the premises and within the three flats inspected. We noted some did not have any record of testing and some which were tested over 5 years ago. All electrical installations are required to be tested regularly to the standards defined by the IET Wiring Regulations (BS 7671).
Date First Identified:	29/06/2021	Recommended Action: The mains electrical supply and distribution installation and wiring should be tested at least every five years by a registered NICEIC contractor to satisfy compliance with the requirements of the Electricity at Work Regulations 1989 in addition to the IET Wiring Regulations BS7671:2018 18th edition.
Date of FRA	29/06/2021	
Rectify Within: (months)	6	
Budget Cost:	No cost

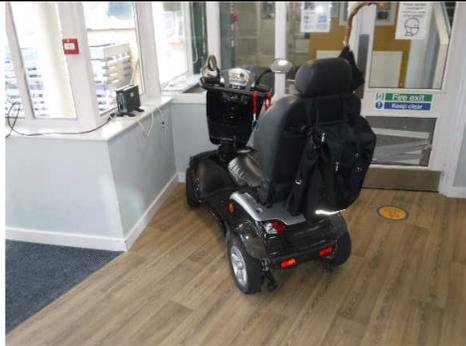
MEDIUM		3

During our inspection we noted a mobility scooter which was being charged within the communal lounge. The charger for the scooter was connected to a trailing extension lead which passed under one of the final exit doors. The extension lead and charger did not appear to be PAT tested. We would recommend that residents are reminded only to charge scooters in the designated areas, all portable appliances are PAT tested and the trailing lead is removed to negate the potential trip hazard.

Assessors Observations: During our inspection we noted a mobility scooter which was being charged within the communal lounge. The charger for the scooter was connected to a trailing extension lead which passed under one of the final exit doors. The extension lead and charger did not appear to be PAT tested.	
Date First Identified:	05/06/2020	Recommended Action: We would recommend that residents are reminded only to charge scooters in the designated areas, all portable appliances are PAT tested and the trailing lead is removed to negate the potential trip hazard.	
Date of FRA	29/06/2021		
Rectify Within: (months)	6		
Budget Cost:	No cost

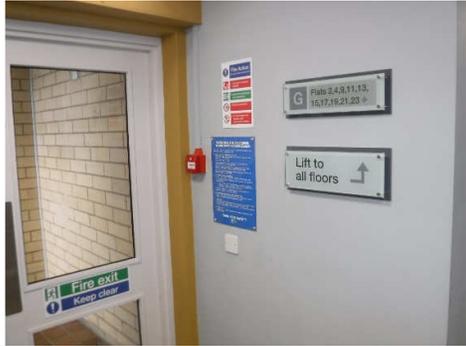
LOW		4

We noted that the 'Fire Exit' signs to some of the final exit doors are fixed to the door leaves themselves which would not be visible when in the open position. We would recommend that the signs are repositioned above the doors.

Assessors Observations: We noted that the 'Fire Exit' signs to some of the final exit doors are fixed to the door leaves themselves which would not be visible when in the open position.	
Date First Identified:	29/06/2021	Recommended Action: We would recommend that the signs are repositioned above the doors.	
Date of FRA	29/06/2021		
Rectify Within: (months)	12		
Budget Cost:	No cost

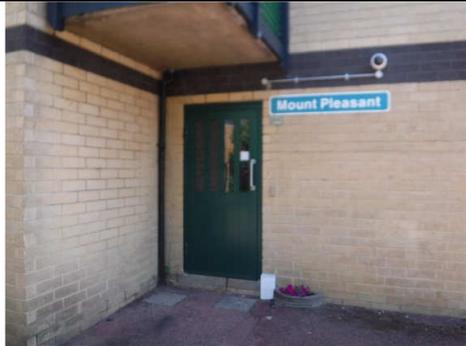
MEDIUM		5

There is no 'Fire Exit Keep Clear' signs fitted adjacent to the final exit doors externally. We would recommend that signage is fitted above the doors to ensure occupants and visitors are aware not to block the emergency exit doors.

Assessors Observations: There is no 'Fire Exit Keep Clear' signs fitted adjacent to the final exit doors externally.
Date First Identified:	29/06/2021	Recommended Action: We would recommend that signage is fitted above the doors to ensure occupants and visitors are aware not to block the emergency exit doors.
Date of FRA	29/06/2021	
Rectify Within: (months)	6	
Budget Cost:	£40

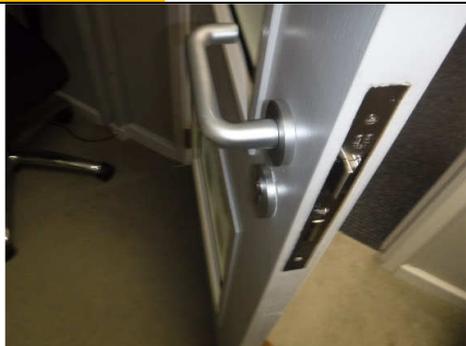
MEDIUM		6

The office and scooter store doors are both fitted with a key operated locking mechanism. We would recommend that thumb turn locking mechanisms are installed to both doors to ensure occupants can escape in an emergency situation.

Assessors Observations: The office and scooter store doors are both fitted with a key operated locking mechanism.
Date First Identified:	29/06/2021	Recommended Action: We would recommend that thumb turn locking mechanisms are installed to both doors to ensure occupants can escape in an emergency situation.
Date of FRA	29/06/2021	
Rectify Within: (months)	6	
Budget Cost:	£50

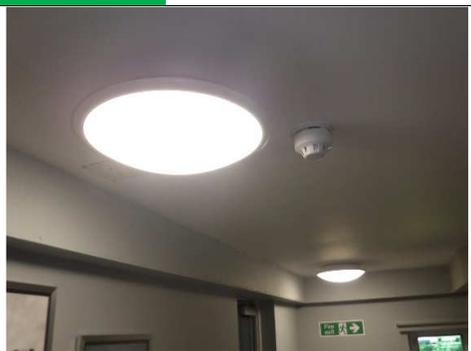
LOW		7

We noted one of the smoke detectors in the means of escape adjacent to Flat 9 was installed within close proximity to the light fitting. We would recommend that the smoke detectors are repositioned a minimum 300mm away from any vertical obstructions.

Assessors Observations: We noted one of the smoke detectors in the means of escape adjacent to Flat 9 was installed within close proximity to the light fitting.
Date First Identified:	29/06/2021	Recommended Action: We would recommend that the smoke detectors are repositioned a minimum 300mm away from any vertical obstructions.
Date of FRA	29/06/2021	
Rectify Within: (months)	12	
Budget Cost:	£40

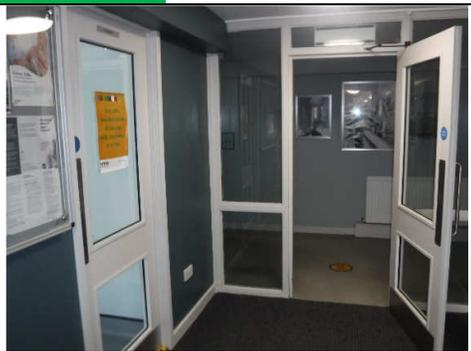
LOW		8

Some of the fire doors which have swing free door closers fitted do not display the correct signage / no signage installed. The existing signs should be removed and replaced with 'Automatic Fire Door Keep Clear' signs.

Assessors Observations: Some of the fire doors which have swing free door closers fitted do not display the correct signage / no signage installed.
Date First Identified:	29/06/2021	Recommended Action: The existing signs should be removed and replaced with 'Automatic Fire Door Keep Clear' signs.
Date of FRA	29/06/2021	
Rectify Within: (months)	12	
Budget Cost:	£10

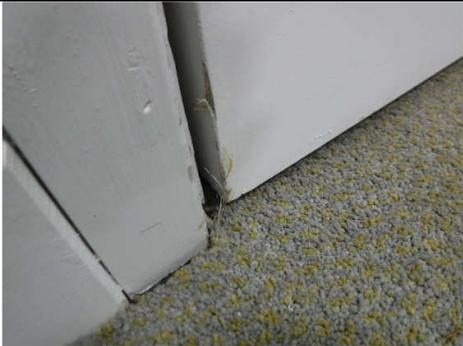
MEDIUM		9

The fire door to the electrical intake room / server room was warped and would not perform as required under fire conditions. We would recommend that the door is replaced with a certified door set fitted by third party accredited contractors.

Assessors Observations: The fire door to the electrical intake room / server room was warped and would not perform as required under fire conditions.
Date First Identified:	29/06/2021	Recommended Action: We would recommend that the door is replaced with a certified door set fitted by third party accredited contractors.
Date of FRA	29/06/2021	
Rectify Within: (months)	6	
Budget Cost:	£400

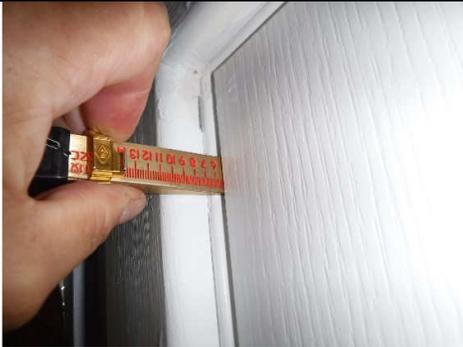
MEDIUM		10

As part of the assessment, the flat entrance doors to numbers 2, 6 and 11 were inspected for specification and action. We noted excessive gaps between the doors and frames and to the bottom of the doors. We would recommend all doors are inspected and adjusted to ensure the gaps a maximum of 3mm +/- 1mm and 3mm to the bottom of the doors.

Assessors Observations: As part of the assessment, the flat entrance doors to numbers 2, 6 and 11 were inspected for specification and action. We noted excessive gaps between the doors and frames and to the bottom of the doors.
Date First Identified:	29/06/2021	Recommended Action: We would recommend all doors are inspected and adjusted to ensure the gaps a maximum of 3mm +/- 1mm and 3mm to the bottom of the doors.
Date of FRA	29/06/2021	
Rectify Within: (months)	6	
Budget Cost:	£70

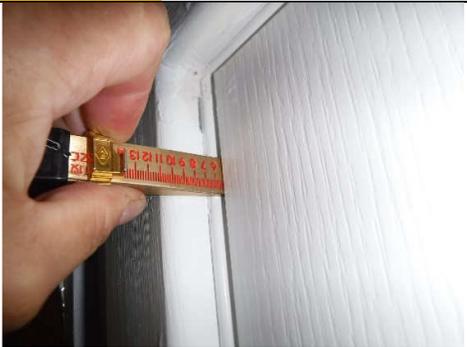
MEDIUM		12

We noted a number of the fire doors throughout the property on the escape routes with excessive gaps between the doors and frames and to the bottom of the doors. We would recommend all doors are inspected and adjusted to ensure the gaps a maximum of 3mm +/- 1mm and 3mm to the bottom of the doors.

Assessors Observations: We noted a number of the fire doors throughout the property on the escape routes with excessive gaps between the doors and frames and to the bottom of the doors.
Date First Identified:	29/06/2021	Recommended Action: We would recommend all doors are inspected and adjusted to ensure the gaps a maximum of 3mm +/- 1mm and 3mm to the bottom of the doors.
Date of FRA	29/06/2021	
Rectify Within: (months)	6	
Budget Cost:	£1,260

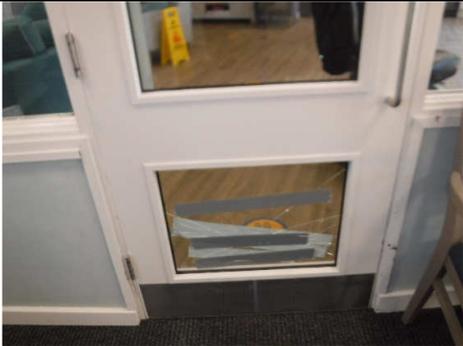
MEDIUM		13

The glazing to the communal lounge fire door was broken and will reduce the overall fire resistance of the door. We would recommend that the glazing unit is replaced with equivalent glazing in accordance with the certified manufacturer's instructions.

Assessors Observations: The glazing to the communal lounge fire door was broken and will reduce the overall fire resistance of the door.
Date First Identified:	29/06/2021	Recommended Action: We would recommend that the glazing unit is replaced with equivalent glazing in accordance with the certified manufacturer's instructions.
Date of FRA	29/06/2021	
Rectify Within: (months)	6	
Budget Cost:	£75

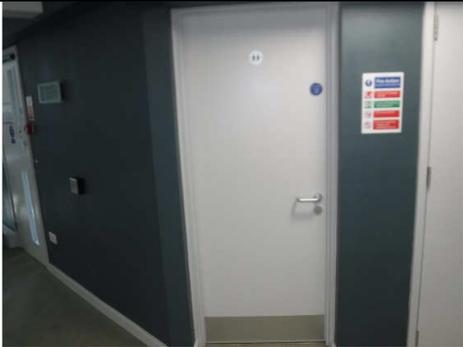
LOW		14

The fire door to the first floor wc is not fitted with an automatic self-closing device. We would recommend that a self-closing device is installed to this door due to the presence of an electric water heater within the room.

Assessors Observations: The fire door to the first floor wc is not fitted with an automatic self-closing device.
Date First Identified:	29/06/2021	Recommended Action: We would recommend that a self-closing device is installed to this door due to the presence of an electric water heater within the room.
Date of FRA	29/06/2021	
Rectify Within: (months)	12	
Budget Cost:	£125

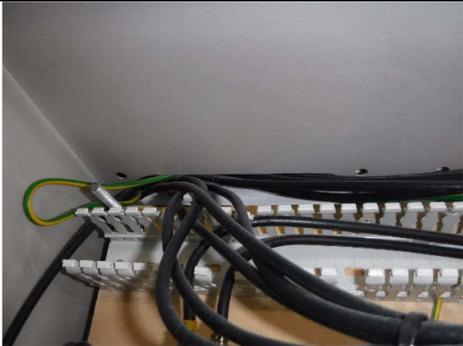
MEDIUM		15

We undertook a limited inspection of the compartmentation in the building. We noted penetrations within the service risers where cables / pipes have been installed, breaches to the ceiling / no intumescent collar to the SVP within the cupboard containing an electric water heater and to the ceiling above the electrical apparatus cabinet in the laundry. We would recommend that all

Assessors Observations: We undertook a limited inspection of the compartmentation in the building. We noted penetrations within the service risers where cables / pipes have been installed, breaches to the ceiling / no intumescent collar to the SVP within the cupboard containing an electric water heater and to the ceiling above the electrical apparatus cabinet in the laundry.
Date First Identified:	29/06/2021	Recommended Action: We would recommend that all penetrations / breaches are remedied by a 3 rd party accredited company with the service penetrations marked up and labelled.
Date of FRA	29/06/2021	
Rectify Within: (months)	6	
Budget Cost:	£1,000

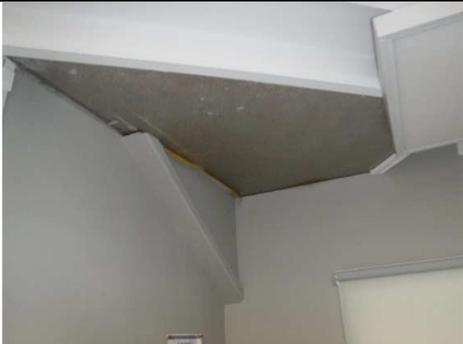
MEDIUM		16

There is a section of the ceiling in the office which we could not confirm the material type of and its fire resistance. We would recommend that the client checks their records to confirm the fire resistance of the ceiling as this forms the soffit of the escape stair above.

Assessors Observations: There is a section of the ceiling in the office which we could not confirm the material type of and its fire resistance.
Date First Identified:	22/06/2021	Recommended Action: We would recommend that the client checks their records to confirm the fire resistance of the ceiling as this forms the soffit of the escape stair above.
Date of FRA	29/06/2021	
Rectify Within: (months)	6	
Budget Cost:	No cost

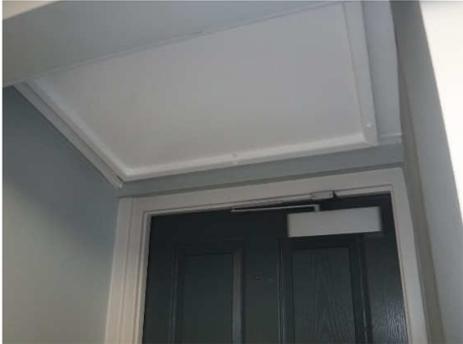
MEDIUM		17

There are a number of panels fixed to the ceilings in the means of escape adjacent to the flat entrance doors. We could not confirm the material type and its fire resistance. We would recommend that the client checks their records to confirm the fire resistance of the panels.

Assessors Observations: There are a number of panels fixed to the ceilings in the means of escape adjacent to the flat entrance doors. We could not confirm the material type and its fire resistance.
Date First Identified:	22/06/2021	Recommended Action: We would recommend that the client checks their records to confirm the fire resistance of the panels.
Date of FRA	29/06/2021	
Rectify Within: (months)	6	
Budget Cost:	No cost

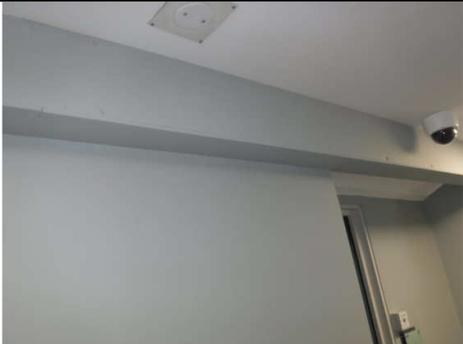
MEDIUM		18

Throughout the communal means of escape there is boxing at high level which we could not confirm the material type of. We would recommend that the client checks their records to confirm the fire resistance of the boxings.

Assessors Observations: Throughout the communal means of escape there is boxing at high level which we could not confirm the material type of.
Date First Identified:	22/06/2021	Recommended Action: We would recommend that the client checks their records to confirm the fire resistance of the boxings.
Date of FRA	29/06/2021	
Rectify Within: (months)	6	
Budget Cost:	No cost

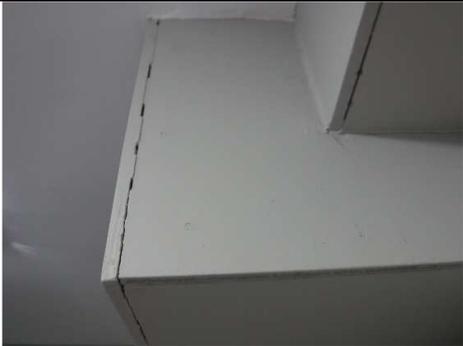
MEDIUM		19

Within the electrical intake cupboard / server room an extractor fan has been installed which is ducted into the high-level boxings in the means of escape. The unit does not appear to be fire rated, we would recommend that this is replaced with a fire rated unit.

Assessors Observations: Within the electrical intake cupboard / server room an extractor fan has been installed which is ducted into the high-level boxings in the means of escape.
Date First Identified:	22/06/2021	Recommended Action: The unit does not appear to be fire rated, we would recommend that this is replaced with a fire rated unit.
Date of FRA	29/06/2021	
Rectify Within: (months)	6	
Budget Cost:	£125

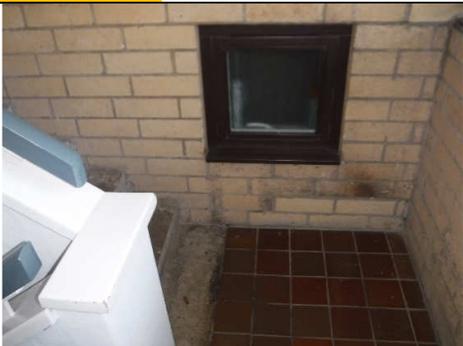
MEDIUM		20

Within the escape stair Flats 3 and 33 have a window that opens onto the escape stair, we also noted ventilation grilles fitted to the walls. We also noted ventilation grilles fitted within the ceilings in the means of escape. We could not identify if the room is a high-risk room although this still presents a hazard. We would recommend that the ventilation grilles are replaced with intumescent units, windows are replaced with fire rated window units and they are reconfigured so they do not open out onto the stair presenting a trip hazard.

Assessors Observations: Within the escape stair Flats 3 and 33 have a window that opens onto the escape stair, we also noted ventilation grilles fitted to the walls. We also noted ventilation grilles fitted within the ceilings in the means of escape. We could not identify if the room is a high-risk room although this still presents a hazard.
Date First Identified:	22/06/2021	Recommended Action: We would recommend that the ventilation grilles are replaced with intumescent units, windows are replaced with fire rated window units and they are reconfigured so they do not open out onto the stair presenting a trip hazard.
Date of FRA	29/06/2021	
Rectify Within: (months)	6	
Budget Cost:	£500

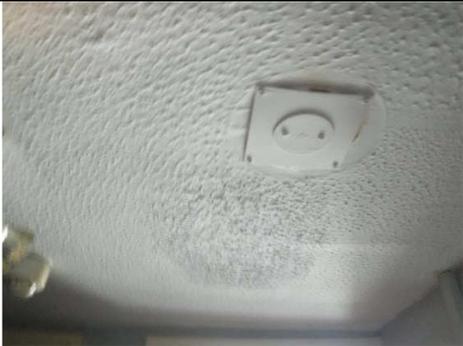
MEDIUM		21

We noted blanking discs fitted to the ceilings throughout the building, including with the apartments which we assume are due to the removal of light fittings. We would recommend that the client undertakes further investigation to ensure the blanking discs provide a minimum 60 minutes fire resistance.

Assessors Observations: We noted blanking discs fitted to the ceilings throughout the building, including with the apartments which we assume are due to the removal of light fittings.
Date First Identified:	22/06/2021	Recommended Action: We would recommend that the client undertakes further investigation to ensure the blanking discs provide a minimum 60 minutes fire resistance.
Date of FRA	29/06/2021	
Rectify Within: (months)	6	
Budget Cost:	No cost

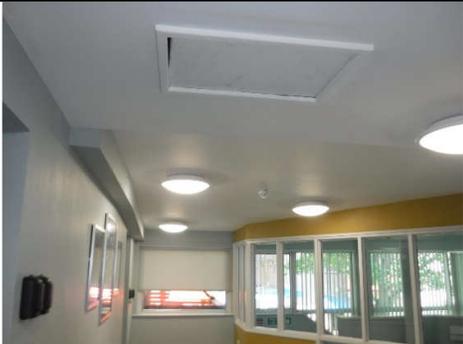
MEDIUM		22

We noted access hatches throughout the building which did not appear to be fire resistant. We would recommend that the client undertakes further investigation to ensure the access panels provide a minimum 60 minutes fire resistance and if not then we recommend that the hatches are replaced with fire rated units.

Assessors Observations: We noted access hatches throughout the building which did not appear to be fire resistant.
Date First Identified:	22/06/2021	Recommended Action: We would recommend that the client undertakes further investigation to ensure the access panels provide a minimum 60 minutes fire resistance and if not then we recommend that the hatches are replaced with fire rated units.
Date of FRA	29/06/2021	
Rectify Within: (months)	6	
Budget Cost:	No cost

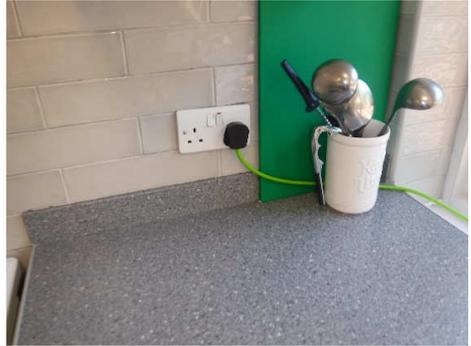
LOW		23

We inspected the portable electrical appliances throughout the premises and noted that some of the appliances did not appear to have been tested within the last year. We recommend that all appliances are tested annually, each appliance is given a label after being tested and an inventory of the equipment is maintained on site.

Assessors Observations: We inspected the portable electrical appliances throughout the premises and noted that some of the appliances did not appear to have been tested within the last year.
		Recommended Action: We recommend that all appliances are tested annually, each appliance is given a label after being tested and an inventory of the equipment is maintained on site.
Date First Identified:	22/06/2021	
Date of FRA	29/06/2021	
Rectify Within: (months)	12	
Budget Cost:	No cost

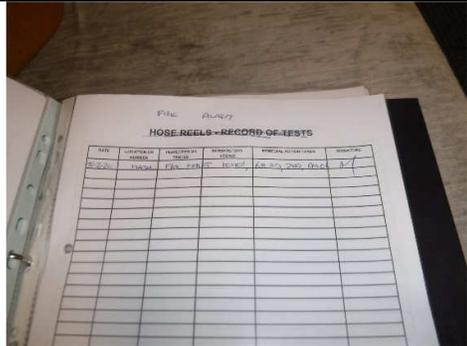
LOW		25

<p>Assessors Observations:</p> <p>The FADS is required to be tested in accordance with BS5839 which requires weekly tests of the call points and 6 monthly servicing of the system by a competent contractor. The weekly testing of manual call points is being undertaken with the latest test recorded as 23/06/21.</p>
Date First Identified:	22/06/2021	<p>Recommended Action:</p> <p>The records confirm that the last test by a competent engineer was undertaken on 05/02/20 and is therefore out of date.</p>
Date of FRA	29/06/2021	
Rectify Within: (months)	12	
Budget Cost:	No cost

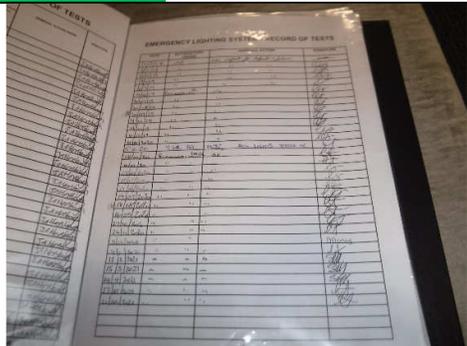
LOW		26

The emergency lighting is required to be tested and maintained in accordance with BS5266 which requires monthly short duration tests and annual full discharge tests which should be detailed in a Fire Logbook. The system was last subject to a monthly test on 21/06/21 which is recorded in the fire logbook. The last entry recorded for the annual discharge tests was in February 2020 and is therefore out of date. We would recommend that the client checks their records to ensure the system is being maintained and tested in accordance with BS5266.

<p>Assessors Observations:</p> <p>The emergency lighting requires monthly short duration tests and annual full discharge tests which should be detailed in a Fire Logbook. The system was last subject to a monthly test on 21/06/21 which is recorded in the fire logbook. The last entry recorded for the annual discharge tests was in February 2020 and is therefore out of date.</p>
Date First Identified:	22/06/2021	<p>Recommended Action:</p> <p>We would recommend that the client checks their records to ensure the system is being maintained and tested in accordance with BS5266.</p>
Date of FRA	29/06/2021	
Rectify Within: (months)	12	
Budget Cost:	No cost
