**FIRE RISK ASSESSMENT
18-20 BRINKBURN STREET,
BYKER,
NEWCASTLE UPON TYNE NE6 2JU**

JANUARY 2021

STORM TEMPEST
PROPERTY CONSULTANCY

Reference: PA-3888-01-21

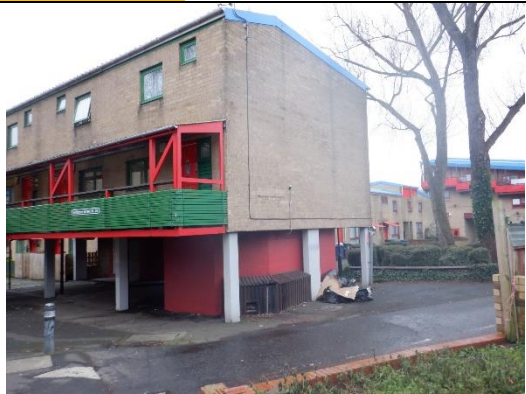
MEDIUM		1

We noted combustible waste material under the block. In order to ensure that the build-up of combustible materials does not continue to the point that a high fire loading is created and/or the means of escape from the building are seriously obstructed it is strongly recommended the items are removed and that procedures, managerial checks, are put in place to monitor the area under the block to ensure it remains free from combustible material.

<p>Assessors Observations:</p> <p>We noted combustible waste material under the block.</p>
Date First Identified:	27/01/2021	<p>Recommended Action:</p> <p>In order to ensure that the build-up of combustible materials does not continue to the point that a high fire loading is created and/or the means of escape from the building are seriously obstructed it is strongly recommended the items are removed and that procedures, managerial checks, are put in place to monitor the area under the block to ensure it remains free from combustible material.</p>
Date of FRA:	27/01/2021	
Rectify Within: (months)	6	
Budget Cost:	No cost

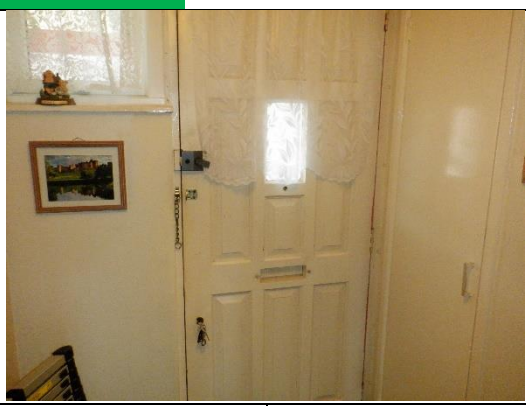
LOW		2

4.2 Fire Doors We were able to access number 18 to inspect the specification of the flat entrance door. The door is a solid door with glazed panel hung on 3 non-fire rated hinges and fitted with rim lock, security chain, mortice lock with no mechanical override, draw bolt, door viewer and letter box aperture.

We are unable to determine the fire rating of the door. Current design guidance, (BS 9991:2015 Fire safety in the design, management and use of residential buildings - Code of Practice) recommends that doors from maisonettes opening onto balconies providing a single direction of escape should be FD 30 self-closing doors. We recommend the client examines their installation records to confirm the entrance doors meet the required standard. Where it cannot be confirmed, where possible, we recommend the doors are upgraded, where this is not possible we recommend the doors are replaced with doors meeting the required standard. We further recommend that the mortice locks on all doors are fitted with a mechanical override that negates the use of a key to operate the lock in an emergency.

<p>Assessors Observations:</p> <p>We are unable to determine the fire rating of the entrance doors. Current design guidance, (BS 9991:2015 Fire safety in the design, management and use of residential buildings - Code of Practice) recommends that doors from maisonettes opening onto balconies providing a single direction of escape should be FD 30 self-closing doors.</p>
Date First Identified:	27/01/2021	<p>Recommended Action:</p> <p>We recommend the client examines their installation records to confirm the entrance doors meet the required standard. Where it cannot be confirmed, where possible, we recommend the doors are upgraded, where this is not possible, we recommend the doors are replaced with doors meeting the required standard. We further recommend that the mortice locks on all doors are fitted with a mechanical override that negates the use of a key to operate the lock in an emergency.</p>

Date of FRA:	27/01/2021	
Rectify Within: (months)	12	
Budget Cost:	£600

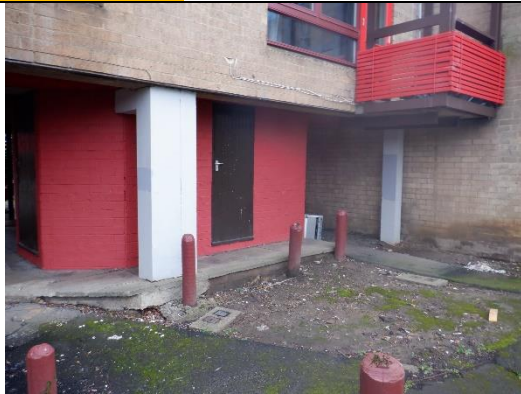
3

4.3 Fire Compartmentation The dwelling entry level is separated from the space below by concrete construction. We were unable to access the cupboards or the sub-station on the ground floor so we are unable to comment on the integrity of the ceiling above.

We were unable to access the cupboards or the sub-station on the ground floor so we are unable to comment on the integrity of the ceiling above.

We recommend the client access the cupboards and the sub-station to determine the condition of the ceiling and any breaches noted are adequately sealed to maintain the fire resistance of the

ceiling. Any works to be carried out by a third party, accredited contractor.

We recommend the client access the cupboards and the sub-station to determine the condition of the ceiling and any breaches noted are adequately sealed to maintain the fire resistance of the ceiling. Any works to be carried out by a third party, accredited contractor.
