**FIRE RISK ASSESSMENT  
3-7 RABY CROSS,  
BYKER,  
NEWCASTLE UPON TYNE NE6 2FF**

**JANUARY 2021**

**Reference:** PA-3888-01-21

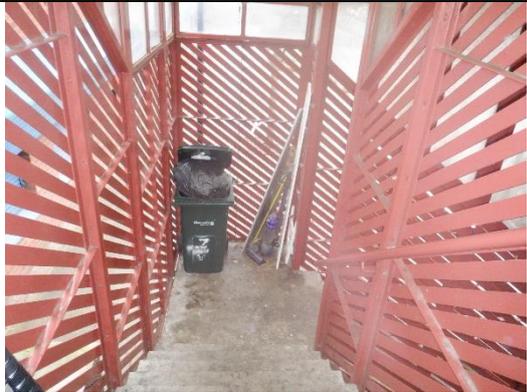
<b>MEDIUM</b>		<b>1</b>

We noted combustible material (wheely bins) on the balcony and staircase. In order to ensure that the build-up of materials does not continue to the point that a high fire loading is created and/or the means of escape from the building are seriously obstructed it is strongly recommended the items are removed and that procedures, managerial checks, are put in place to monitor the means of escape to ensure they remain free from combustible material and are not obstructed.

<b>Assessors Observations:</b> We noted wheely bins and planters located on the balcony and staircase.	
<b>Date First Identified:</b>	27/01/2021	<b>Recommended Action:</b> In order to ensure that the build-up of materials does not continue to the point that a high fire loading is created and/or the means of escape from the building are seriously obstructed it is strongly recommended the items are removed and that procedures, managerial checks, are put in place to monitor the means of escape to ensure they remain free from combustible material and are not obstructed.	
<b>Date of FRA:</b>	27/01/2021		
<b>Rectify Within: (months)</b>	6		
<b>Budget Cost:</b>	No cost

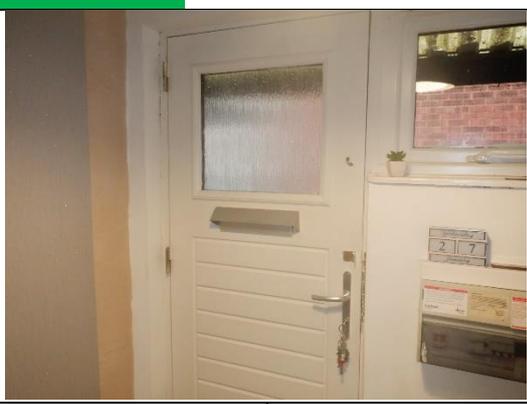
<b>LOW</b>		<b>2</b>

4.2 Fire Doors We were able to access number 3 to inspect the specification of the flat entrance door. The door is a solid door with glazed panel hung on 3 non-fire rated hinges and fitted with mortice lock with no mechanical override, door viewer and letter box aperture.

We are unable to determine the fire rating of the flat entrance doors. Current design guidance, (BS 9991:2015 Fire safety in the design, management and use of residential buildings - Code of Practice) recommends that doors from maisonettes opening onto balconies providing a single direction of escape should be FD 30 self-closing doors. We recommend the client examines their installation records to confirm the entrance doors meet the required standard. Where it cannot be confirmed, where possible, we recommend the doors are upgraded, where this is not possible we recommend the doors are replaced with doors meeting the required standard. We further recommend that the mortice locks on all doors are fitted with a mechanical override that negates the use of a key to operate the lock in an emergency.

<b>Assessors Observations:</b> We are unable to determine the fire rating of the entrance doors. Current design guidance, (BS 9991:2015 Fire safety in the design, management and use of residential buildings - Code of Practice) recommends that doors from maisonettes opening onto balconies providing a single direction of escape should be FD 30 self-closing doors.	
<b>Date First Identified:</b>	27/01/2021	<b>Recommended Action:</b> We recommend the client examines their installation records to confirm the entrance doors meet the required standard. Where it cannot be confirmed, where possible, we recommend the doors are upgraded, where this is not possible, we recommend the doors are replaced with doors meeting the required standard. We further recommend that the mortice locks on all doors are fitted with a mechanical override that negates the use of a key to operate the lock in an emergency.

<b>Date of FRA:</b>	27/01/2021		
<b>Rectify Within: (months)</b>	12		
<b>Budget Cost:</b>	£600

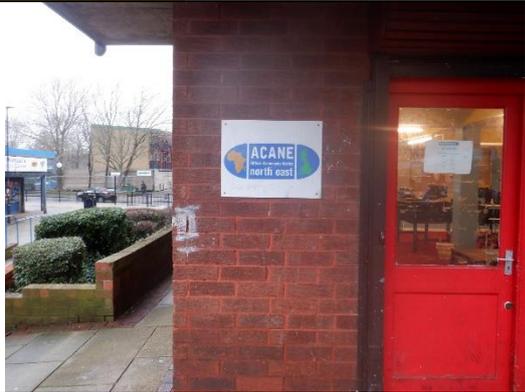
<b>MEDIUM</b>		<b>3</b>

4.3 Fire Compartmentation The dwelling entry level is separated from the space below by concrete construction. We were unable to access the offices below so we are unable to comment on the integrity of the ceiling above.

<p><b>Assessors Observations:</b></p> <p>We were unable to access the offices below so we are unable to comment on the integrity of the ceiling above.</p>
<b>Date First Identified:</b>	27/01/2021	<p><b>Recommended Action:</b></p> <p>We recommend the client arranges access with the occupiers of the office below to determine the condition of the ceiling and any breaches noted are adequately sealed to maintain the fire resistance of the ceiling. Any works to be carried out by a third party, accredited contractor.</p>
<b>Date of FRA:</b>	27/01/2021	
<b>Rectify Within: (months)</b>	6	
<b>Budget Cost:</b>	No cost

We recommend the client arranges access with the occupiers of the office below to determine the condition of the ceiling and any breaches noted are adequately sealed to maintain the fire

resistance of the ceiling. Any works to be carried out by a third party, accredited contractor.

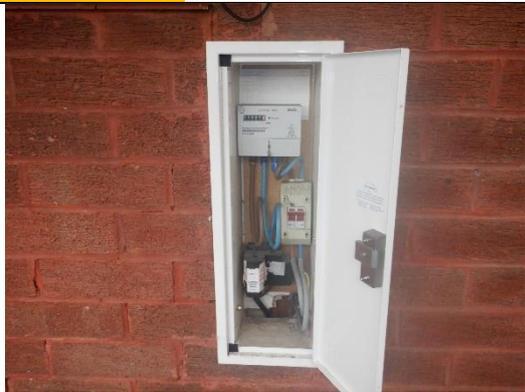
<b>MEDIUM</b>		<b>4</b>

<p><b>Assessors Observations:</b></p> <p>We noted holes within the submerged meter boxes.</p>
<b>Date First Identified:</b>	27/01/2021	<p><b>Recommended Action:</b></p> <p>We recommend all breaches are appropriately sealed to maintain the integrity of the wall, the work to be carried out by a suitably qualified person or organisation that can demonstrate the appropriate level of skill and competency. Certification under a UKAS accredited passive fire protection installer scheme would be a way of establishing those criteria. And that fire resistant over boxes are installed over the existing enclosures.</p>
<b>Date of FRA:</b>	27/01/2021	
<b>Rectify Within: (months)</b>	6	
<b>Budget Cost:</b>	£750

We noted holes within the submerged meter boxes. We recommend all breaches are appropriately sealed so as to maintain the integrity of the wall, the work to be carried out by a suitably qualified person or organisation that can demonstrate the appropriate level of skill and competency. Certification under a UKAS accredited passive fire protection installer scheme would be a way of establishing those criteria. And that fire resistant over boxes are installed over the existing enclosures.
