**FIRE RISK ASSESSMENT**  
**31-33 BRINKBURN STREET,**  
**BYKER,**  
**NEWCASTLE UPON TYNE NE6 2JU**

JANUARY 2021

**Reference:** PA-3888-01-21

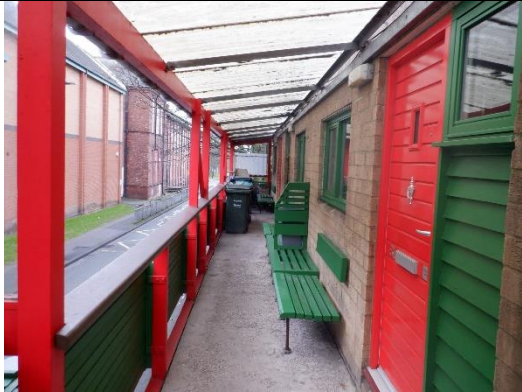
<b>MEDIUM</b>		<b>1</b>

We noted wheely bins and planters on the balcony. We recommend they are removed and the client engages with the residents to remind them of the importance of maintain a clear, unobstructed means of escape.

<b>Assessors Observations:</b> We noted wheely bins and planters located on the balcony.	
<b>Date First Identified:</b>	27/01/2021	<b>Recommended Action:</b> We recommend the they are removed and the client engages with the residents to remind them of the importance of maintain a clear, unobstructed means of escape.	
<b>Date of FRA:</b>	27/01/2021		
<b>Rectify Within: (months)</b>	6		
<b>Budget Cost:</b>	No cost

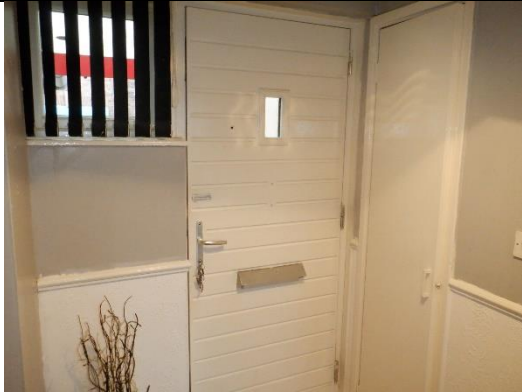
<b>LOW</b>		<b>2</b>

4.2 Fire Doors We were able to access number 31 to inspect the specification of the flat entrance door. The door is a solid door with glazed panel hung on 3 steel hinges and fitted with mortice lock with no mechanical override, door viewer and letter box aperture.

We are unable to determine the fire rating of the flat entrance doors. Current design guidance, (BS 9991:2015 Fire safety in the design, management and use of residential buildings - Code of Practice) recommends that doors from maisonettes opening onto balconies providing a single direction of escape should be FD 30 self-closing doors. We recommend the client examines their installation records to confirm the entrance doors meet the required standard. Where it cannot be confirmed, where possible, we recommend the doors are upgraded, where this is not possible we recommend the doors are replaced with doors meeting the required standard. We further recommend that the mortice locks on all doors are fitted with a mechanical override that negates the use of a key to operate the lock in an emergency.

<b>Assessors Observations:</b> We are unable to determine the fire rating of the entrance doors. Current design guidance, (BS 9991:2015 Fire safety in the design, management and use of residential buildings - Code of Practice) recommends that doors from maisonettes opening onto balconies providing a single direction of escape should be FD 30 self-closing doors.	
<b>Date First Identified:</b>	27/01/2021	<b>Recommended Action:</b> We recommend the client examines their installation records to confirm the entrance doors meet the required standard. Where it cannot be confirmed, where possible, we recommend the doors are upgraded, where this is not possible, we recommend the doors are replaced with doors meeting the required standard. We further recommend that the mortice locks on all doors are fitted with a mechanical override that negates the use of a key to operate the lock in an emergency.

<b>Date of FRA:</b>	27/01/2021		
<b>Rectify Within: (months)</b>	12		
<b>Budget Cost:</b>	£600

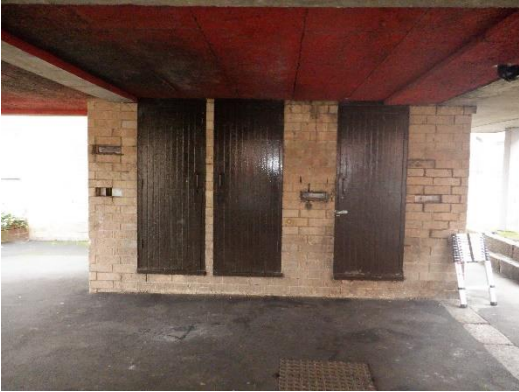
<b>MEDIUM</b>		<b>3</b>

the sub-station on the ground floor so we are unable to comment on the integrity of the ceiling above.

<b>Assessors Observations:</b> We were unable to access the cupboards or the sub-station on the ground floor so we are unable to comment on the integrity of the ceiling above.	
<b>Date First Identified:</b>	27/01/2021	<b>Recommended Action:</b> We recommend the client access the cupboards and the sub-station to determine the condition of the ceiling and any breaches noted are adequately sealed to maintain the fire resistance of the ceiling. Any works to be carried out by a third party, accredited contractor.	
<b>Date of FRA:</b>	27/01/2021		
<b>Rectify Within: (months)</b>	6		
<b>Budget Cost:</b>	No cost

We recommend the client access the cupboards and the sub-station to determine the condition of the ceiling and any breaches noted are adequately sealed to maintain the fire resistance of the ceiling. Any works to be carried out by a third party, accredited contractor.

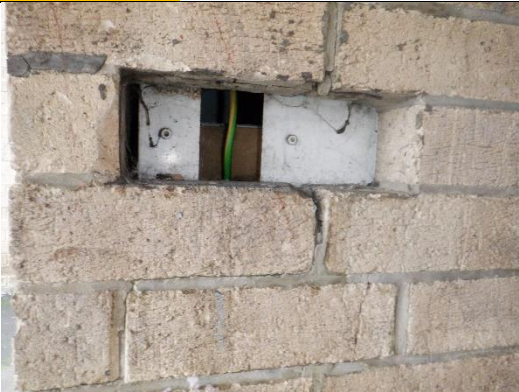
<b>MEDIUM</b>		<b>4</b>

We did note breaches in the walls enclosing the meter cupboards in the space below the dwellings. These breaches may allow the passage of fire and smoke from a fire outside to spread to the inside of the cupboards and possibly beyond.

<b>Assessors Observations:</b> We did note breaches in the walls enclosing the meter cupboards in the space below the dwellings. These breaches may allow the passage of fire and smoke from a fire outside to spread to the inside of the cupboards and possibly beyond.	
<b>Date First Identified:</b>	27/01/2021	<b>Recommended Action:</b> We recommend the client ensures that all breaches to the external walls are appropriately sealed to maintain the fire resistance of the wall. The works should be carried out by a third party, accredited contractor.	
<b>Date of FRA:</b>	27/01/2021		
<b>Rectify Within: (months)</b>	6		
<b>Budget Cost:</b>	£100

We recommend the client ensures that all breaches to the external walls are appropriately sealed to maintain the fire resistance of the wall. The works should be carried out by a third party, accredited contractor.
