**FIRE RISK ASSESSMENT
7-11 RABY CRESCENT,
BYKER,
NEWCASTLE UPON TYNE NE6 2FD**

FEBRUARY 2021

Reference: PA-3888-02-21

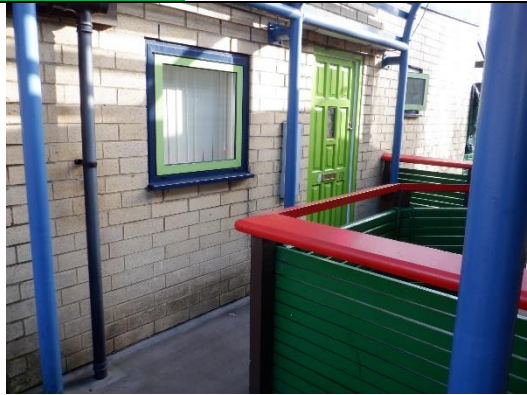
LOW		3

4.2 Fire Doors We were able to access number 10 to inspect the specification of the flat entrance door. The door is a solid door with glazed panel hung on 3 hinges and fitted with rim lock, security chain, mortice lock with no mechanical override, two concealed door security bolts and letter box aperture.

Assessors Observations: We were able to access number 10 to inspect the specification of the flat entrance door. The door is a solid door with glazed panel hung on 3 hinges and fitted with rim lock, security chain, mortice lock with no mechanical override, two concealed door security bolts and letter box aperture.	
Date First Identified:	26/02/2021	Recommended Action: We recommend the mortice locks on all doors are fitted with a mechanical override that negates the use of a key to operate the lock in an emergency and the concealed door security bolts are removed from door number 10.	
Date of FRA:	26/02/2021		
Rectify Within: (months)	12		
Budget Cost:	£1200

We recommend the mortice locks on all doors are fitted with a mechanical override that negates the use of a key to operate the lock in an emergency and the concealed door security bolts are removed from door number 10.

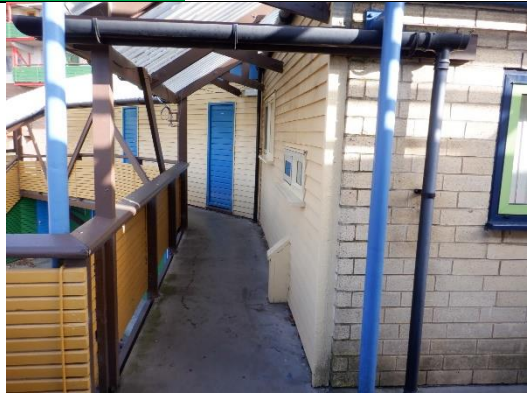
LOW		4

Assessors Observations: We were unable to access two of the three service cupboards on level one.	
Date First Identified:	26/02/2021	Recommended Action: We recommend the client gains access to these rooms to assess the compartmentation within and where there are breaches, they are sealed using approved techniques and the work carried out by an accredited, third party contractor.	
Date of FRA:	26/02/2021		
Rectify Within: (months)	12		
Budget Cost:	No cost

We were unable to access two of the three service cupboards on level one. We recommend the client gains access to these rooms to assess the compartmentation within and where there are breaches, they are sealed using approved techniques and the work carried out by an accredited, third party contractor.
