**FIRE RISK ASSESSMENT  
BRINKBURN HOUSE, 1-5 & 9-19  
BRINKBURN COURT,  
NEWCASTLE UPON TYNE,  
TYNE AND WEAR, NE6 2JW.**

NOVEMBER 2021

**Reference:** JA-4009-04-21

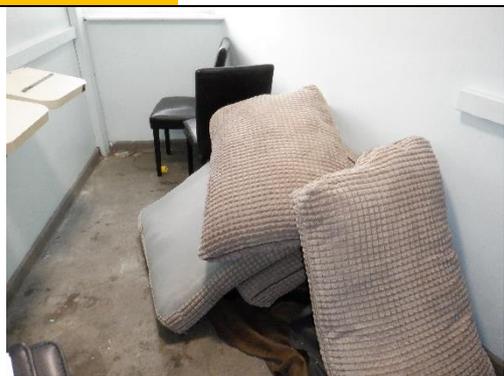
<b>MEDIUM</b>		<b>1</b>

A room on the 2<sup>nd</sup> floor assumed to be a former bin store (currently no bins within) was found to have sofa cushions, chair and timber stored within, increasing the fuel load of this particular location. We recommend the client arranges for the removal of the said items and informs all residents that the rooms is not to be used to store discarded furniture.

<b>Assessors Observations:</b>	A room on the 2 <sup>nd</sup> floor assumed to be a former bin store (currently no bins within) was found to have sofa cushions, chair and timber stored within, increasing the fuel load of this particular location.
<b>Date First Identified:</b>	17/11/21	<b>Recommended Action:</b>	We recommend the client arranges for the removal of the said items and informs all residents that the rooms is not to be used to store discarded furniture.
<b>Date of FRA:</b>	17/11/21		
<b>Rectify Within: (months)</b>	6		
<b>Budget Cost:</b>	No Cost

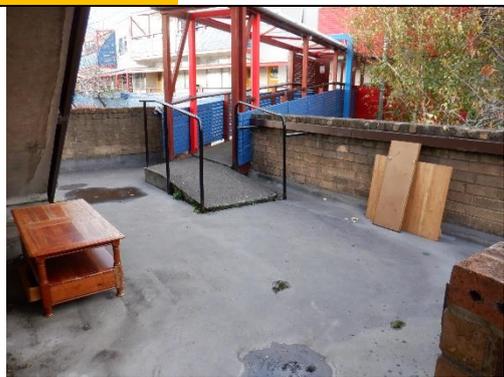
<b>MEDIUM</b>		<b>2</b>

We noted locations throughout the communal walkways associated with the building where discarded furniture has been allowed to accumulate, namely near to the access bridge of an adjoining block and also outside of flat 10. It was also noted a rubbish bag has been left on the ground floor at the south elevations emergency exit. All communal area means of escape must be kept clear of obstructions and maintained as sterile an area as practicable, free from combustible materials to ensure all means of escape are clear to pass in the event of an emergency evacuation.

<b>Assessors Observations:</b>	We noted locations throughout the communal walkways associated with the building where discarded furniture has been allowed to accumulate, namely near to the access bridge of an adjoining block and also outside of flat 10. It was also noted a rubbish bag has been left on the ground floor at the south elevations emergency exit.
<b>Date First Identified:</b>	17/11/21	<b>Recommended Action:</b>	All communal area means of escape must be kept clear of obstructions and maintained as sterile an area as practicable, free from combustible materials to ensure all means of escape are clear to pass in the event of an emergency evacuation.
<b>Date of FRA:</b>	17/11/21		
<b>Rectify Within: (months)</b>	6		
<b>Budget Cost:</b>	No Cost

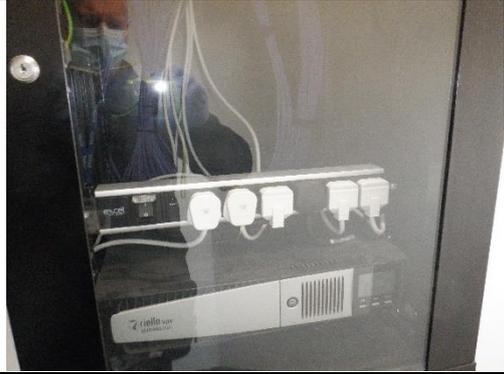
<b>LOW</b>		<b>3</b>

Regular testing of electrical appliances should be undertaken in accordance with the Electricity at Work Regulations 1989. This is applicable to any portable electrical devices located within any communal areas or any rooms/cupboards off the means of escape which are under the landlords control. Within the communications rooms on the first floor we noted a data cabinet with numerous data equipment plugged into an extension lead. We did not note any labelling to indicate the equipment, or the extension lead has been tested for electrical safety within the last 12 months (Portable Appliance Test (PAT)). We recommend the client confirms all such equipment has been tested for electrical safety within the last 12 months and if not, arranges for it to be undertaken and a schedule introduced for it to be carried out annually thereafter.

<b>Assessors Observations:</b> Within the communications rooms on the first floor we noted a data cabinet with numerous data equipment plugged into an extension lead. We did not note any labelling to indicate the equipment, or the extension lead has been tested for electrical safety within the last 12 months (Portable Appliance Test (PAT)).	
<b>Date First Identified:</b>	17/11/21	<b>Recommended Action:</b> We recommend the client confirms all such equipment has been tested for electrical safety within the last 12 months and if not, arranges for it to be undertaken and a schedule introduced for it to be carried out annually thereafter. This may reduce the risk of electrical faults occurring with portable electrical equipment, a common cause of fires.	
<b>Date of FRA:</b>	17/11/21		
<b>Rectify Within: (months)</b>	12		
<b>Budget Cost:</b>	No Cost

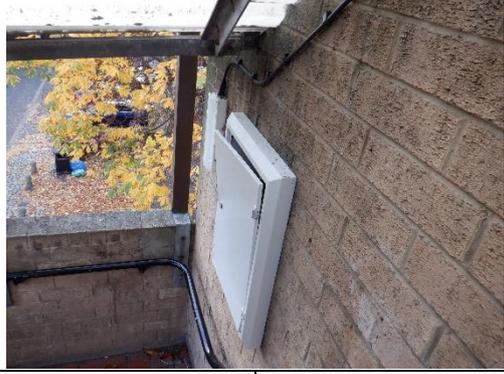
<b>LOW</b>		<b>4</b>

It was noted the electrical meter box for flat 16 is damaged and open to the elements. Should rain enter the box there is the potential for a short circuit to occur, which may lead to a fire. We recommend the door on to the cabinet is replaced so that it can be closed and locked and prevent the ingress of water.

<b>Assessors Observations:</b> It was noted the electrical meter box for flat 16 is damaged and open to the elements. Should rain enter the box there is the potential for a short circuit to occur, which may lead to a fire.	
<b>Date First Identified:</b>	17/11/21	<b>Recommended Action:</b> We recommend the door on to the cabinet is replaced so that it can be closed and locked and prevent the ingress of water.	
<b>Date of FRA:</b>	17/11/21		
<b>Rectify Within: (months)</b>	12		
<b>Budget Cost:</b>	No Cost

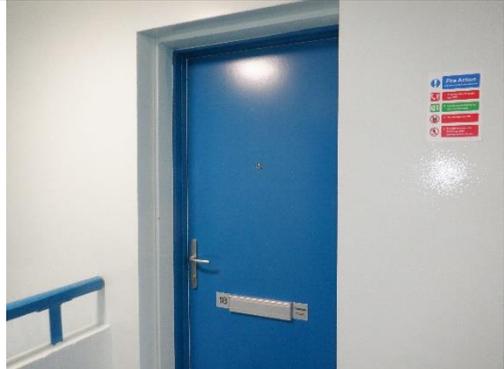
<b>MEDIUM</b>		<b>5</b>

We were unable to enter any flats on the day of the visit, particularly flats 9 and 19, which are bypassed by flats 10 and 17 respectively as their only means of escape and flat 18, which opens onto the protected stairwell should be a minimum FD30S door with a self-closing device fitted. A revisit is required to fully assess they are a minimum standard of FD30S with self-closing device and complies with BS8214, however, in the interim, we recommend the client arranges access to these flats and assesses the fire rated integrity of these doors and compliance with this standard.

<p><b>Assessors Observations:</b></p> <p>We were unable to enter any flats on the day of the visit, particularly flats 9 and 19, which are bypassed by flats 10 and 17 respectively as their only means of escape and flat 18, which opens onto the protected stairwell should be a minimum FD30S door with a self-closing device fitted.</p>
<b>Date First Identified:</b>	17/11/21	<p><b>Recommended Action:</b></p> <p>A revisit is required to fully assess they are a minimum standard of FD30S with self-closing device and complies with BS8214, however, in the interim, we recommend the client arranges access to these flats and assesses the fire rated integrity of these doors and compliance with this standard.</p>
<b>Date of FRA:</b>	17/11/21	
<b>Rectify Within: (months)</b>	6	
<b>Budget Cost:</b>	No Cost

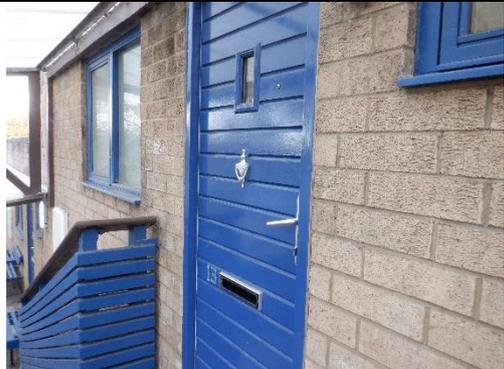
<b>MEDIUM</b>		<b>6</b>

We noted the letter box flap to number 13 on the external side of the door is missing. It is recommended this is replaced to ensure the fire rated integrity of the flat entrance door is not compromised.

<p><b>Assessors Observations:</b></p> <p>We noted the letter box flat to number 13 on the external side of the door is missing.</p>
<b>Date First Identified:</b>	17/11/21	<p><b>Recommended Action:</b></p> <p>It is recommended this is replaced to ensure the fire rated integrity of the flat entrance door is not compromised.</p>
<b>Date of FRA:</b>	17/11/21	
<b>Rectify Within: (months)</b>	6	
<b>Budget Cost:</b>	£20

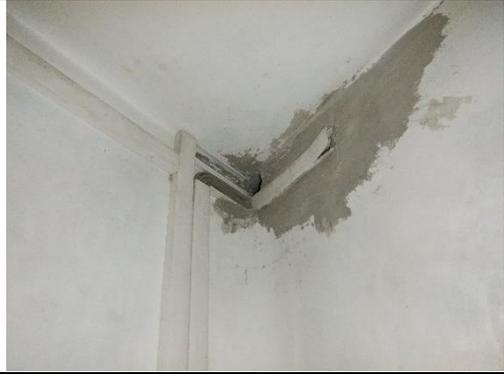
<b>MEDIUM</b>		<b>7</b>

We noted within the electrical cupboard off the comms room located on the ground floor, what appeared to be a large hole in the top corner of the room. We recommend the client instructs this potential compartment breach to be inspected by a specialist and if required has it adequately fire stopped by approved 3<sup>rd</sup> party fire stopping contractors to ensure cold smoke or products of combustion cannot pass into any protected escape routes if a fire was to occur within this cupboard space.

<b>Assessors Observations:</b> We noted within the electrical cupboard off the comms room located on the ground floor, what appeared to be a large hole in the top corner of the room.	
<b>Date First Identified:</b>	17/11/21	<b>Recommended Action:</b> We recommend the client instructs this potential compartment breach to be inspected by a specialist and if required has it adequately fire stopped by approved 3 <sup>rd</sup> party fire stopping contractors to ensure cold smoke or products of combustion cannot pass into any protected escape routes if a fire was to occur within this cupboard space.	
<b>Date of FRA:</b>	17/11/21		
<b>Rectify Within: (months)</b>	6		
<b>Budget Cost:</b>	No Cost

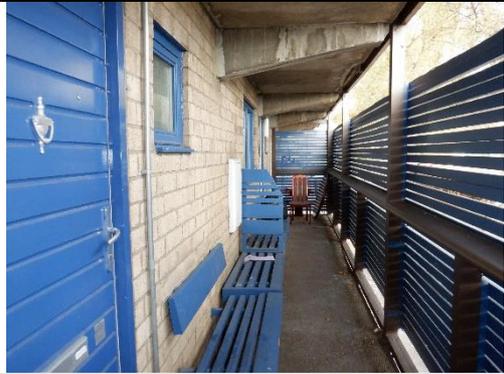
<b>MEDIUM</b>		<b>8</b>

<b>Assessors Observations:</b> The only means of escape from flat 10 is to bypass flat 9. A fire within flat 9 could block the only means of escape from flat 10 if doors/windows facing onto the means of escape became compromised.	
<b>Date First Identified:</b>	17/11/21	<b>Recommended Action:</b> The client should check that any windows (and doors) facing/opening onto this means of escape are appropriately fire rated.	
<b>Date of FRA:</b>	17/11/21		
<b>Rectify Within: (months)</b>	6		
<b>Budget Cost:</b>	No Cost

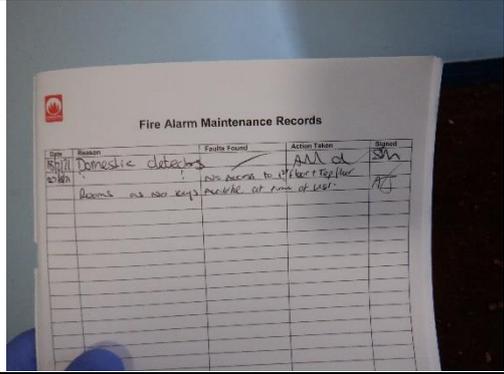
<b>LOW</b>		<b>9</b>

Upon inspection of the fire logbook located on site, the fire alarm maintenance records indicated that the domestic detectors were serviced on 18/2/21 with no faults found and on the 27/08/21 there was no access to the first floor and the top floor rooms (as noted in the fire log book).

<b>Assessors Observations:</b> Upon inspection of the fire logbook located on site, the fire alarm maintenance records indicated that the domestic detectors were serviced on 18/2/21 with no faults found and on the 27/08/21 there was no access to the first floor and the top floor rooms (as noted in the fire log book).	
		<b>Recommended Action:</b> We recommend the client ensures the system is tested and maintained accordingly (weekly tests and 6 month servicing) ensuring a sufficient portion of the system is maintained every 6 months as required	
<b>Date First Identified:</b>	17/11/21		
<b>Date of FRA:</b>	17/11/21		
<b>Rectify Within: (months)</b>	12		
<b>Budget Cost:</b>	No Cost

We recommend the client ensures the system is tested and maintained accordingly and ensures a sufficient portion of the system is maintained every 6 months as required

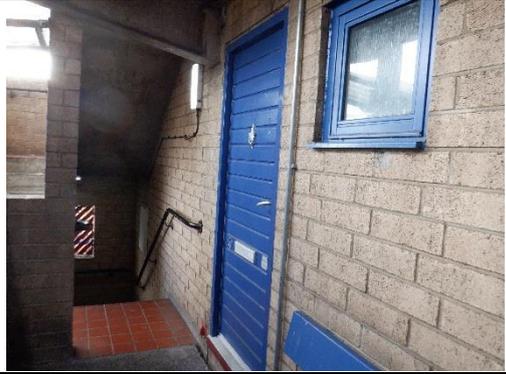
<b>LOW</b>		<b>11</b>

<p><b>Assessors Observations:</b></p> <p>There is generally adequate directional signage fitted within the building conforming to BS5499 on most floors. However, from the second floor to the south elevation of the building there appears to be a lack of signage to the stairwell when exiting from flats 16-14 on the 2<sup>nd</sup> floor balcony and 9-10 on the first floor balcony.</p>	
<b>Date First Identified:</b>	17/11/21	<p><b>Recommended Action:</b></p> <p>We recommend additional direction fire exit signage is installed within this location.</p>	
<b>Date of FRA:</b>	17/11/21		
<b>Rectify Within: (months)</b>	12		
<b>Budget Cost:</b>	£20
