**FIRE RISK ASSESSMENT
AVONDALE HOUSE,
50 RABY WAY, BYKER,
NEWCASTLE UPON TYNE NE6 2FQ**

OCTOBER 2021

STORM TEMPEST
PROPERTY CONSULTANCY

Reference: 4009-04-21-IC

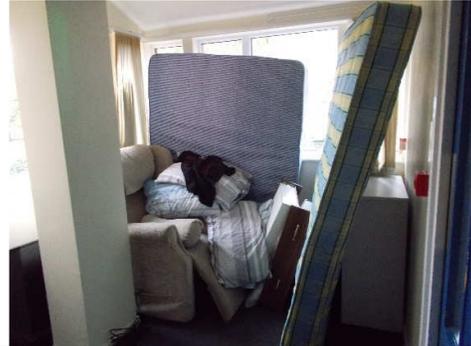
| HIGH | | 1 | | |

At the time of the inspection, combustible materials and obstructions were present in numerous locations throughout. This included items such as mattresses, bedding, wardrobes, sofas, upholstered chairs, ovens, washing machines, cardboard packaging and more. We have requested the staff on duty at the time to remove these items as soon as practicable to ensure there is no fire loading on the means of escape and it is available for use at all times. Notwithstanding this, should there be a need for the removal of furniture etc from any flat on a temporary or permanent basis, either, arrangements should be made for the collection and removal in advance, or the items should be stored elsewhere off the means of escape until they can be returned to the room they belong to.

| | | <p>At the time of the inspection, combustible materials and obstructions were present in numerous locations throughout. This included items such as mattresses, bedding, wardrobes, sofas, upholstered chairs, ovens, washing machines, cardboard packaging and more.</p> | | |

| Date of FRA | 28/10/21 | <p>We have requested the staff on duty at the time to remove these items as soon as practicable to ensure there is no fire loading on the means of escape and it is available for use at all times. Notwithstanding this, should there be a need for the removal of furniture etc from any flat on a temporary or permanent basis, either, arrangements should be made for the collection and removal in advance, or the items should be stored elsewhere off the means of escape until they can be returned to the room they belong to.</p> | | |

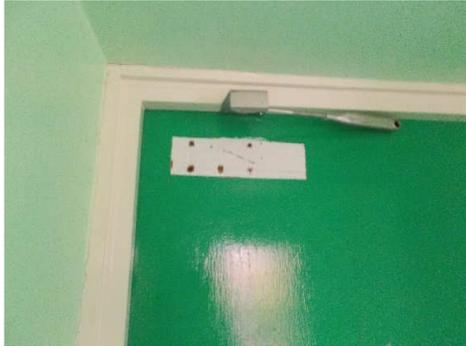
| HIGH | | 2 |

It was noted almost every flat entrance door has had its self-closing device disconnected or removed. These devices are essential in ensuring flat entrance doors close effectively in order to contain any fire within, and allow other residents to use the means of escape safely. We recommend a full survey of all flat

| HIGH | | 2 |
|---|---|--|
| | | <p>Assessors Observations:</p> <p>Almost every flat entrance door has had its self-closing device disconnected or removed. These devices are essential in ensuring flat entrance doors close effectively in order to contain any fire within, and allow other residents to use the means of escape safely.</p> |

entrance doors is undertaken and ensure each door has a working self-closing device. In addition, we recommend staff undertake regular safety tours of the premises to ensure means of escape are available and flat entrance doors are maintained adequately.

| HIGH | | 2 |
|---|---|--|
| Date First Identified: | 28/10/21 | <p>Recommended Action:</p> <p>We recommend a full survey of all flat entrance doors is undertaken and ensure each door has a working self-closing device. In addition, we recommend staff undertake regular safety tours of the premises to ensure means of escape are available and flat entrance doors are maintained adequately.</p> |

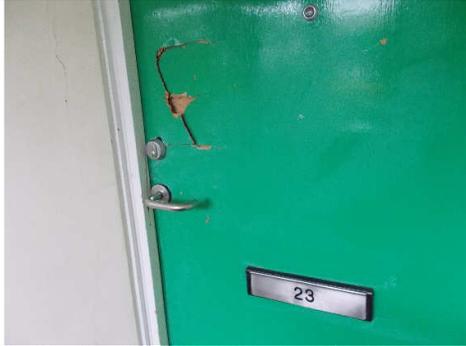
| MEDIUM | | 3 |

The door to flat 23 has been subject to impact damage and is unlikely to perform as it should in a fire. We recommend this door is replaced with a FD30S SC door to BS8214.

| MEDIUM | | 3 |
|---|---|---|
| | | <p>Assessors Observations:</p> <p>The door to flat 23 has been subject to impact damage and is unlikely to perform as it should in a fire.</p> |

| MEDIUM | | 3 |
|---|---|---|
| Date First Identified: | 28/10/21 | <p>Recommended Action:</p> <p>We recommend this door is replaced with a FD30S SC door to BS8214.</p> |

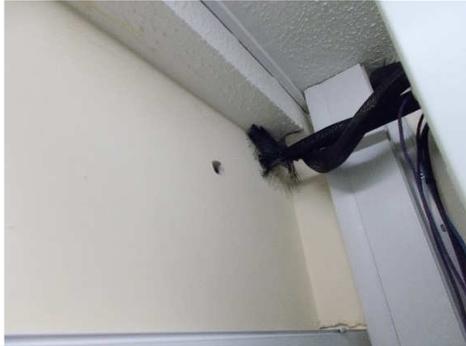
| MEDIUM | | 4 | | |

Numerous breaches were noted within the server room on the entrance foyer. We recommend these breaches are addressed using a suitable fire stopping material to ensure a minimum 30 minutes fire resistance.

| | | <p>Numerous breaches were noted within the server room on the entrance foyer.</p> | | |

| Date First Identified: | 28/10/21 | Recommended Action: We recommend these breaches are addressed using a suitable fire stopping material to ensure a minimum 30 minutes fire resistance. | | |

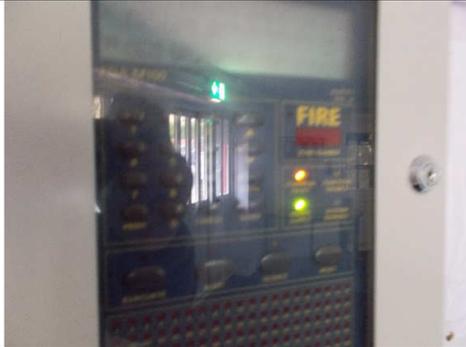
| MEDIUM | | 5 | | |

At the time of the inspection the fire alarm panel was showing a "Fault" indicator. We recommend this is investigated to ensure the fire alarm and detection system is working correctly.

| | | <p>At the time of the inspection the fire alarm panel was showing a "Fault" indicator.</p> | | |

| Date First Identified: | 28/10/21 | Recommended Action: We recommend this is investigated to ensure the fire alarm and detection system is working correctly. | | |

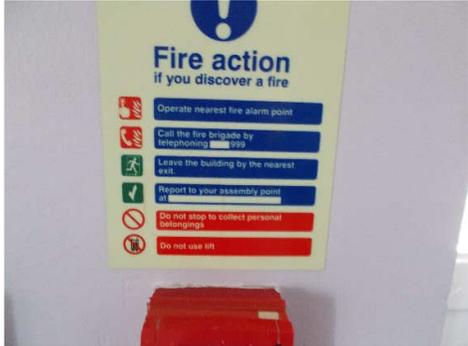
| LOW | | 6 |

The general fire action notice in the hall is not completed. We recommend the location of the assembly point is added to the notice. "No Smoking" notices are displayed at appropriate locations.

| LOW | | 6 |
|---|---|--|
| | | <p>Assessors Observations:</p> <p>The general fire action notice in the hall is not completed.</p> |

| LOW | | 6 |
|---|---|--|
| Date First Identified: | 28/10/21 | <p>Recommended Action:</p> <p>We recommend the location of the assembly point is added to the notice.</p> |
