**FIRE RISK ASSESSMENT
7-12 FELTON HOUSE,
NEWCASTLE UPON TYNE,
TYNE AND WEAR, NE6 2NW.**

FEBRUARY 2022

STORM TEMPEST
PROPERTY CONSULTANCY

Reference: JA-4009-04-21

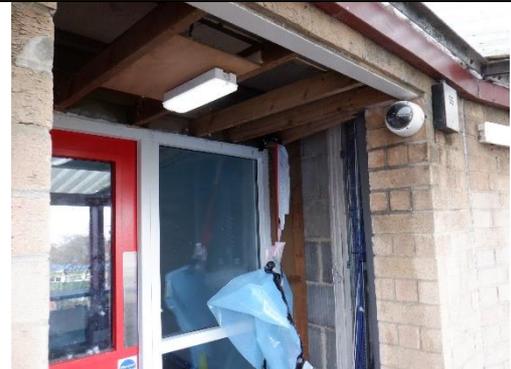
MEDIUM		1

Through the access door to the semi open balcony on the 2nd floor, repair works are being undertaken, leaving wood beams, plastics and wiring exposed. This is within a secured location and only accessible by residents and their visitors and can be considered as low fire risk in relation to arson. However, we would recommend the works are completed as soon as practicable as we believe the designed compartmentation to the protected stairwell may currently be compromised.

<p>Assessors Observations:</p> <p>Through the access door to the semi open balcony on the 2nd floor, repair works are being undertaken, leaving wood beams, plastics and wiring exposed. This is within a secured location and only accessible by residents and their visitors and can be considered as low fire risk of deliberate ignition.</p>
Date First Identified:	09/02/22	<p>Recommended Action:</p> <p>We would recommend the works are completed as soon as practicable as currently we believe the designed compartmentation to the protected stairwell is compromised.</p>
Date of FRA:	09/02/22	
Rectify Within: (months)	6	
Budget Cost:	No Cost

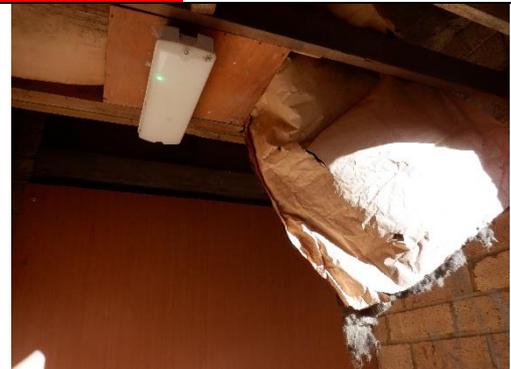
HIGH		2

The rear exit from the ground floor is currently boarded up with chipboard for unknown reasons. Externally to this, there appears to be damage to the porch overhang which leaves timber beams and insulation/paper exposed. We believe this to be a high risk of attracting arsonists and recommend this is repaired as soon as practicable.

4.9 Arson The risk of an arson attack is considered high due to the exposed insulation material located above the rear emergency exit door on the ground floor. We have recommended this is repaired and made good.

<p>Assessors Observations:</p> <p>The rear exit from the ground floor is currently boarded up with chipboard for unknown reasons. Externally to this, there appears to be damage to the porch overhang which leaves timber beams and insulation/paper exposed.</p>
Date First Identified:	09/02/22	<p>Recommended Action:</p> <p>We believe this to be a high risk of attracting arsonists and recommend this is repaired as soon as practicable.</p>
Date of FRA:	09/02/22	
Rectify Within: (months)	1	
Budget Cost:	No Cost

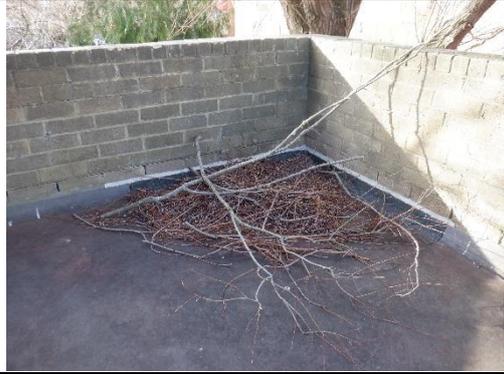
MEDIUM		3

There is a large accumulation of foliage and branches on the walkway adjacent to the access bridge to Felton Walk. We recommend the combustible material is removed to prevent accidental or deliberate ignition potentially blocking the means of escape.

Assessors Observations: There is a large accumulation of foliage and branches on the walkway adjacent to the access bridge to Felton Walk.	
Date First Identified:	09/02/22	Recommended Action: We recommend the combustible material is removed to prevent accidental or deliberate ignition potentially blocking the means of escape.	
Date of FRA:	09/02/22		
Rectify Within: (months)	6		
Budget Cost:	No Cost

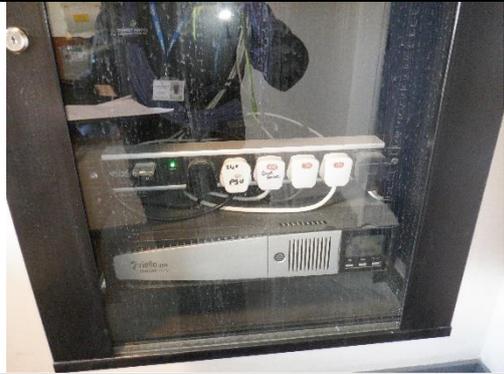
LOW		4

Assessors Observations: Within the communications rooms on the first floor we noted a data cabinet with numerous data equipment plugged into an extension lead. We did not note any labelling to indicate the equipment, or the extension lead has been tested for electrical safety within the last 12 months (Portable Appliance Test (PAT)).	
Date First Identified:	09/02/22	Recommended Action: We recommend the client confirms all such equipment has been tested for electrical safety within the last 12 months and if not, arranges for it to be undertaken and a schedule introduced for it to be carried out annually thereafter.	
Date of FRA:	09/02/22		
Rectify Within: (months)	12		
Budget Cost:	No Cost

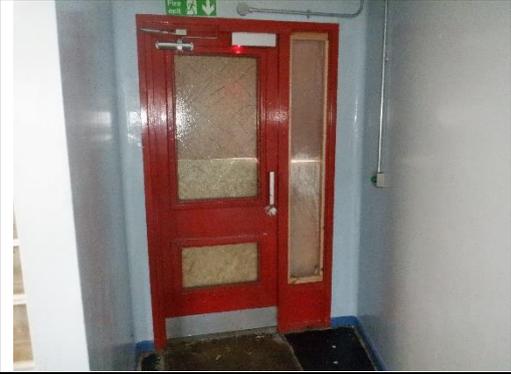
MEDIUM		5

A second door within the lobby provides an exit to the rear of the building. On the day of the visit this door has been boarded up for unknown reasons, taking this emergency exit out of service. We recommend any repairs etc. are carried out, and the emergency exit is brought back into service as soon as practicable.

Assessors Observations: A second door within the lobby provides an exit to the rear of the building. On the day of the visit this door has been boarded up for unknown reasons, taking this emergency exit out of service.	
Date First Identified:	09/02/22	Recommended Action: We recommend any repairs etc. are carried out, and the emergency exit is brought back into service as soon as practicable.	
Date of FRA:	09/02/22		
Rectify Within: (months)	6		
Budget Cost:	No Cost

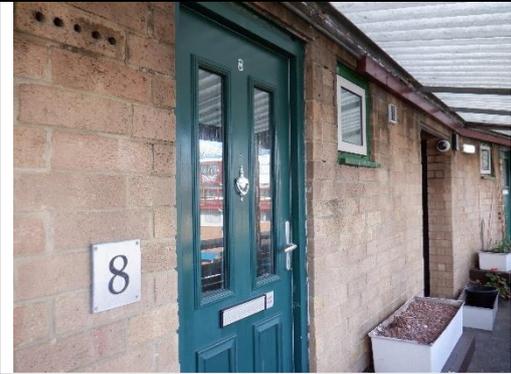
LOW		6

The exceptions to this would be flat 7, with the only means of escape being to bypass flat entrance door number 8. We could not access flat 8 on the day of the visit and as such were unable to assess if the flat door to flat 8 met the benchmark standard (at least FD30S, self-closing). We recommend the client arranges access or checks the records to confirm this is the case.

Assessors Observations: The only means of escape from flat 7 is to bypass flat entrance door number 8. We could not access flat 8 on the day of the visit and as such were unable to assess if the flat door to flat 8 met the benchmark standard (at least FD30S, self-closing).	
Date First Identified:	09/02/22	Recommended Action: We recommend the client arranges access or checks the records to confirm this is the case.	
Date of FRA:	09/02/22		
Rectify Within: (months)	12		
Budget Cost:	No Cost

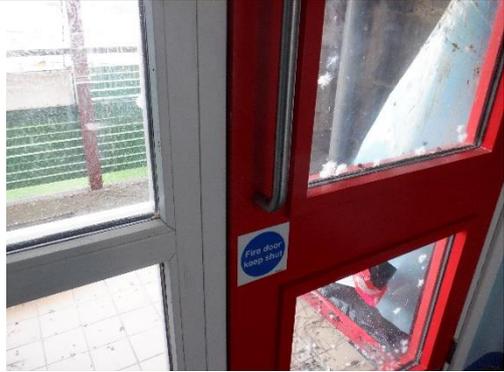
MEDIUM		7

We noted an FD60S fire door leading to the walkway balconies of on the 2nd floor from the protected stairwell did not close to its rebate. We recommend the doors self-closer is adjusted to ensure the door closes fully to its rebate, to ensure the fire rated integrity of the fire door is maintained.

Assessors Observations: We noted an FD60S fire door leading to the walkway balconies of on the 2 nd floor from the protected stairwell did not close to its rebate.	
Date First Identified:	09/02/22	Recommended Action: We recommend the doors self-closer is adjusted to ensure the door closes fully to its rebate, to ensure the fire rated integrity of the fire door is maintained.	
Date of FRA:	09/02/22		
Rectify Within: (months)	6		
Budget Cost:	£35

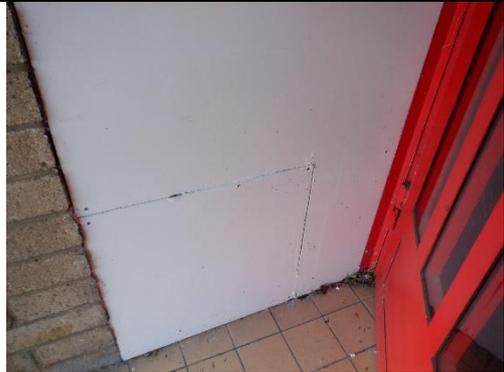
MEDIUM		8

Beside the main entrance we noted a hatch had been made to side panel adjacent to the front door, This has been refixed to the wall with screws, however, the hatch outline is still visible and may not afford the required compartmentation to this panel. We recommend this is investigated and if required, either the full panel replaced, or a fire rated seal is made to restore the fire rated properties of the panel.

Assessors Observations: Beside the main entrance we noted a hatch had been made to side panel adjacent to the front door, This has been refixed to the wall with screws, however, the hatch outline is still visible and may not afford the required compartmentation to this panel.	
Date First Identified:	09/02/22	Recommended Action: We recommend this is investigated and if required, either the full panel replaced, or a fire rated seal is made to restore the fire rated properties of the panel.	
Date of FRA:	09/02/22		
Rectify Within: (months)	6		
Budget Cost:	£40

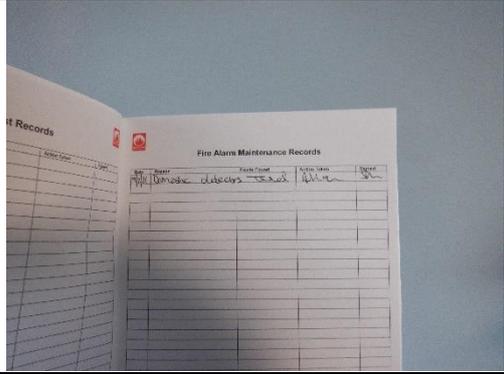
LOW		9

A fire logbook located on site indicated the domestic detectors last underwent maintenance on 19/02/21, however there was no indication of any weekly testing having been carried out or testing of the detectors provided within the flats.

Assessors Observations: A fire logbook located on site the fire alarm system linked to the bin store last underwent maintenance on 19/02/21, however there was no indication of any weekly testing having been carried out or testing of the detectors provided within the flats.	
Date First Identified:	09/02/22	Recommended Action: We recommend the client ensures the system is tested and maintained accordingly and ensures a sufficient portion of the system is maintained every 6 months as required, to include the bin store and flats in accordance with BS 5839.	
Date of FRA:	09/02/22		
Rectify Within: (months)	12		
Budget Cost:	No Cost

We recommend the client ensures the system is tested and maintained accordingly and ensures a sufficient portion of the system is maintained every 6 months as required, to include the bin store and flats in accordance with BS 5839.

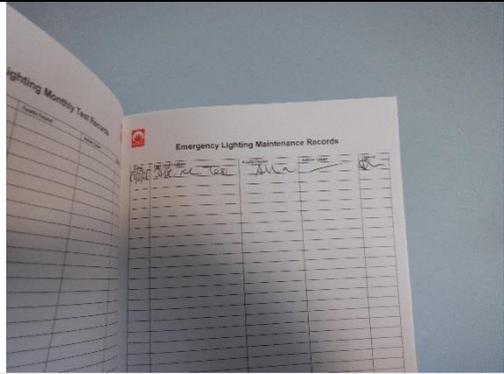
LOW		10

We did not identify if monthly functional tests are being carried out as we could not locate any entries within the fire logbook. Client held records indicate the system underwent its annual test on 19/02/21.

Assessors Observations: We could not identify if monthly functional tests are being carried on the emergency lighting out as we could not locate any entries within the fire logbook. Client held records indicate the system underwent its annual test on 19/02/21.	
Date First Identified:	09/02/22	Recommended Action: We recommend the client confirms monthly functional tests are carried out, and if not, instructs them to be carried out in accordance with BS 5266.	
Date of FRA:	09/02/22		
Rectify Within: (months)	12		
Budget Cost:	No Cost

We recommend the client confirms monthly functional tests are carried out, and if not, instructs them to be carried out in accordance with BS 5266.

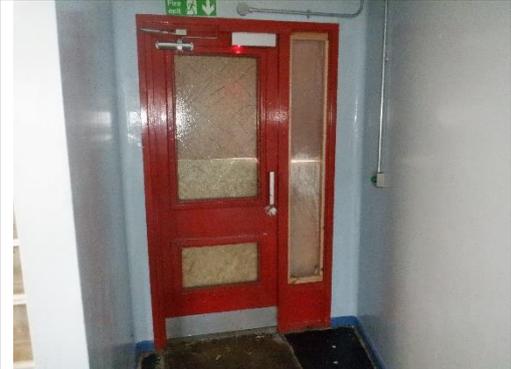
LOW		11

<p>Assessors Observations:</p> <p>The rear emergency exit on the ground floor has been taken out of service.</p>
		<p>Recommended Action:</p> <p>We recommend the fire evacuation plan if not already done so is amended to incorporate this. We also recommend the fire exit signage above the door is removed until the escape route is brought back into service.</p>
Date First Identified:	09/02/22	
Date of FRA:	09/02/22	
Rectify Within: (months)	12	
Budget Cost:	No Cost

As mentioned within this report, the rear emergency exit on the ground floor has been taken out of service. We therefore recommend the fire evacuation plan if not already done so is amended to incorporate this. We also recommend the fire exit signage above the door is removed until the escape route is brought back into service.
