**FIRE RISK ASSESSMENT
33-37 HEADLAM GREEN,
NEWCASTLE UPON TYNE,
TYNE AND WEAR, NE6 2PG.**

MAY 2022

STORM TEMPEST
PROPERTY CONSULTANCY

Reference: 4180-04-22-JA

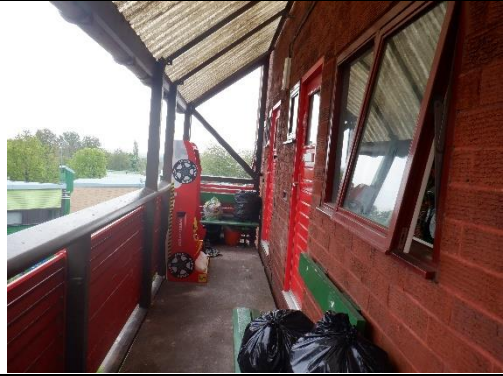
MEDIUM		1

- Electrical PVC insulation throughout.
- Timber panelling to walkway balconies and residents private balconies with corrugated PVC roofing.
- Timber benches on communal walkway balconies.
- Rubbish bags stored on the communal walkway of flats 35, 36 and 37.
- A child's timber bed frame stored outside flat 37.

We noted bags of rubbish and a child's timber bed frame stored on the communal walkway of the first floor. All walkways should be maintained free from any combustible materials and obstructions. We recommend the items are removed and residents reminded to keep all escape routes clear at all times.

Assessors Observations: We noted bags of rubbish and a child's timber bed frame stored on the communal walkway of the first floor. All walkways should be maintained free from any combustible materials and obstructions.
Date First Identified:	09/05/22	Recommended Action: We recommend the items are removed and residents reminded to keep all escape routes clear at all times.
Date of FRA:	09/05/22	
Rectify Within: (months)	6	
Budget Cost:	No Cost

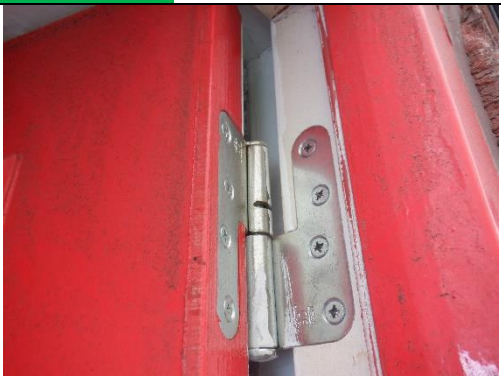
LOW		4

- 4.2 Fire Doors Flats within this complex open onto a semi open walkway balcony, and generally occupants would not be required to bypass other flat entrance doors during an emergency fire evacuation, with the exception of flats 36 and 37, where the occupants egressing from their flats would bypass flat entrance doors to make an escape.

As such, flats 35 and 36 are required to meet the current benchmark standard for flat entrance doors as being self-closing, capable of providing 30-minute fire resistance and incorporating intumescent strips and smoke seals FD30S.

Assessors Observations:	
		Flats 35 and 36 are required to be fitted with fire doors complying with BS 8214. We were unable to access flats 35 or 36 to check against this standard.	
Date First Identified:	09/05/22	Recommended Action: We recommend the client gains access to confirm the flat entrance door meets BS 8214 for timber fire resisting doors.	
Date of FRA:	09/05/22		
Rectify Within: (months)	12		
Budget Cost:	No Cost

We were unable to access flats 35 or 36 to check against this standard and recommend the client gains access to confirm the flat entrance door meets BS 8214 for timber fire resisting doors.
