FIRE RISK ASSESSMENT

38-42 HEADLAM GREEN,

MAY 2022

Reference: 4180-04-22-JA

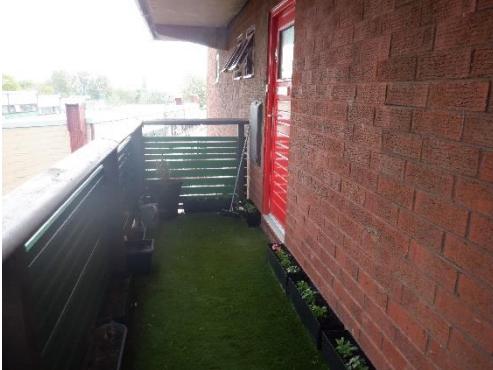
LOW	1

We noted decorative artificial grass on the walkway leading to flat 38, and although we believe this to be non-flammable, care should be taken to ensure hot surfaces such as barbeques etc. do not come into contact with the grass, which would cause it to melt.

<p>Assessors Observations:</p> <p>We noted decorative artificial grass on the walkway balcony leading to flat 38.</p>
Date First Identified:	09/05/22	Recommended Action:
Date of FRA:	09/05/22	Although we believe this to be non-flammable, care should be taken to ensure hot surfaces such as barbeques etc. do not come into contact with the grass, which would cause it to melt. Residents should be reminded that all balconies should be maintained clear of any sources of ignition as much as is practicable.
Rectify Within: (months)	12	
Budget Cost:	No Cost

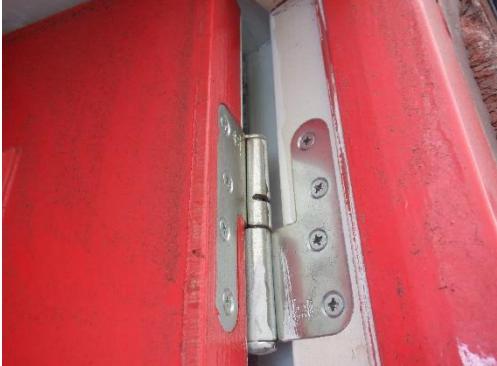
MEDIUM	4

We accessed flat 40 to check the standard of the flat entrance door. The door itself appeared to be a notional part glazed fire door

(44mm thickness) and although we noted what appeared to be a seal fitted to the internal angle of the frame rebate, we could not confirm the presence of intumescent and cold smoke seals. The door was not fitted with a self-closing device.

<p>Assessors Observations:</p> <p>Flats 40 and 41 are required to be fitted with fire doors complying with BS 8214. We accessed flat 40 to check the standard of the flat entrance door. The door itself appeared to be a notional part glazed fire door (44mm thickness) however it has no self-closer and we could not confirm the presence of intumescent or cold smoke seals.</p>
Date First Identified:	09/05/22	<p>Recommended Action:</p> <p>We recommend the client gains access to confirm the flat entrance door of flats 40 and 41 do not meet BS 8214 for timber fire resisting doors and has them upgraded accordingly.</p>
Date of FRA:	09/05/22	
Rectify Within: (months)	6	
Budget Cost:	£200

We recommend the client gains access to confirm the flat entrance door of flats 40 and 41 do not meet BS 8214 for timber fire resisting doors and has them upgraded accordingly.
