**FIRE RISK ASSESSMENT
2 & 10-28 BYKER CRESCENT, BYKER,
NEWCASTLE UPON TYNE
NE6 2JT**

MARCH 2022

Reference: BC/09/03/22/IC

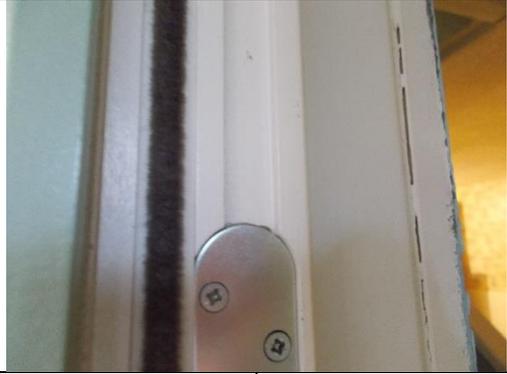
MEDIUM		1

flat entrance doors to number 2 is a FD60S door with fire rated letterbox and door viewer, but does not have a self-closing device attached and part of its combined intumescent strip and cold smoke seal is missing. In addition, it appears to have suffered some damage as it is difficult to close. As this particular door is located adjacent to a final exit, we recommend a self-closing device is attached to this door to ensure it can close fully against its rebate unaided and under its own weight, is rehung so that it can close fully against its rebate, and the combined intumescent strip and cold smoke seal is reinstated.

<p>Assessors Observations:</p> <p>The flat entrance doors to number 2 is a FD60S door but does not have self-closing device attached and part of its combined intumescent strip and cold smoke seal is missing. In addition, it appears to have suffered some damage as it is difficult to close.</p>
		<p>Recommended Action:</p> <p>As this particular door is located adjacent to a final exit, we recommend a self-closing device is attached to this door to ensure it can close fully against its rebate unaided and under its own weight, is rehung so that it can close fully against its rebate, and the combined intumescent strip and cold smoke seal is reinstated.</p>
		<p>Date First Identified:</p> <p style="text-align: center;">09/03/22</p>
		<p>Date of FRA</p> <p style="text-align: center;">09/03/22</p>
		<p>Rectify Within: (months)</p> <p style="text-align: center;">6</p>
<p>Budget Cost:</p> <p style="text-align: center;">£150</p>

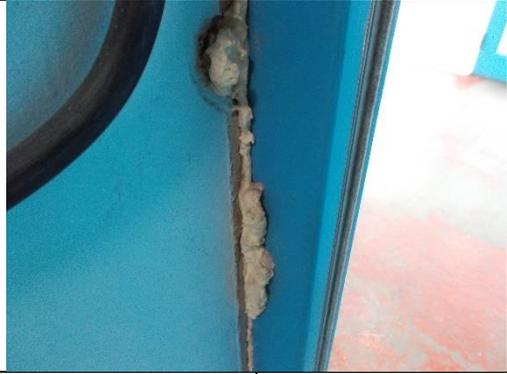
MEDIUM		2

It was noted within the landlord services room (door 3/3.1) yellow PU expandable foam has been used to seal gaps around the door frame. Yellow PU foam is highly flammable and is not suitable within this particular compartment. This foam should be removed and the gaps sealed using a suitable fire stopping material capable of achieving a minimum 60 minutes fire resistance.

<p>Assessors Observations:</p> <p>Within the landlord services room (door 3/3.1) yellow PU expandable foam has been used to seal gaps around the door frame. Yellow PU foam is highly flammable and is not suitable within this particular compartment.</p>
		<p>Recommended Action:</p> <p>This foam should be removed and the gaps sealed using a suitable fire stopping material capable of achieving a minimum 60 minutes fire resistance.</p>
		<p>Date First Identified:</p> <p style="text-align: center;">09/03/22</p>
		<p>Date of FRA</p> <p style="text-align: center;">09/03/22</p>
		<p>Rectify Within: (months)</p> <p style="text-align: center;">6</p>
<p>Budget Cost:</p> <p style="text-align: center;">£20</p>

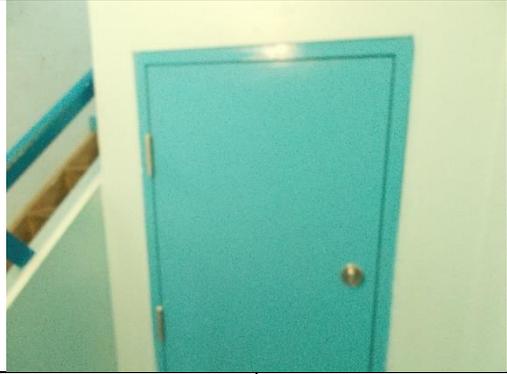
LOW		3

Assessors Observations:			
		The fire door to the cupboard in the lobby of entrance 3 requires a "Fire Door Keep Locked" sign to be attached to the face of the door.			
		Date First Identified:	09/03/22	Recommended Action:	
		Date of FRA	09/03/22	As above	
		Rectify Within: (months)	12		
Budget Cost:	£10

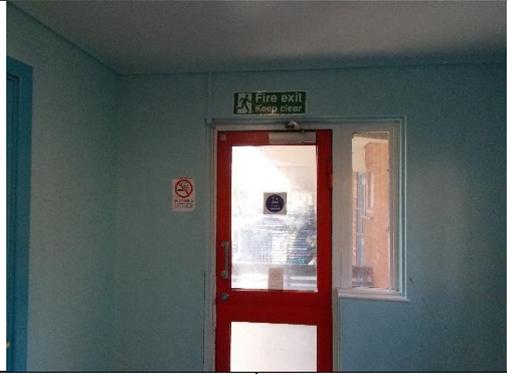
LOW		4

The exit door leading from the rear of the ground floor lobby requires a directional thumb turn sign indicating its correct use.

Assessors Observations:			
		The exit door leading from the rear of the ground floor lobby requires a directional thumb turn sign indicating its correct use.			
		Date First Identified:	09/03/22	Recommended Action:	
		Date of FRA	09/03/22	As above	
		Rectify Within: (months)	12		
Budget Cost:	£10
