**FIRE RISK ASSESSMENT REVIEW
1-7 THORNBOROUGH HOUSE,
NEWCASTLE UPON TYNE,
TYNE AND WEAR, NE6 2NS.**

MAY 2022

STORM TEMPEST
PROPERTY CONSULTANCY

Reference: 4180-04-22-JA

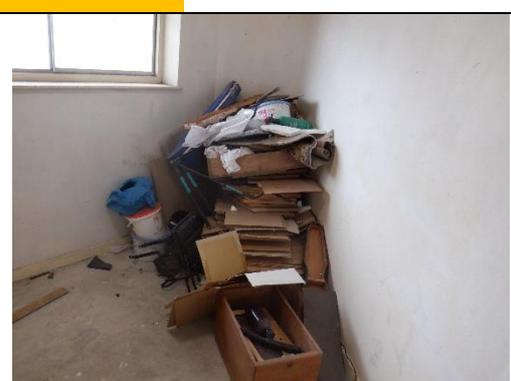
MEDIUM		1

- 2.2.4 We accessed a cupboard located off the first floor stairwell and noted storage of combustible waste material and rubbish which included cardboard and timber. We also noted storage of discarded timber furniture within the former refuse room on the 2nd floor. Although we understand the cupboard on the first floor is not accessed by residents and was appropriately locked on the day of the visit, we recommend both rooms are cleared of the rubbish and rooms off the means of escape are maintained clear of rubbish and waste items at all times.

<p>Assessors Observations:</p> <p>We accessed a cupboard located off the first floor stairwell and noted storage of combustible waste material and rubbish which included cardboard and timber. We also noted storage of discarded timber furniture within the former refuse room on the 2nd floor.</p>
Ref:	2.2.4	<p>Recommended Action:</p> <p>We recommend both rooms are cleared of the rubbish and rooms off the means of escape are maintained clear of rubbish and waste items at all times.</p>
Date First Identified:	09/05/22	
Date of FRA Review:	09/05/22	
Rectify Within: (months)	6	
Budget Cost:	No Cost

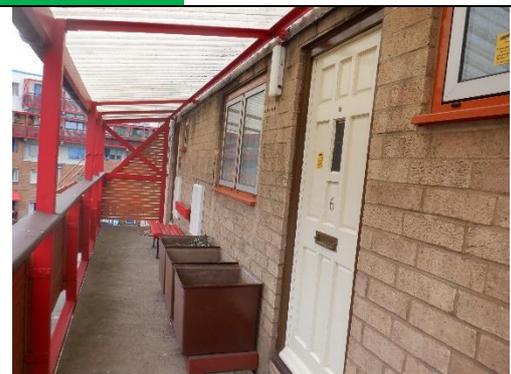
LOW		3

- 2.3.2 Second floor flats within this complex open onto a semi open walkway balcony, and generally occupants would not be required to bypass other flat entrance doors during an emergency fire evacuation, with flat 6 being an exception as occupants from flat 7 would be required to bypass flat 6 in order to exit to an ultimate place of safety away from the property. As such, flat 6 would be required to meet the current benchmark standard for flat entrance doors to be self-closing, capable of

- providing 30-minute fire resistance and incorporating intumescent strips and smoke seals FD30S. We were unable to access flat 6 to check against this standard and recommend the client gains access to confirm the flat entrance door meets BS 8214 for timber fire resisting doors.

<p>Assessors Observations:</p> <p>Occupants from flat 7 would be required to bypass flat 6 in order to exit to an ultimate place of safety away from the property. As such, flat 6 would be required to meet the current benchmark standard for flat entrance doors to be self-closing, capable of providing 30-minute fire resistance and incorporating intumescent strips and smoke seals.</p>
		<p>Ref: 2.3.2</p> <p>Recommended Action:</p> <p>We were unable to access flat 6 to check against this standard and recommend the client gains access to confirm the flat entrance door meets BS 8214 for timber fire resisting doors.</p>
Date First Identified:	09/05/22	
Date of FRA Review:	09/05/22	
Rectify Within: (months)	12	
Budget Cost:	No Cost

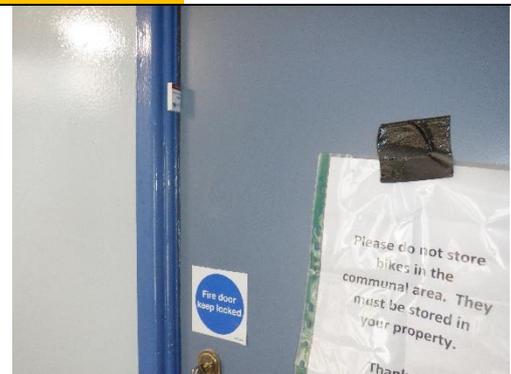
MEDIUM		4

- 2.3.3 All service cupboards and the former bin store are FD60S fire doors hung on 1½ pair of fire rated hinges with a self-closing device fitted and fitted with combined intumescent and cold smoke seals. Numerous doors inspected were noted to have excessive gaps between the door and frame beyond 4mm, potentially allowing the products of combustion to pass in a fire situation. We recommend the doors are rehung to ensure the gaps are 3mm ± 1mm.

<p>Assessors Observations:</p> <p>All service cupboards and the former bin store are FD60S fire doors. Numerous doors inspected were noted to have excessive gaps between the door and frame beyond 4mm, potentially allowing the products of combustion to pass in a fire situation.</p>
		<p>Ref: 2.3.3</p> <p>Recommended Action:</p> <p>We recommend the doors are rehung to ensure the gaps are 3mm ± 1mm.</p>
Date First Identified:	09/05/22	
Date of FRA Review:	09/05/22	
Rectify Within: (months)	6	
Budget Cost:	£100

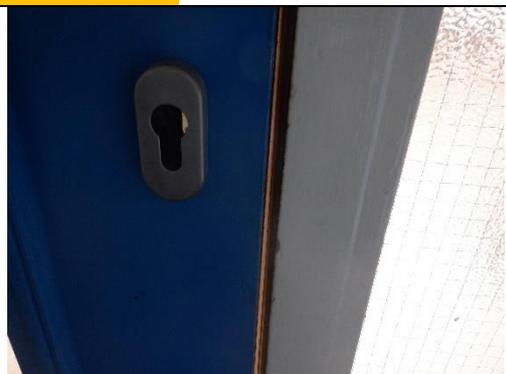
MEDIUM		5

- 2.3.4 The FD60 rated fire door from the communal stairway to the external walkway on the second floor has excessive gaps between the door and frame and we were also unable to confirm the presence of intumescent seals on the door or frame. We recommend the door is rehung to ensure the gaps are 3mm ± 1mm between the door and frame and the client confirms the fire door meets the requirements as outlined within BS 8214 for timber fire resisting doors, to ensure the fire rated integrity and smoke control of the fire door is fully maintained.

<p>Assessors Observations:</p> <p>The FD60 rated fire door from the communal stairway to the external walkway on the second floor has excessive gaps between the door and frame and we were also unable to confirm the presence of intumescent seals on the door or frame.</p>
Ref:	2.3.4	<p>Recommended Action:</p> <p>We recommend the door is rehung to ensure the gaps are 3mm ± 1mm between the door and frame and the client confirms the fire door meets the requirements as outlined within BS 8214 for timber fire resisting doors, to ensure the fire rated integrity and smoke control of the fire door is fully maintained.</p>
Date First Identified:	09/05/22	
Date of FRA Review:	09/05/22	
Rectify Within: (months)	6	
Budget Cost:	£35

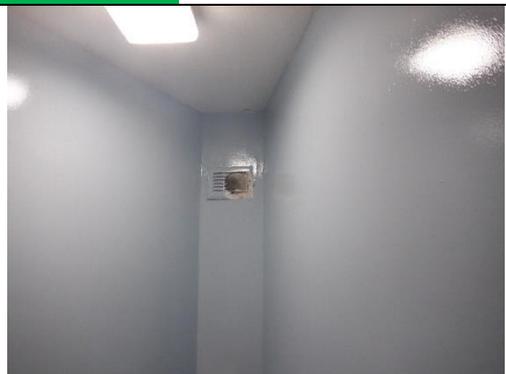
LOW		6

- 2.3.6 We noted a ventilation grille fitted within the former refuse store on the 2nd floor. We are unsure where this vents to. The client should have this checked and if not venting to an external wall, should have it replaced with an intumescent type of grille.

<p>Assessors Observations:</p> <p>We noted a ventilation grille fitted within the former refuse store on the 2nd floor. We are unsure where this vents to.</p>
Ref:	2.3.6	<p>Recommended Action:</p> <p>The client should have this checked and if not venting to an external wall, should have it replaced with an intumescent type of grille.</p>
Date First Identified:	09/05/22	
Date of FRA Review:	09/05/22	
Rectify Within: (months)	12	
Budget Cost:	No Cost

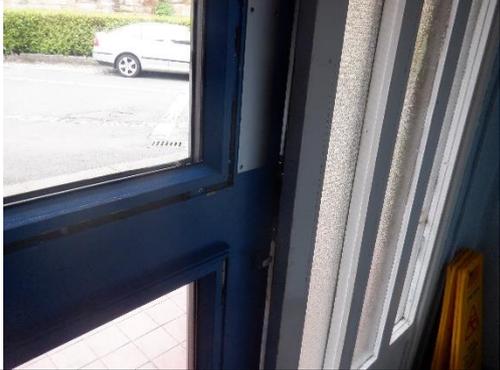
LOW		8

- 2.3.9 We noted the communal entrance to the stairwell and the flats beyond did not self-close due to what appeared to be a stiff latching mechanism. This may allow unauthorised persons to enter the building increasing the risk of arson. We recommend the latch/self-closer is adjusted to ensure the door closes fully under its own weight.

<p>Assessors Observations:</p> <p>We noted the communal entrance to the stairwell and the flats beyond did not self-close due to what appeared to be a stiff latching mechanism. This may allow unauthorised persons to enter the building increasing the risk of arson.</p>
Ref:	2.3.9	<p>Recommended Action:</p> <p>We recommend the latch/self-closer is adjusted to ensure the door closes fully under its own weight.</p>
Date First Identified:	09/05/22	
Date of FRA Review:	09/05/22	
Rectify Within: (months)	12	
Budget Cost:	£20
