FIRE RISK ASSESSMENT REVIEW
1-3 BRINKBURN CLOSE,
NEWCASTLE UPON TYNE,
NE6 2HW

JUNE 2022

Reference: 4180-04-22-DS

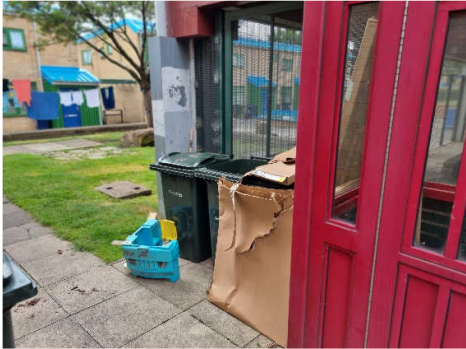
MEDIUM		1

2.2.2 At the time of the survey the external wheelie bins were being stored up against the stairwell lobby area's walls. We recommend the external wheelie bins are relocated away from the buildings elevations.

Assessors Observations: At the time of the survey the external wheelie bins were being stored up against the stairwell lobby area's walls.
		Recommended Action: We recommend the external wheelie bins are relocated away from the buildings elevations.
Ref:	2.2.2	
Date First Identified:	30/06/21	
Date of FRA Review:	30/06/22	
Rectify Within: (months)	6	
Budget Cost:	No Cost

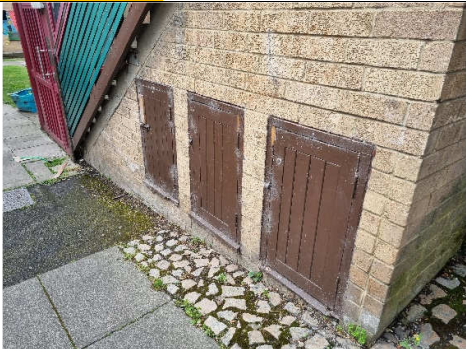
MEDIUM		3

2.2.4 At the time of the survey we were unable to gain access into cupboards located under the external communal staircase. We recommend the under stairs cupboards are inspected and cleared of any stored sources of fuel.

<p>Assessors Observations:</p> <p>At the time of the survey we were unable to gain access into cupboards located under the external communal staircase.</p>
Ref:	2.2.4	<p>Recommended Action:</p> <p>We recommend the under stairs cupboards are inspected and cleared of any stored sources of fuel.</p>
Date First Identified:	30/06/21	
Date of FRA Review:	30/06/22	
Rectify Within: (months)	6	
Budget Cost:	No Cost

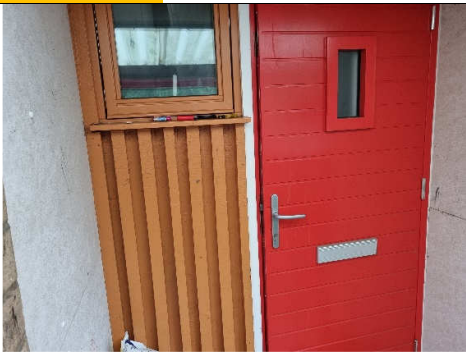
MEDIUM		4

2.2.6 The Client operates a no-smoking policy within the building, with appropriate signage displayed. At the time of the inspection there was evidence of smoking activities taking place externally adjacent to the front door of Flat 1. We would recommend that the client instructs residents not to smoke in the communal areas of the building and also externally in close proximity to final exit doors and windows.

<p>Assessors Observations:</p> <p>The Client operates a no-smoking policy within the building, with appropriate signage displayed. At the time of the inspection there was evidence of smoking activities taking place externally adjacent to the front door of Flat 1.</p>
Ref:	2.2.6	<p>Recommended Action:</p> <p>We would recommend that the client instructs residents not to smoke in the communal areas of the building and also externally in close proximity to final exit doors and windows.</p>
Date First Identified:	30/06/22	
Date of FRA Review:	30/06/22	
Rectify Within: (months)	6	
Budget Cost:	No Cost

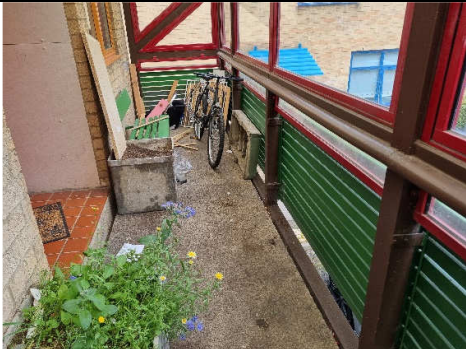
MEDIUM		5

<p>Assessors Observations:</p> <p>We noted various combustible items stored on the means of escape / balcony walkway.</p>
Ref:	2.3.2	<p>Recommended Action:</p> <p>We would recommend that these items are removed to reduce the fuel load and remove any tripping hazards.</p>
Date First Identified:	30/06/21	
Date of FRA Review:	30/06/22	
Rectify Within: (months)	6	
Budget Cost:	No Cost

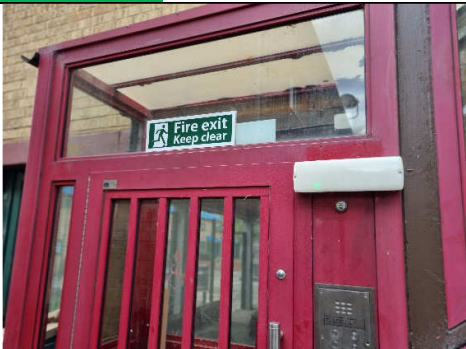
LOW		6

- 2.3.3 There is a 3 hour non-maintained emergency lighting system installed within the means of escape that conforms to BS 5266. The emergency lighting is required to be tested and maintained in accordance with BS 5266. There are no records on site to confirm if the emergency lighting is being maintained in accordance with BS5266. The client should check their records to confirm if the system is maintained and if not this should be undertaken in accordance with BS5266 and records made available.

<p>Assessors Observations:</p> <p>There is a 3 hour non-maintained emergency lighting system installed within the means of escape that conforms to BS 5266. The emergency lighting is required to be tested and maintained in accordance with BS 5266. There are no records on site to confirm if the emergency lighting is being maintained in accordance with BS5266.</p>
Ref:	2.3.3	<p>Recommended Action:</p> <p>The client should check their records to confirm if the system is maintained and if not this should be undertaken in accordance with BS5266 and records made available.</p>
Date First Identified:	30/06/22	
Date of FRA Review:	30/06/22	
Rectify Within: (months)	12	
Budget Cost:	No Cost
