**FIRE RISK ASSESSMENT  
4-5 THE CHEVRON, BYKER,  
NEWCASTLE UPON TYNE,  
NE6 1RP**

**MARCH 2022**

**Reference:** 4009-04-21-IC

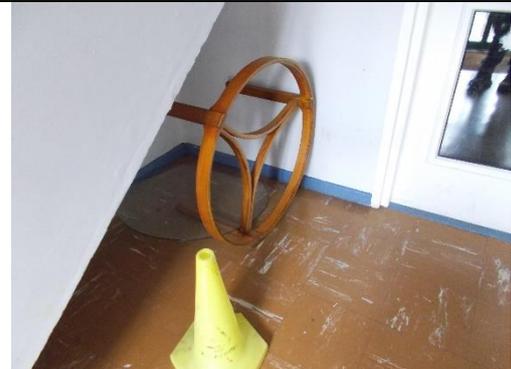
<b>MEDIUM</b>		<b>1</b>

It was noted there is a cane/wooden table underneath the communal stair. We recommend this is removed, residents are reminded to dispose of unwanted items responsibly and this area kept sterile.

<p><b>Assessors Observations:</b></p> <p>There is a cane/wooden table underneath the communal stair.</p>
<b>Date First Identified:</b>	29/03/2022	<p><b>Recommended Action:</b></p> <p>We recommend this is removed, residents are reminded to dispose of unwanted items responsibly and this area kept sterile.</p>
<b>Date of FRA</b>	29/03/2022	
<b>Rectify Within: (months)</b>	6	
<b>Budget Cost:</b>	No Cost

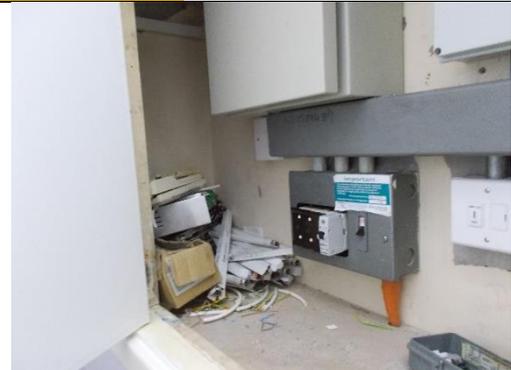
<b>MEDIUM</b>		<b>2</b>

Within the meter cupboard in the rear lobby there are combustible items such as cardboard and cable insulation. We recommend these items are removed and this cupboard kept sterile.

<p><b>Assessors Observations:</b></p> <p>Within the meter cupboard in the rear lobby there are combustible items such as cardboard and cable insulation.</p>
<b>Date First Identified:</b>	23/08/2017	<p><b>Recommended Action:</b></p> <p>We recommend these items are removed and this cupboard kept sterile. <b>We would specifically draw your attention to this matter which has been identified during previous inspections of this building. This recommendation should be addressed appropriately with due consideration to the protracted period for remediation.</b></p>
<b>Date of FRA</b>	29/03/2022	
<b>Rectify Within: (months)</b>	6	
<b>Budget Cost:</b>	No Cost

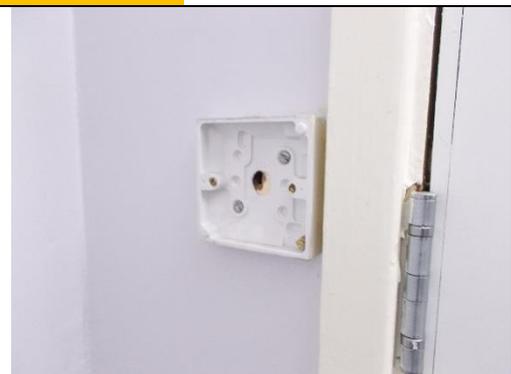
<b>MEDIUM</b>		<b>5</b>

It was noted, there are two breaches within the electrical cabinet walls. We recommend these breaches are addressed using the same material surrounding the breach in order to achieve a minimum 60 minutes fire resistance.

<b>Assessors Observations:</b>			
		There are two breaches within the electrical cabinet walls.			
		<b>Date First Identified:</b>	29/03/2022	<b>Recommended Action:</b>	
		<b>Date of FRA</b>	29/03/2022	We recommend these breaches are addressed using the same material surrounding the breach in order to achieve a minimum 60 minutes fire resistance.	
		<b>Rectify Within: (months)</b>	6		
<b>Budget Cost:</b>	£25

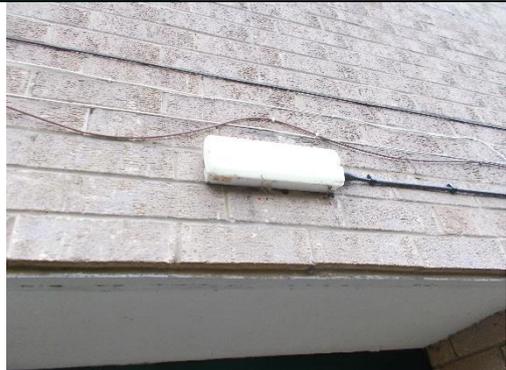
LOW		7

It was noted both the front and rear external emergency lighting units above both exit doors do not appear to be working. We recommend these defects are addressed.

<b>Assessors Observations:</b> Both the front and rear external emergency lighting units above both exit doors do not appear to be working.
<b>Date First Identified:</b>	29/03/2022	<b>Recommended Action:</b> We recommend these defects are addressed.
<b>Date of FRA</b>	29/03/2022	
<b>Rectify Within: (months)</b>	12	
<b>Budget Cost:</b>	No Cost

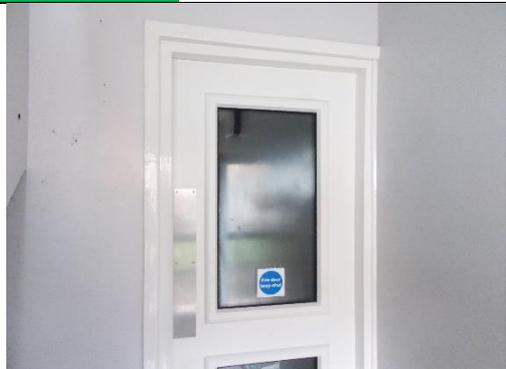
LOW		8

<b>Assessors Observations:</b> There is no "Fire Exit" sign above the lobby door leading to the rear final exit door.
<b>Date First Identified:</b>	29/03/2022	<b>Recommended Action:</b> We recommend one such sign is provided.
<b>Date of FRA</b>	29/03/2022	
<b>Rectify Within: (months)</b>	12	
<b>Budget Cost:</b>	£10

- It was noted, there is no "Fire Exit" sign above the lobby door leading to the rear final exit door. We recommend one such sign is provided.
- All signage should satisfy the requirements of BS 5499-5 and be installed in accordance with the recommendations of BS 5499-4.
