FIRE RISK ASSESSMENT
9-14 THE CHEVRON, BYKER,
NEWCASTLE UPON TYNE,
NE6 1RP

MARCH 2022

Reference: 4009-04-21-IC

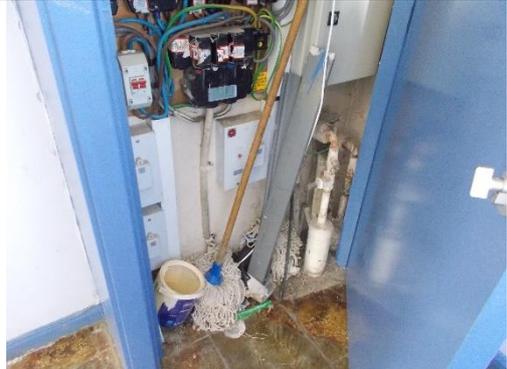
MEDIUM		1

It was noted, within the unlocked electrical meter/distribution board cupboard in the ground floor lobby, combustible items are being stored including mops which could potentially be wet. We recommend these items are removed and this cupboard kept sterile and locked shut.

Assessors Observations: Within the unlocked electrical meter/distribution board cupboard in the ground floor lobby, combustible items are being stored including mops which could potentially be wet.		
Date First Identified:	29/03/2022	Recommended Action: We recommend these items are removed and this cupboard kept sterile and locked shut.		
Date of FRA	29/03/2022			
Rectify Within: (months)	6			
Budget Cost:	No Cost

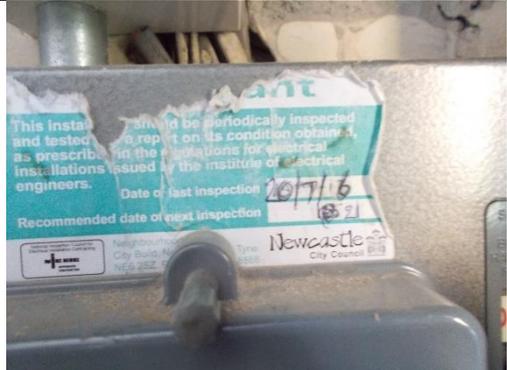
LOW		2

The communal electrical and distribution equipment is located within the fire rated electrical cupboard in the entrance lobby. Labelling indicated the last time the landlords electrical supply and distribution system was subject to a 5-year fixed wiring inspection by a competent engineer was on 10/07/2016, which is outside of the required frequency for inspection and test. We recommend the client confirms the landlords electrical supply and distribution equipment has been subject to inspection and test by a competent engineer within the previous 5 years, and if not, make arrangements for this to be undertaken as soon as practicable.

Assessors Observations: Labelling indicated the last time the landlords electrical supply and distribution system was subject to a 5-year fixed wiring inspection by a competent engineer was on 10/07/2016, which is outside of the required frequency for inspection and test.		
Date First Identified:	29/03/2022	Recommended Action: We recommend the client confirms the landlords electrical supply and distribution equipment has been subject to inspection and test by a competent engineer within the previous 5 years, and if not, make arrangements for this to be undertaken as soon as practicable.		
Date of FRA	29/03/2022			
Rectify Within: (months)	12			
Budget Cost:	No Cost

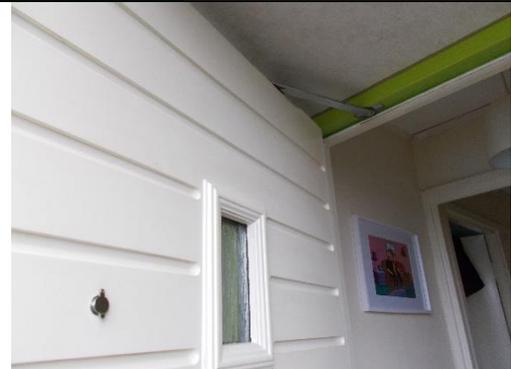
LOW		3

As part of the assessment, the flat entrance door to number 13 was inspected for specification and action. The flat entrance doors are good quality timber doors with a glazed panel and window to the left and right of the door respectively. However, it was noted that the flat entrance doors do not appear to be fire doors. We recommend the flat entrance doors to the first two apartments (flat numbers 12 and 13) opening onto the common walkway / balcony should be FD30S doors with a self-closing device fitted. The client should also confirm the glazed units / frames will provide a minimum 30 minutes fire resistance. This will ensure residents can

evacuate their apartments and be able to pass a fire within an adjoining flat and reach the stairway / final exit. (LGG Fire Safety in Purpose Built Blocks of Flats Sec 59.5).

Assessors Observations: The flat entrance doors are good quality timber doors with a glazed panel and window to the left and right of the door respectively. However, it was noted that the flat entrance doors do not appear to be fire doors.
Date First Identified:	23/08/2017	Recommended Action: We recommend the flat entrance doors to the first two apartments (flat numbers 12 and 13) opening onto the common walkway / balcony should be FD30S doors with a self-closing device fitted. The client should also confirm the glazed units / frames will provide a minimum 30 minutes fire resistance. This will ensure residents can evacuate their apartments and be able to pass a fire within an adjoining flat and reach the stairway / final exit. (LGG Fire Safety in Purpose Built Blocks of Flats Sec 59.5). We would specifically draw your attention to this matter which has been identified during previous inspections of this building. This recommendation should be addressed appropriately with due consideration to the protracted period for remediation.

Date of FRA	29/03/2022	
Rectify Within: (months)	12	
Budget Cost:	No Cost

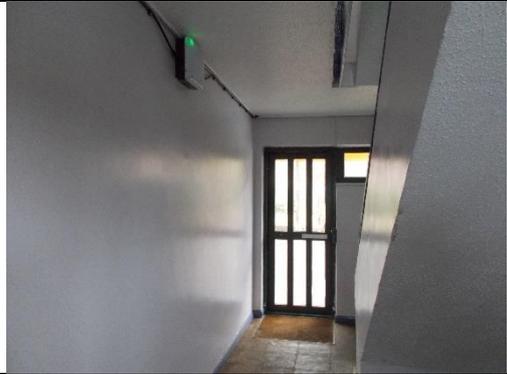
LOW		5

It was noted, there are no "Fire Exit" signs above both final exits in the ground floor lobby. We recommend such signage is provided.

<p>Assessors Observations:</p> <p>There are no "Fire Exit" signs above both final exits in the ground floor lobby.</p>
Date First Identified:	29/03/2022	<p>Recommended Action:</p> <p>We recommend such signage is provided.</p>
Date of FRA	29/03/2022	
Rectify Within: (months)	12	
Budget Cost:	£20

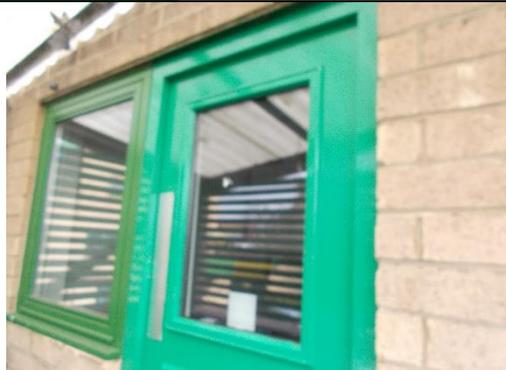
LOW		6

The FD60S SC part glazed door adjacent to flat 12 leading onto the stair requires directional fire exit signage above the door and also a "Fire Door Keep Shut" sign to be attached to the balcony side of the door.

Assessors Observations: The FD60S SC part glazed door adjacent to flat 12 leading onto the stair requires directional fire exit signage above the door and also a "Fire Door Keep Shut" sign to be attached to the balcony side of the door.
Date First Identified:	29/03/2022	Recommended Action: As above.
Date of FRA	29/03/2022	
Rectify Within: (months)	12	
Budget Cost:	£20
