**FIRE RISK ASSESSMENT  
9-16 GRAHAM HOUSE, BYKER,  
NEWCASTLE UPON TYNE.  
NE6 1AT**

**JULY 2022**

**Reference:** GH/06/07/22/IC

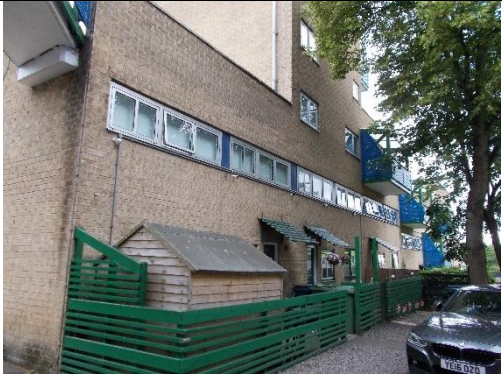
<b>MEDIUM</b>		<b>1</b>

It was noted that some residents have installed a garden shed within their garden which are close to the fabric of the building. It is unclear what materials are stored within that may increase the risk of a fire developing, and in addition the sheds may be an easy target for vandalism and or/arson. Due to their close proximity to the building, any resultant fire may damage the building, with fire gases potentially entering the building through any open windows in its vicinity. We recommend the client confirms these sheds are allowed on these properties. If so, we would advise that the timber construction of the sheds are treated with a suitable approved fire retardant to minimise fire spread which may affect the safety of the residents.

<p><b>Assessors Observations:</b></p> <p>Some residents have installed a garden shed within their garden which are close to the fabric of the building. It is unclear what materials are stored within that may increase the risk of a fire developing, and in addition the sheds may be an easy target for vandalism and or/arson. Due to their close proximity to the building, any resultant fire may damage the building, with fire gases potentially entering the building through any open windows in its vicinity.</p>
<b>Date First Identified:</b>	06/07/22	<p><b>Recommended Action:</b></p> <p>We recommend the client confirms these sheds are allowed on these properties. If so, we would advise that the timber construction of the sheds are treated with a suitable approved fire retardant to minimise fire spread which may affect the safety of the residents.</p>
<b>Date of FRA</b>	06/07/22

<b>Rectify Within: (months)</b>	6	
<b>Budget Cost:</b>	No Cost

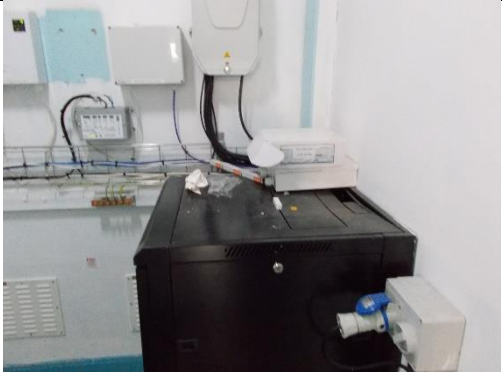
<b>LOW</b>		<b>2</b>

Within the landlord services room on the second floor there are combustible items such as cardboard packaging on top of the electrical equipment cabinet. We recommend these are removed, this compartment kept sterile and the engineers reminded to remove any refuse following servicing operations.

<p><b>Assessors Observations:</b></p> <p>Within the landlord services room on the second floor there are combustible items such as cardboard packaging on top of the electrical equipment cabinet.</p>
<b>Date First Identified:</b>	06/07/22	<p><b>Recommended Action:</b></p> <p>We recommend these are removed, this compartment kept sterile and the engineers reminded to remove any refuse following servicing operations.</p>
<b>Date of FRA</b>	06/07/22	
<b>Rectify Within: (months)</b>	12	
<b>Budget Cost:</b>	No Cost

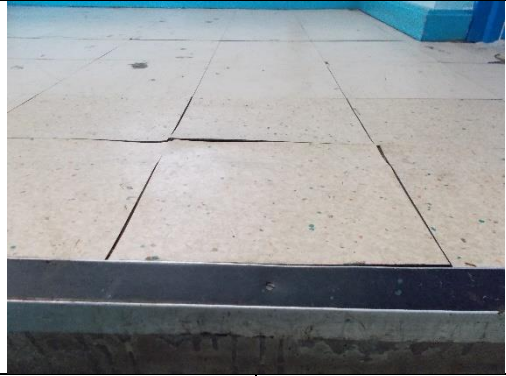
<b>MEDIUM</b>		<b>3</b>

It was noted the vinyl flooring is in a poor state of repair in several areas on the second-floor landing as well as on the stair down from the second floor. This poses a potential trip hazard for those evacuating. We recommend the vinyl tiles be reassessed and replaced where necessary.

<b>Assessors Observations:</b> The vinyl flooring is in a poor state of repair in several areas on the second-floor landing as well as on the stair down from the second floor. This poses a potential trip hazard for those evacuating.	
<b>Date First Identified:</b>	06/07/22	<b>Recommended Action:</b> We recommend the vinyl tiles are assessed and replaced where necessary.	
<b>Date of FRA</b>	06/07/22		
<b>Rectify Within: (months)</b>	6		
<b>Budget Cost:</b>	£150

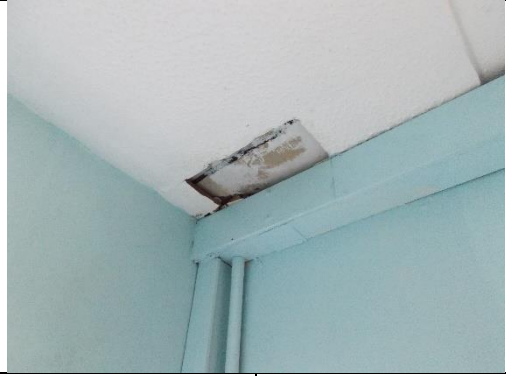
<b>MEDIUM</b>		<b>4</b>

Adjacent to flat 10, there is a breach at ceiling level where cables penetrate. We recommend this breach in compartmentation is addressed using a suitable fire stopping material to achieve at least 60 minutes fire resistance.

<b>Assessors Observations:</b> Adjacent to flat 10, there is a breach at ceiling level where cables penetrate.	
<b>Date First Identified:</b>	06/07/22	<b>Recommended Action:</b> We recommend this breach in compartmentation is addressed using a suitable fire stopping material to achieve at least 60 minutes fire resistance.	
<b>Date of FRA</b>	06/07/22		
<b>Rectify Within: (months)</b>	6		
<b>Budget Cost:</b>	£50

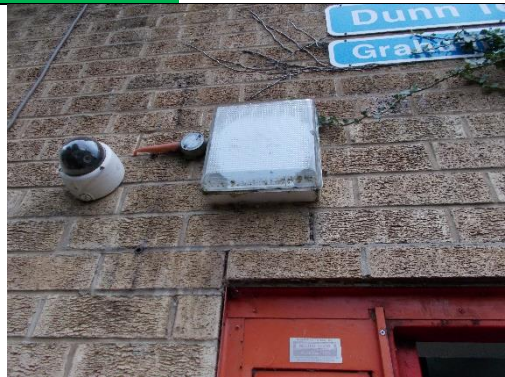
<b>LOW</b>		<b>6</b>

It was noted the emergency lighting luminaire outside of entrance 27a does not appear to be working. We recommend this is investigated and the defect rectified.

<p><b>Assessors Observations:</b></p> <p>The emergency lighting luminaire outside of entrance 27a does not appear to be working.</p>
<b>Date First Identified:</b>	06/07/22	<p><b>Recommended Action:</b></p> <p>We recommend this is investigated and the defect rectified.</p>
<b>Date of FRA</b>	06/07/22	
<b>Rectify Within: (months)</b>	12	
<b>Budget Cost:</b>	No Cost

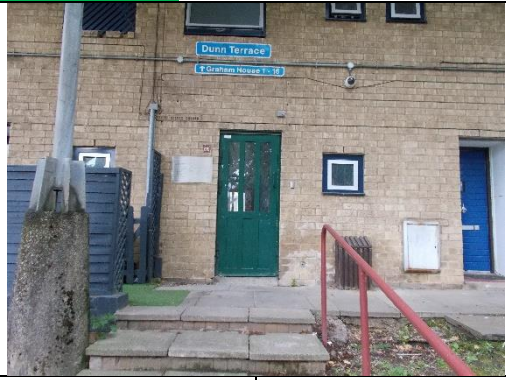
<b>LOW</b>		<b>7</b>

Outside of the exit 27b, there are steps down within a short distance of leaving the premises. It is also particularly dark due to overhanging branches from nearby trees. For this reason, we recommend one emergency lighting luminaire is installed above this exit door to provide adequate illumination for those evacuating.

<b>Assessors Observations:</b> Outside of the exit 27b, there are steps down within a short distance of leaving the premises. It is also particularly dark due to overhanging branches from nearby trees.	
<b>Date First Identified:</b>	06/07/22	<b>Recommended Action:</b> For this reason, we recommend one emergency lighting luminaire is installed above this exit door to provide adequate illumination for those evacuating.	
<b>Date of FRA</b>	06/07/22		
<b>Rectify Within: (months)</b>	12		
<b>Budget Cost:</b>	£150

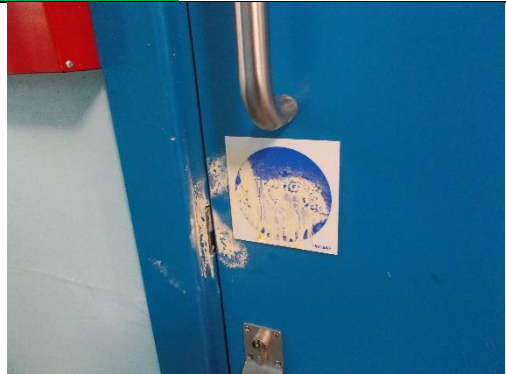
<b>LOW</b>		<b>8</b>

- The bin store (door 27A / G.1) requires a "Fire Door Keep Locked" sign installed to the face of the door in order to replace an existing damaged sign.

<b>Assessors Observations:</b> The bin store (door 27A / G.1) requires a "Fire Door Keep Locked" sign installed to the face of the door in order to replace an existing damaged sign.	
<b>Date First Identified:</b>	06/07/22	<b>Recommended Action:</b> As above.	
<b>Date of FRA</b>	06/07/22		
<b>Rectify Within: (months)</b>	12		
<b>Budget Cost:</b>	£10
