FIRE RISK ASSESSMENT
1-4 Ralph Erskine House, 45-47
Brinkburn Street, Newcastle upon Tyne,
Tyne and Wear NE6 2LE

JANUARY 2022

STORM TEMPEST
PROPERTY CONSULTANCY

Reference: PA-4009-04-21

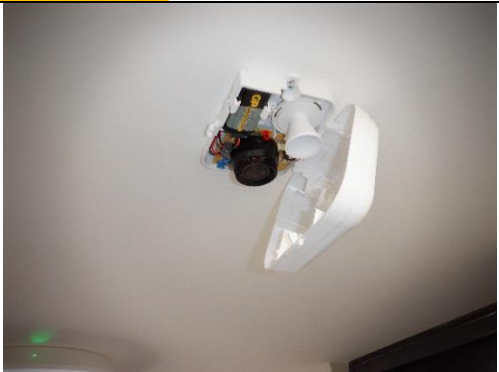
MEDIUM		3

4.4 Fire Alarm and
Detection System We noted a mains powered automatic detector in the ground-floor corridor and a battery-operated smoke detector at the head of the stair. Within apartment 3 we noted mains powered, automatic detection in the living room/diner and the circulation space.

Assessors Observations:	
		We noted a a battery-operated smoke detector at the head of the stair.	
Date First Identified:	26/01/2022	Recommended Action: We recommend that the communal fire alarm system is connected to the low voltage mains supply in the building.	
Date of FRA:	26/01/2022		
Rectify Within: (months)	6		
Budget Cost:	£100

We recommend that the communal fire alarm system is connected to the low voltage mains supply in the building.
