**FIRE RISK ASSESSMENT**  
**138-142 RABY STREET, BYKER,**  
**NEWCASTLE UPON TYNE,**  
**NE6 2BY**

AUGUST 2022

**Reference:** 4180-04-22-IC

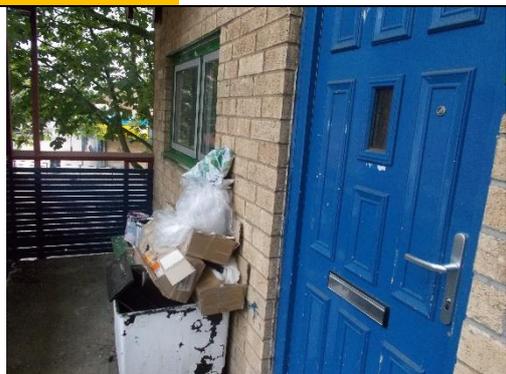
<b>MEDIUM</b>		<b>1</b>

It was noted, outside of flat entrance doors to numbers 138, 140 and 142 there are large amounts of combustible refuse. This practice partially obstructs the means of escape for others, increases the risk of an arson attack, and any subsequent fire is likely to spread to other parts of the building and affect the safety of the residents. We recommend this refuse is removed, the means of escape kept clear at all times and residents are reminded to dispose of their refuse responsibly to ensure the means of escape is available for the residents' to use in an emergency.

<p><b>Assessors Observations:</b></p> <p>Outside of flat entrance doors to numbers 138, 140 and 142 there are large amounts of combustible refuse. This practice partially obstructs the means of escape for others, increases the risk of an arson attack, and any subsequent fire is likely to spread to other parts of the building and affect the safety of the residents.</p>
<b>Date First Identified:</b>	15/08/2022	<p><b>Recommended Action:</b></p> <p>We recommend this refuse is removed, the means of escape kept clear at all times and residents are reminded to dispose of their refuse responsibly to ensure the means of escape is available for the residents' to use in an emergency.</p>
<b>Date of FRA</b>	15/08/2022	
<b>Rectify Within: (months)</b>	6	
<b>Budget Cost:</b>	No Cost

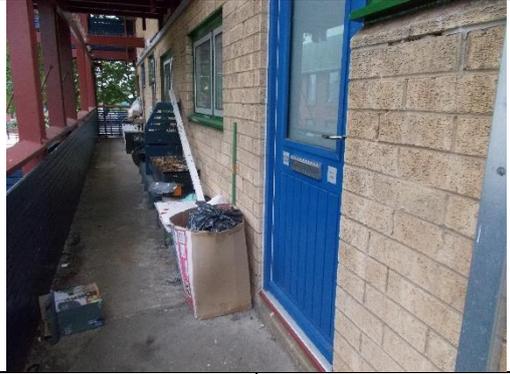
<b>MEDIUM</b>		<b>3</b>

4.2 Fire Doors      Flat entrance doors open onto the 1<sup>st</sup> floor semi enclosed balcony. We were able to gain access to apartment 140 in order to inspect the specification of its entrance door. The entrance doors are good quality timber doors, one with a glazed panel. However, it was noted that the flat entrance doors do not appear to be fire doors. We recommend the flat entrance doors to flats numbered 138 and 140 opening onto the common walkway / balcony should be FD30S doors with a self-closing device fitted. This will ensure residents can evacuate their apartments and be able to pass a fire within an adjoining flat and reach the stairway / final exit. (LGG Fire Safety in Purpose Built Blocks of Flats Sec 59.5).

<b>Assessors Observations:</b> The flat entrance doors do not appear to be fire doors.
<b>Date First Identified:</b>	15/08/2022	<b>Recommended Action:</b> We recommend the flat entrance doors to flats numbered 138 and 140 opening onto the common walkway / balcony should be FD30S doors with a self-closing device fitted. This will ensure residents can evacuate their apartments and be able to pass a fire within an adjoining flat and reach the stairway / final exit. (LGG Fire Safety in Purpose Built Blocks of Flats Sec 59.5).
<b>Date of FRA</b>	15/08/2022	
<b>Rectify Within: (months)</b>	6	
<b>Budget Cost:</b>	£1200

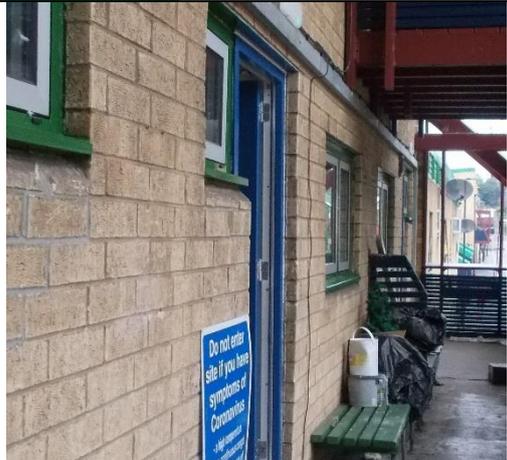
LOW		4

Windows opening onto the communal walkway are double glazed aluminium units set into timber frames and do not appear to be fire rated. They also do not extend a minimum of 1100mm above balcony floor level as required by LGG Fire Safety in Purpose Built Blocks of Flats Sec 59.5. These windows are also part of the listed status of the building. We recommend the windows for flats 138 and 140 which do not extend to the required minimum distance of 1100mm above balcony floor level, are upgraded to provide a minimum of 30 minutes fire resistance in order to allow the means of escape to be used by residents safely in a fire situation.

<b>Assessors Observations:</b> Windows opening onto the communal walkway are double glazed aluminium units set into timber frames and do not appear to be fire rated. They also do not extend a minimum of 1100mm above balcony floor level as required by LGG Fire Safety in Purpose Built Blocks of Flats Sec 59.5. These windows are also part of the listed status of the building.
		<b>Recommended Action:</b> We recommend the windows for flats 138 and 140 which do not extend to the required minimum distance of 1100mm above balcony floor level, are upgraded to provide a minimum of 30 minutes fire resistance in order to allow the means of escape to be used by residents safely in a fire situation.
		<b>Date First Identified:</b> 15/08/2022
		<b>Date of FRA</b> 15/08/2022
		<b>Rectify Within: (months)</b> 12
<b>Budget Cost:</b> £2000

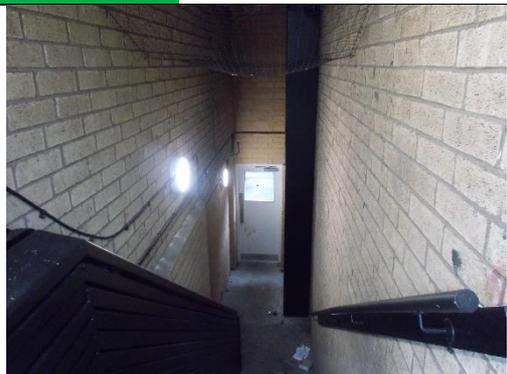
LOW		5

There were no records available to confirm the emergency lighting is subject to a monthly functional test or whether the annual discharge of the luminaires has taken place by a competent person. We recommend the client confirms the monthly functional test of the luminaires and the annual discharge test of the luminaire is being carried out, and if not, arrange for this to be undertaken as soon as practicable.

<b>Assessors Observations:</b> There were no records available to confirm the emergency lighting is subject to a monthly functional test or whether the annual discharge of the luminaires has taken place by a competent person.
		<b>Recommended Action:</b> We recommend the client confirms the monthly functional test of the luminaires and the annual discharge test of the luminaire is being carried out, and if not, arrange for this to be undertaken as soon as practicable.
		<b>Date First Identified:</b> 15/08/2022
		<b>Date of FRA</b> 15/08/2022
		<b>Rectify Within: (months)</b> 12
<b>Budget Cost:</b> No Cost
