**FIRE RISK ASSESSMENT
BRINKBURN HOUSE, 1-5 & 9-19
BRINKBURN COURT, BYKER,
NEWCASTLE UPON TYNE, NE6 2JW**

NOVEMBER 2022

Reference: BHBC/07/11/22/IC

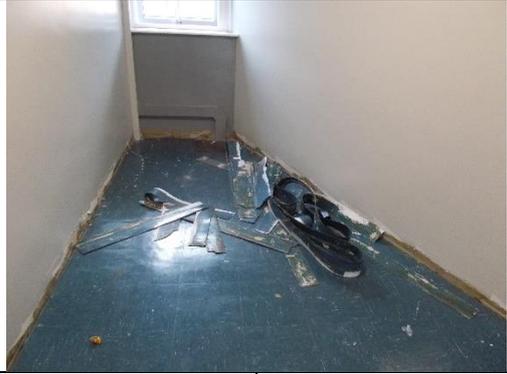
MEDIUM		1

<p>Assessors Observations:</p> <p>Following ongoing improvement works to the block, vinyl offcuts used in the flooring programme have been left by contractors outside Landlord Services cupboard 18A 1.1.</p>
Date First Identified:	07/11/2022	<p>Recommended Action:</p> <p>We recommend these are removed and contractors reminded to dispose of their waste products responsibly, daily.</p>
Date of FRA	07/11/2022	
Rectify Within: (months)	6	
Budget Cost:	No Cost

It was noted that following ongoing improvement works to the block, vinyl offcuts used in the flooring programme have been left by contractors outside Landlord Services cupboard 18A 1.1. We recommend these are removed and contractors reminded to dispose of their waste products responsibly, daily.

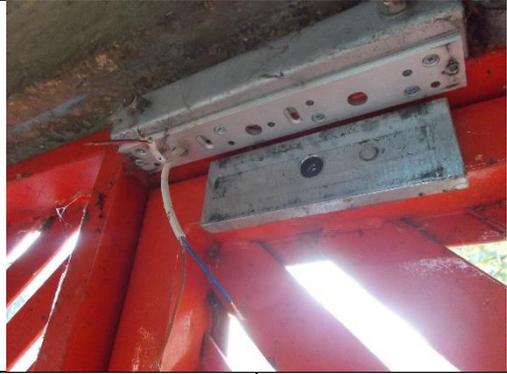
LOW		2

<p>Assessors Observations:</p> <p>The mag lock device for the rear emergency exit door on the ground floor has been damaged exposing the electrical cabling.</p>
Date First Identified:	07/11/2022	<p>Recommended Action:</p> <p>Although low risk, we recommend this defect is addressed to prevent any potential electrical sparking as well as preventing unauthorised access to the block.</p>
Date of FRA	07/11/2022	
Rectify Within: (months)	12	
Budget Cost:	£150

It was noted the mag lock device for the rear emergency exit door on the ground floor has been damaged exposing the electrical cabling. Although low risk, we recommend this defect is addressed to prevent any potential electrical sparking as well as preventing unauthorised access to the block.

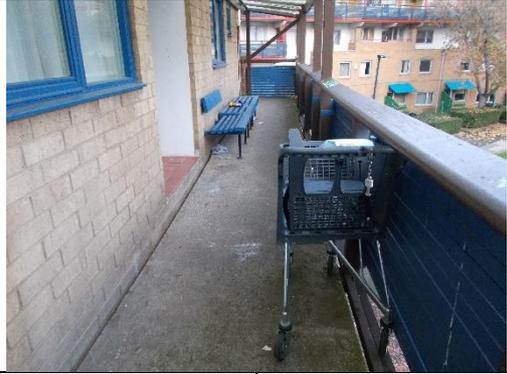
MEDIUM		3

Assessors Observations: There is a discarded shopping trolley partially obstructing the means of escape outside flat 11.	
		Recommended Action: We recommend this is removed and residents reminded to keep the means of escape free from obstructions and available for use for all.	
Date First Identified:	07/11/2022		
Date of FRA	07/11/2022		
Rectify Within: (months)	6		
Budget Cost:	No Cost

It was noted there is a discarded shopping trolley partially obstructing the means of escape outside flat 11. We recommend this is removed and residents reminded to keep the means of escape free from obstructions and available for use for all.

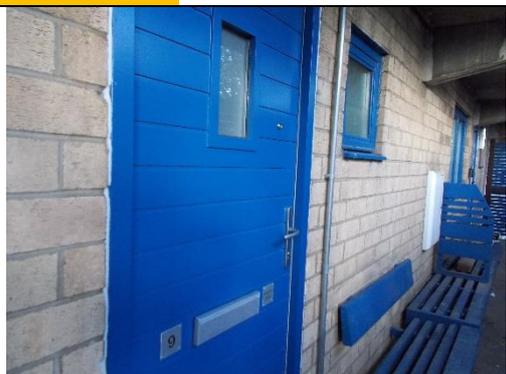
MEDIUM		4

<p>Assessors Observations:</p> <p>We were unable to enter flats 9 and 19, which are bypassed by flats 10 and 17 respectively as their only means of escape and flat 18, which opens onto the protected stairwell. These should be a minimum FD30S door with a self-closing device fitted.</p>
Date First Identified:	17/11/2021	<p>Recommended Action:</p> <p>A revisit is required to fully assess they are a minimum standard of FD30S with self-closing device and complies with BS8214, however, in the interim, we recommend the client arranges access to these flats and assesses the fire rated integrity of these doors and compliance with this standard. This will ensure residents can evacuate their apartments and be able to pass a fire within an adjoining flat and reach the stairway / final exit. (LGG Fire Safety in Purpose Built Blocks of Flats Sec 59.5).</p> <p style="color: red;">We would specifically draw your attention to this matter which has been identified during previous inspections of this building. This recommendation should be addressed appropriately with due consideration to the protracted period for remediation.</p>

Date of FRA	07/11/2022	
Rectify Within: (months)	6	
Budget Cost:	No Cost

However, we were unable to enter flats 9 and 19, which are bypassed by flats 10 and 17 respectively as their only means of escape and flat 18, which opens onto the protected stairwell. These should be a minimum FD30S door with a self-closing device fitted. A revisit is required to fully assess they are a minimum standard of FD30S with self-closing device and complies with BS8214, however, in the interim, we recommend the client arranges access to these flats and assesses the fire rated integrity of these doors and compliance with this standard. This will ensure residents can evacuate their apartments and be able to pass a fire within an adjoining flat and reach the stairway / final exit. (LGG Fire Safety in Purpose Built Blocks of Flats Sec 59.5).

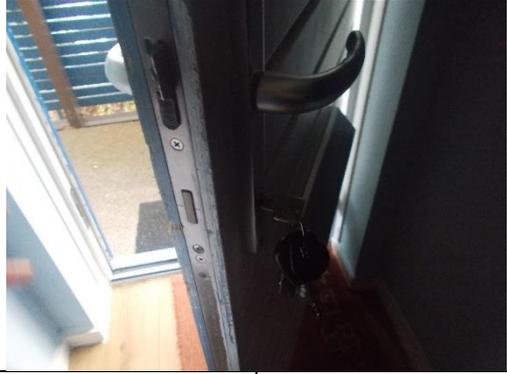
LOW		5

Assessors Observations: Within flat 12, the flat entrance door was secured via a mortice lock with keys.	
Date First Identified:	07/11/2022	Recommended Action: In order to ensure a speedy evacuation in an emergency, we recommend a thumb turn device is incorporated in this door, to avoid the need for searching for keys.	
Date of FRA	07/11/2022		
Rectify Within: (months)	12		
Budget Cost:	£50

It was noted within flat 12, the flat entrance door was secured via a mortice lock with keys. In order to ensure a speedy evacuation in an emergency, we recommend a thumb turn device is incorporated in this door, to avoid the need for searching for keys.

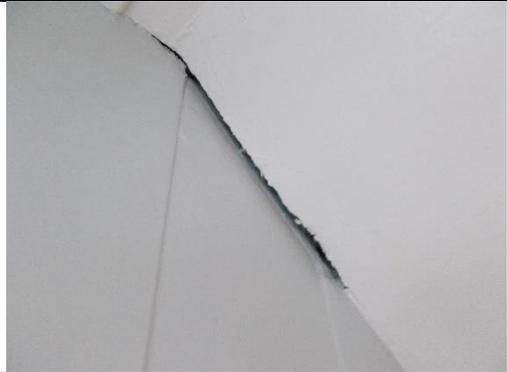
MEDIUM		6

Assessors Observations: There is a breach at the junction of wall and ceiling approximately 300mm x 20mm, opposite landlord services room 18A G/.1.	
Date First Identified:	07/11/2022	Recommended Action: We recommend this breach is addressed using the same construction materials surrounding it in order to maintain a minimum 60 minutes fire resistance.	
Date of FRA	07/11/2022		
Rectify Within: (months)	6		
Budget Cost:	£40

It was noted there is a breach at the junction of wall and ceiling approximately 300mm x 20mm, opposite landlord services room 18A G/.1. We recommend this breach is addressed using the same construction materials surrounding it in order to maintain a minimum 60 minutes fire resistance.

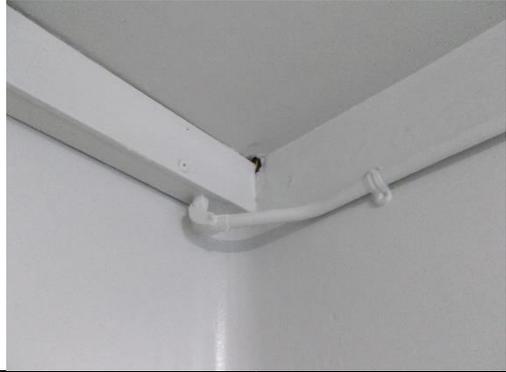
MEDIUM		7

<p>Assessors Observations:</p> <p>There is a breach at the junction of wall and ceiling in the bin store where the trucking ends and cables penetrate the wall.</p>
Date First Identified:	07/11/2022	<p>Recommended Action:</p> <p>We recommend this breach is addressed using the same construction materials surrounding it in order to maintain a minimum 60 minutes fire resistance.</p>
Date of FRA	07/11/2022	
Rectify Within: (months)	6	
Budget Cost:	£20

There is a breach at the junction of wall and ceiling in the bin store where the trucking ends and cables penetrate the wall. We

recommend this breach is addressed using the same construction materials surrounding it in order to maintain a minimum 60 minutes fire resistance.

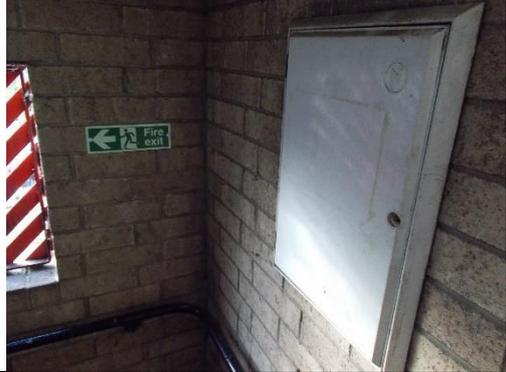
MEDIUM		8

<p>Assessors Observations:</p> <p>There is an electrical meter box on the means of escape leading to the final exit adjacent to flat 9 which has a plastic cover.</p>
Date First Identified:	07/11/2022	<p>Recommended Action:</p> <p>We recommend, this meter box is protected by a fire rated over box.</p>
Date of FRA	07/11/2022	
Rectify Within: (months)	6	
Budget Cost:	£150

It was noted there is an electrical meter box on the means of escape leading to the final exit adjacent to flat 9 which has a plastic cover. We recommend, this meter box is protected by a fire rated over box.

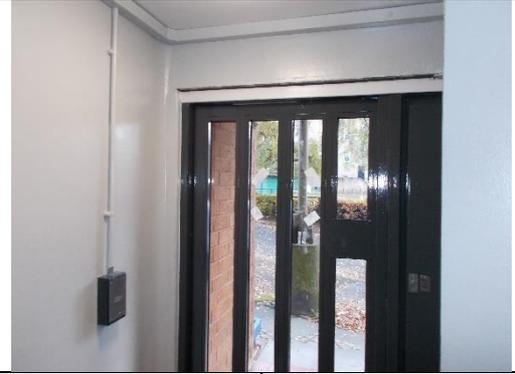
LOW		10

Assessors Observations: It should be noted that ongoing improvement works to this block were being carried out on the day of the assessment which has meant a number of signs have been temporarily removed.
Date First Identified:	07/11/2022	Recommended Action: We recommend these signs should be replaced in their designated area as soon as practicable following completion of works.
Date of FRA	07/11/2022	
Rectify Within: (months)	12	
Budget Cost:	No Cost

It should be noted that ongoing improvement works to this block were being carried out on the day of the assessment which has meant a number of signs have been temporarily removed. We

recommend these signs should be replaced in their designated area as soon as practicable following completion of works.
