**FIRE RISK ASSESSMENT  
1-16 CHIRTON HOUSE,  
HEADLAM GREEN, BYKER,  
NEWCASTLE UPON TYNE NE6 2TW**

OCTOBER 2022

**Reference:** 4180-03-22-PA

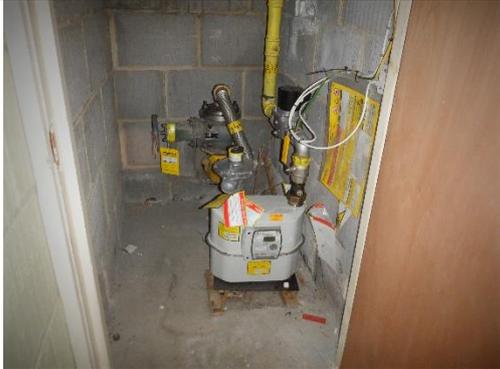
| <b>LOW</b> | | <b>1</b> |

The property gas meter is located within the basement. There was no evidence available to confirm that the gas supply and appliances within the building are subject to appropriate servicing and testing by a person who is, or employed by, a member of a class of persons approved by the HSE under regulation 3 of the Gas Safety (Installation and Use) Regulations 1998 as amended, eg a Gas Safe registered gas engineer.

| <b>LOW</b> | | <b>1</b> |
|---|---|---|
| | | <p><b>Assessors Observations:</b></p> <p>The property gas meter is located within the basement. There was no evidence available to confirm that the gas supply and appliances within the building are subject to appropriate servicing and testing by a person who is, or employed by, a member of a class of persons approved by the HSE under regulation 3 of the Gas Safety (Installation and Use) Regulations 1998 as amended, eg a Gas Safe registered gas engineer.</p> |

The client should examine their maintenance records to ensure up to date certification of gas safety inspections for equipment and supply. If this cannot be confirmed the client should arrange to have the gas supply and equipment serviced as a matter of urgency. Failure to do so could result in the increased risk from a fire due to faulty equipment.

| <b>LOW</b> | | <b>1</b> |
|---|---|---|
| <b>Date First Identified:</b> | 31/10/2022 | <p><b>Recommended Action:</b></p> <p>The client should examine their maintenance records to ensure up to date certification of gas safety inspections for equipment and supply. If this cannot be confirmed the client should arrange to have the gas supply and equipment serviced as a matter of urgency. Failure to do so could result in the increased risk from a fire due to faulty equipment.</p> |

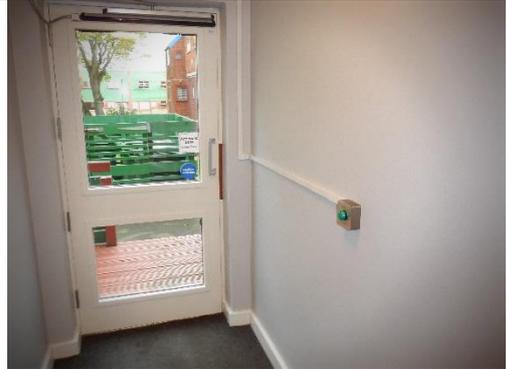
| <b>LOW</b> | | <b>2</b> |

| <b>LOW</b> | | <b>2</b> |
|---|---|--|
| | | <p><b>Assessors Observations:</b></p> <p>Exit doors are power assisted with electro-mechanical locks without emergency overrides. Any exits fitted with electronic locking mechanisms must fail-safe on power failure and have a standby power supply.</p> |

4.1 Escape Routes The premises consist of a main front entrance door accessed off Headlam Street leading directly into the entrance lobby and then into the hall, stairs and landing. Entry is via fob access and the exit doors are power assisted with electro-mechanical locks without emergency overrides. Any exits fitted with electronic locking mechanisms must fail-safe on power failure and have a standby power supply. The client should confirm these doors unlock in the event of a power failure.

| <b>LOW</b> | | <b>2</b> |
|---|---|--|
| <p><b>Date First Identified:</b></p> | <p>31/10/2022</p> | <p><b>Recommended Action:</b></p> <p>The client should confirm these doors unlock in the event of a power failure.</p> |

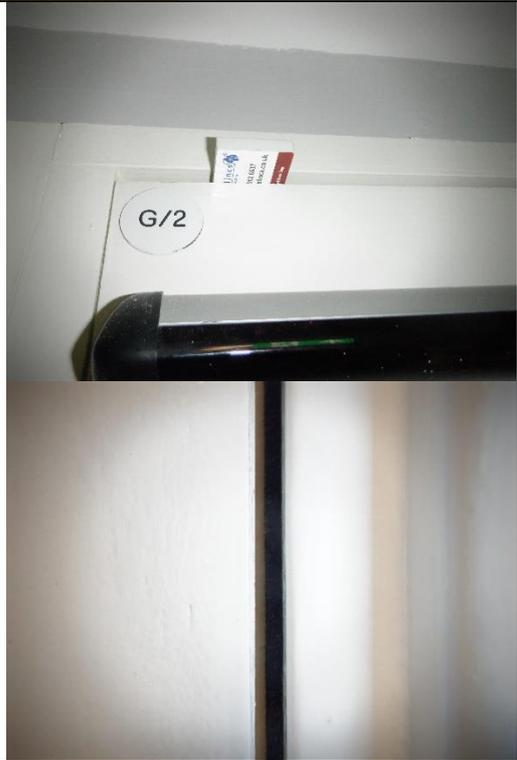
| <b>MEDIUM</b> | | <b>3</b> | |

Best practice guidance for fire doors stipulates that the gaps at the sides and top of a timber fire door should not exceed 3mm, +/- 1mm. We measured the gaps to several communal doors using a gap gauge and noted that numerous doors have gaps in excess of 4mm.

| | | <b>Assessors Observations:</b><br>Best practice guidance for fire doors stipulates that the gaps at the sides and top of a timber fire door should not exceed 3mm, +/- 1mm. We measured the gaps to several communal doors using a gap gauge and noted that numerous doors have gaps in excess of 4mm. | |

We recommend that the doors are surveyed and where doors are found to have gaps in excess of 4mm they are rehung so that there are no gaps between the door and frame in excess of 4mm. Failure to do so could result in the means of escape becoming smoke logged.

| <b>Date First Identified:</b> | 31/10/2022 | <b>Recommended Action:</b><br>We recommend that the doors are surveyed and where doors are found to have gaps in excess of 4mm they are rehung so that there are no gaps between the door and frame in excess of 4mm. Failure to do so could result in the means of escape becoming smoke logged. | |

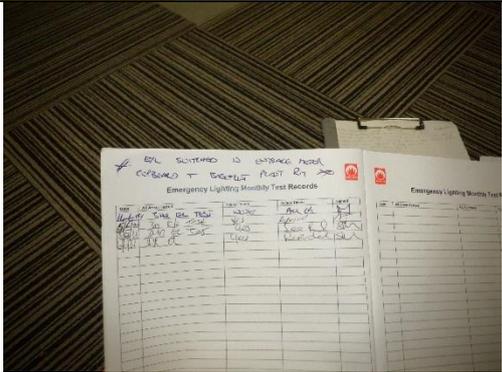
| <b>MEDIUM</b> | | <b>6</b> |

| <b>MEDIUM</b> | | <b>6</b> |
|---|---|--|
| | | <p><b>Assessors Observations:</b></p> <p>There is no record of the monthly function testing of the emergency lighting system.</p> |

There is no record of the monthly function testing of the emergency lighting system. The client should ensure that the emergency lighting system is subject to monthly function testing and an accurate record maintained.

| <b>MEDIUM</b> | | <b>6</b> |
|---|---|--|
| <b>Date First Identified:</b> | 31/10/2022 | <p><b>Recommended Action:</b></p> <p>The client should ensure that the emergency lighting system is subject to monthly function testing and an accurate record maintained.</p> |

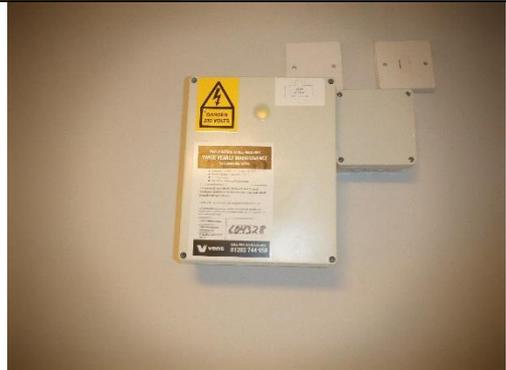
| <b>MEDIUM</b> | | <b>8</b> |

| <b>MEDIUM</b> | | <b>8</b> |
|---|---|--|
| | | <p><b>Assessors Observations:</b></p> <p>The last recorded service of the smoke ventilation system was on the 05/04/2022 and the next scheduled service is the 05/04/2023. A label on the operating equipment states that the recommended service frequency is twice yearly.</p> |

| <b>MEDIUM</b> | | <b>8</b> |
|---|---|--|
| <b>Date First Identified:</b> | 31/10/2022 | <p><b>Recommended Action:</b></p> <p>The client should ensure twice yearly servicing of the smoke ventilation system.</p> |

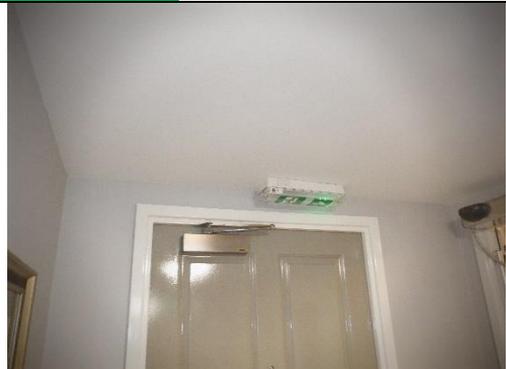
| <b>LOW</b> | | <b>9</b> |

| <b>LOW</b> | | <b>9</b> |
|---|---|--|
| | | <p><b>Assessors Observations:</b></p> <p>We noted a ceiling mounted, illuminated directional sign located outside flat 3.</p> |

We noted a ceiling mounted, illuminated directional sign located outside flat 3. The sign should be repositioned so that it is positioned on the wall to make it more easily noticeable.

| <b>LOW</b> | | <b>9</b> |
|---|---|--|
| <b>Date First Identified:</b> | 31/10/2022 | <p><b>Recommended Action:</b></p> <p>The sign should be repositioned so that it is positioned on the wall to make it more easily noticeable.</p> |
