**FIRE RISK ASSESSMENT
14-21 HEADLAM GREEN,
NEWCASTLE UPON TYNE,
TYNE AND WEAR, NE6 2NZ.**

FEBRUARY 2023

STORM TEMPEST
PROPERTY CONSULTANCY

Reference: 4180-04-22-JA

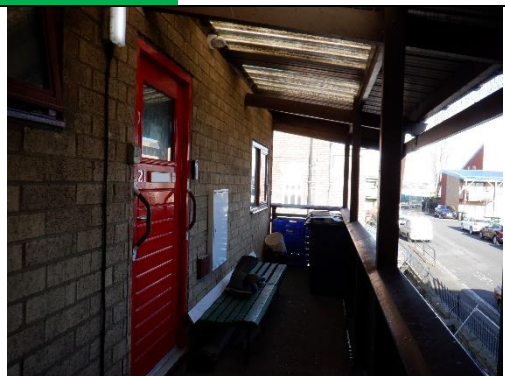
LOW		1

We noted refuse bins are being stored on the walkway/balcony. Although these are secured from the general public, there remains a risk of accidental ignition and the resulting fire spreading to the balustrade and the building preventing egress from the property. We recommend the bins are removed from the walkway balcony.

<p>Assessors Observations:</p> <p>We noted refuse bins are being stored on the walkway/balcony. Although these are secured from the general public, there remains a risk of accidental ignition and the resulting fire spreading to the balustrade and the building preventing egress from the property.</p>			
		<p>Recommended Action:</p> <p>We recommend the bins are removed from the walkway balcony.</p>			
		<p>Date First Identified:</p>	21/02/23		
		<p>Date of FRA:</p>	21/02/23		
		<p>Rectify Within: (months)</p>	12		
<p>Budget Cost:</p>	No Cost

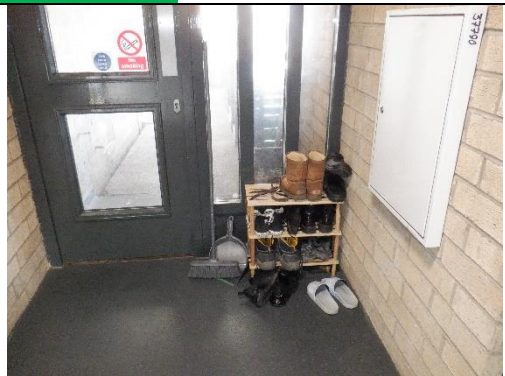
LOW		2

A small shoe rack with shoe storage is located on the communal means of escape. There is also a children's plastic sandpit located within the protected lobby of flats 14 and 17. All means of escape should be kept clear of any additional fuel sources or obstructions. We recommend the items are removed and residents advised of the requirement to keep all means of escape routes clear.

<p>Assessors Observations:</p> <p>A small shoe rack with shoe storage is located on the communal means of escape. There is also a children's plastic sandpit located within the protected lobby of flats 14 and 17.</p>			
		<p>Recommended Action:</p> <p>All means of escape should be kept clear of any additional fuel sources or obstructions. We recommend the items are removed and residents advised of the requirement to keep all means of escape routes clear.</p>			
		<p>Date First Identified:</p>	21/02/23		
		<p>Date of FRA:</p>	21/02/23		
		<p>Rectify Within: (months)</p>	12		
<p>Budget Cost:</p>	No Cost

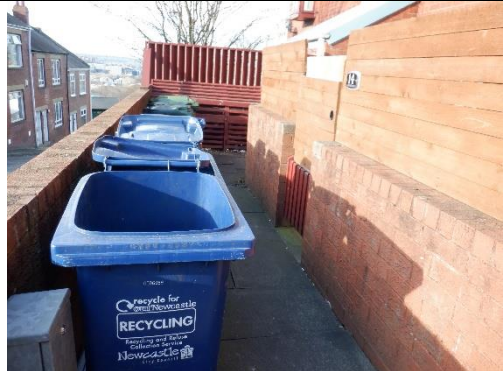
MEDIUM		3

The access pathway to the building entrance at the southern entrance is lined with wheeled bins , which partially obstruct the means of escape. There are also wheeled bins being stored adjacent to the northern entrance, under the communal walkway. As these are accessible to the general public, there is a risk of arson. Any subsequent fire will block the means of escape and potentially spread to the building fabric, possibly resulting in the products of combustion entering the building. We recommend the refuse containers are moved away from the means of escape and the building as far as practicable.

Assessors Observations: The access pathway to the building entrance at the southern entrance is lined with wheeled bins , which partially obstruct the means of escape. There are also wheeled bins being stored adjacent to the northern entrance, under the communal walkway. As these are accessible to the general public, there is a risk of arson.	
Date First Identified:	21/02/23	Recommended Action: We recommend the refuse containers are moved away from the means of escape and the building as far as practicable as any subsequent arson/fire will block the means of escape and potentially spread to the building fabric, possibly resulting in the products of combustion entering the building.	
Date of FRA:	21/02/23		
Rectify Within: (months)	6		
Budget Cost:	No Cost

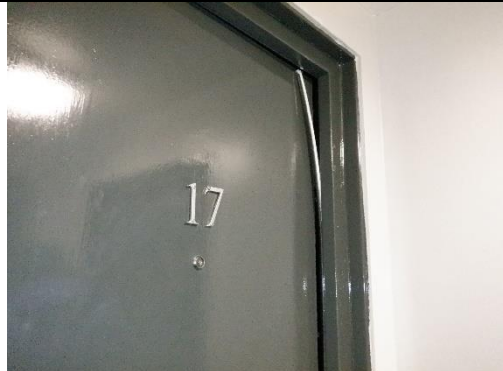
MEDIUM		4

We noted flats 14 and 17 as viewed from the communal areas have loose seals which were jammed in the door. We recommend the client gains access and has the seals correctly fitted to the door or frame as required.

Assessors Observations: We noted flats 14 and 17 as viewed from the communal areas have loose seals which were jammed in the door.	
Date First Identified:	21/02/23	Recommended Action: We recommend the client gains access and has the seals correctly fitted to the door or frame as required.	
Date of FRA:	21/02/23		
Rectify Within: (months)	6		
Budget Cost:	£50

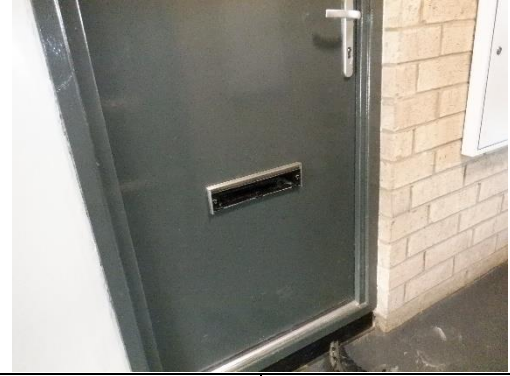
LOW		5

We noted the flat entrance to number 19 has its letterbox flap missing from the door. We recommend this is refitted to ensure the fire rated integrity of the fire door set is not compromised.

Assessors Observations: We noted the flat entrance to number 19 has its letterbox flap missing from the door.	
Date First Identified:	21/02/23	Recommended Action: We recommend this is refitted to ensure the fire rated integrity of the fire door set is not compromised.	
Date of FRA:	21/02/23		
Rectify Within: (months)	12		
Budget Cost:	£40

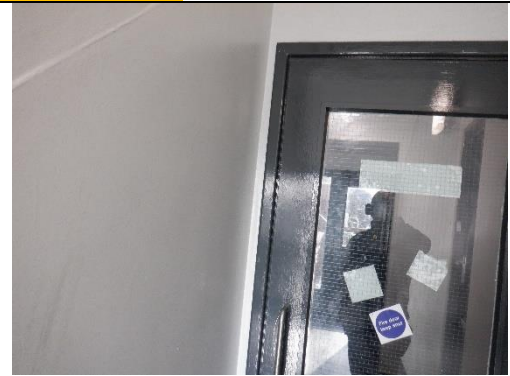
MEDIUM		6

The doors located on the common means of escape accessing the protected lobbies on the lower ground and ground floor and communal walkway balcony off the first floor are FD60 fire doors fitted with overhead self-closing device, with 2x 10mm intumescent seals. We noted the door to the protected lobby of flat 14 and 17

Assessors Observations: We noted the door to the protected lobby of flat 14 and 17 does not close fully to its rebate unaided.	
Date First Identified:	21/02/23	Recommended Action: We recommend the doors self-closing device is adjusted to ensure the door closes fully unaided to its rebate, to ensure compartmentation is maintained as the building design requires.	
Date of FRA:	21/02/23		
Rectify Within: (months)	6		
Budget Cost:	£35

does not close fully to its rebate unaided. We recommend the doors self-closing device is adjusted to ensure the door closes fully unaided to its rebate, to ensure compartmentation is maintained as the building design requires.

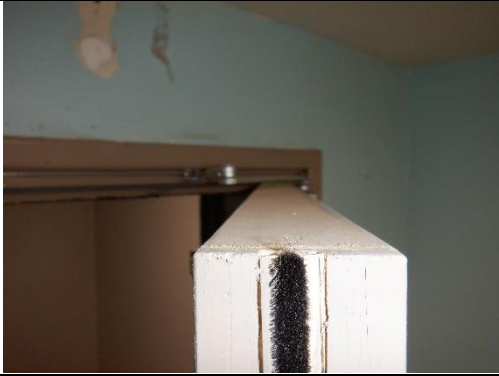
MEDIUM		7

We accessed the electrical utility room and noted the door is an FD60 fire door however the intumescent seal appears to be missing off the top edge of the door. There is a combined intumescent and smoke seal fitted to the leading edge of the door. It is noted there is no automatic fire detection fitted within the room. We recommend intumescent seals are fitted to the top and sides of the door in order to maintain compartmentation to the protected lobby to the flats and prevent the passage of the products of combustion in a fire situation.

Assessors Observations: We accessed the electrical utility room and noted the door is an FD60 fire door however the intumescent seal appears to be missing off the top edge of the door. There is a combined intumescent and smoke seal fitted to the leading edge of the door. It is noted there is no automatic fire detection fitted within the room.	
Date First Identified:	21/02/23	Recommended Action: We recommend intumescent seals are fitted to the top and sides of the door in order to maintain compartmentation to the protected lobby to the flats and prevent the passage of the products of combustion in a fire situation.	
Date of FRA:	21/02/23		
Rectify Within: (months)	6		
Budget Cost:	£40

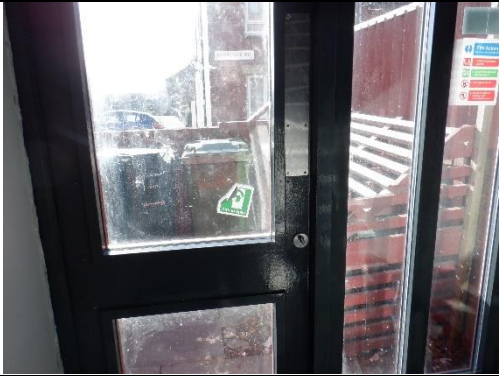
LOW		8

We noted wayfinding signage fitted to an electrical meter cabinet off the stairwell and door signs either peeling off or not fitted in accordance with BS5499-4. We recommend all safe condition fire safety signage or 'fire door keep shut signs are installed correctly.

Assessors Observations: We noted wayfinding signage fitted to an electrical meter cabinet off the stairwell and door signs either peeling off or not fitted in accordance with BS5499-4.	
Date First Identified:	21/02/23	Recommended Action: We recommend all safe condition fire safety signage or 'fire door keep shut signs are installed correctly.	
Date of FRA:	21/02/23		
Rectify Within: (months)	12		
Budget Cost:	£60
