**FIRE RISK ASSESSMENT
SALISBURY HOUSE,
4-11 & 17-27 SALISBURY HOUSE, BYKER,
NEWCASTLE UPON TYNE NE6 1AG**

FEBRUARY 2023

Reference: SH/23/02/23/IC

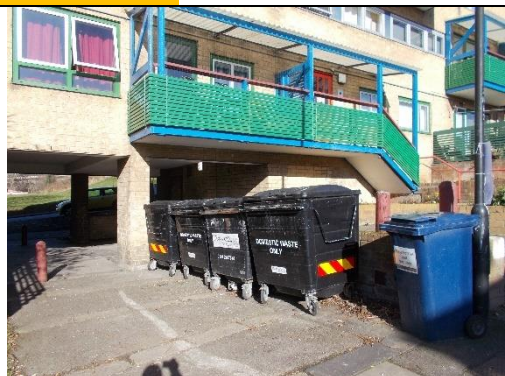
MEDIUM		1

External to the building, there are commercial wheeled bins with associated refuse within underneath dwellings and adjacent to exit 31 as well as residents wheeled bins to the front of the premises outside of flat entrance doors. Should these be accidentally or deliberately ignited there is a risk of fire spread to the building via the timber construction materials above. We recommend the commercial wheeled bins are stored away from the fabric of the building (ideally 5m) and residents are also reminded to store wheeled bins away from the building.

<p>Assessors Observations:</p> <p>There are commercial wheeled bins with associated refuse within, underneath dwellings and adjacent to exit 31, as well as residents wheeled bins to the front of the premises outside of flat entrance doors. Should these be accidentally or deliberately ignited there is a risk of fire spread to the building via the timber construction materials above.</p>
		<p>Date First Identified: 22/02/19</p> <p>Date of FRA: 23/02/23</p> <p>Rectify Within: (months): 6</p> <p>Budget Cost: No Cost</p> <p>Recommended Action:</p> <p>We recommend the commercial wheeled bins are stored away from the fabric of the building (ideally 5m) and residents are also reminded to store wheeled bins away from the building.</p> <p><i>We would specifically draw your attention to this matter which has been identified during previous inspections of this building. This recommendation should be addressed appropriately with due consideration to the protracted period for remediation.</i></p>

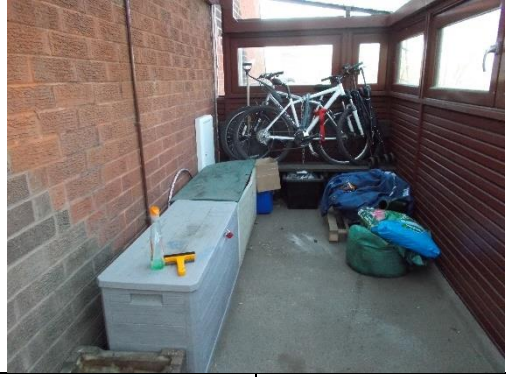
MEDIUM		2

Although there is a "managed use" policy in place for the premises, we believe there are excessive combustible materials stored on the balcony walkway adjacent to the fire exit door (door 31/2.2). Although these items do not cause an obstruction on the walkway, we recommend the client investigates this matter, liaises with the resident involved, with a view to reducing the amount of combustibles stored in this area.

Assessors Observations: Although there is a “managed use” policy in place for the premises, we believe there are excessive combustible materials stored on the balcony walkway adjacent to the fire exit door (door 31/2.2).	
Date First Identified:	23/02/23	Recommended Action: Although these items do not cause an obstruction on the walkway, we recommend the client investigates this matter, liaises with the resident involved, with a view to reducing the amount of combustibles stored in this area.	
Date of FRA	23/02/23		
Rectify Within: (months)	6		
Budget Cost:	No Cost

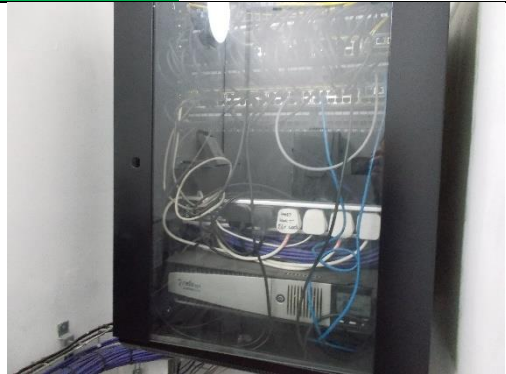
LOW		3

The servers/CCTV equipment within the landlord services room (30/2.1) are connected via standard electrical plugs. We recommend the client confirms these are subject to inspection and test (PAT) by a competent person on an annual basis.

Assessors Observations: The servers/CCTV equipment within the landlord services room (30/2.1) are connected via standard electrical plugs.	
Date First Identified:	23/02/23	Recommended Action: We recommend the client confirms these are subject to inspection and test (PAT) by a competent person on an annual basis.	
Date of FRA	23/02/23		
Rectify Within: (months)	12		
Budget Cost:	No Cost

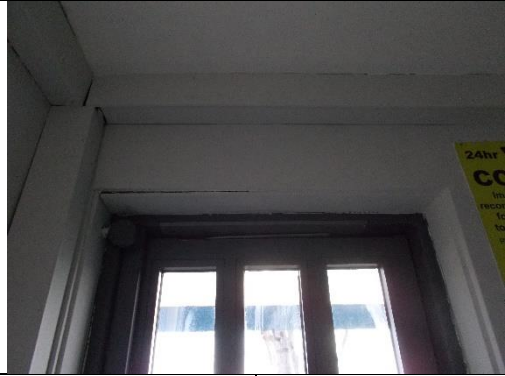
MEDIUM		4

It was noted there are breaches around the boxing in of services internally, immediately adjacent to exits 30 and 31. We recommend

Assessors Observations: There are breaches around the boxing in of services internally, immediately adjacent to exits 30 and 31.		
		Date First Identified:	23/02/23	Recommended Action: We recommend these breaches are addressed using a suitable fire stopping material capable of providing a minimum 30 minutes fire resistance.
		Date of FRA	23/02/23	
		Rectify Within: (months)	6	
		Budget Cost:	£50

these breaches are addressed using a suitable fire stopping material capable of providing a minimum 30 minutes fire resistance.

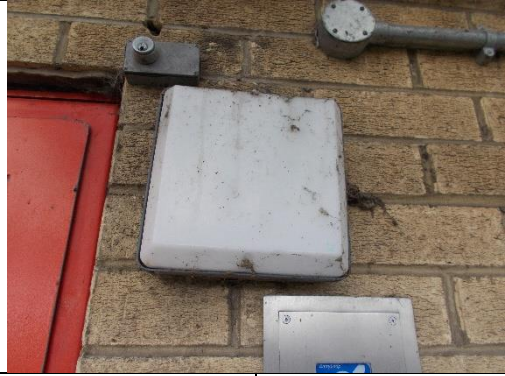
LOW		5

It was noted the emergency lighting luminaire located outside of entrance 31 on the stair does not appear to be working. We recommend the client investigates this matter and addresses any defect identified.

Assessors Observations: The emergency lighting luminaire located outside of entrance 31 on the stair does not appear to be working.		
		Date First Identified:	23/02/23	Recommended Action: We recommend the client investigates this matter and addresses any defect identified.
		Date of FRA	23/02/23	
		Rectify Within: (months)	12	
		Budget Cost:	No Cost

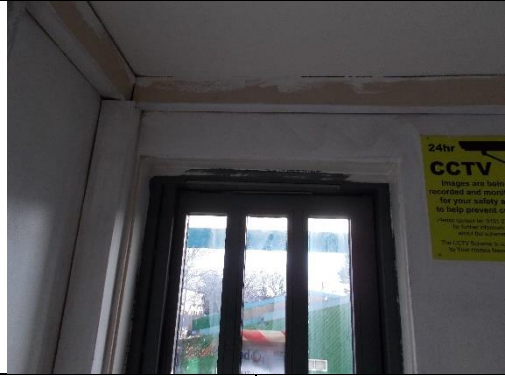
LOW		6

There is no "Fire Exit" sign above both final exit doors (exits 30 and 31). We recommend one such sign is affixed above each of these doors.

<p>Assessors Observations:</p> <p>There is no "Fire Exit" sign above both final exit doors (exits 30 and 31).</p>
Date First Identified:	23/02/23	<p>Recommended Action:</p> <p>We recommend one such sign is affixed above each of these doors.</p>
Date of FRA	23/02/23	
Rectify Within: (months)	12	
Budget Cost:	£20

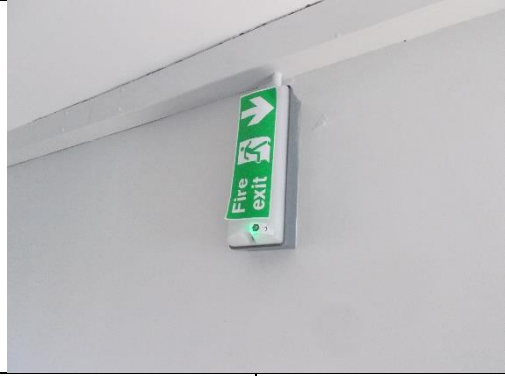
MEDIUM		7

It was noted the directional fire exit signs have been removed from the walls in several locations and stuck on the emergency lighting luminaires, reducing the amount of illumination on the means of escape. in place within the premises. We recommend these directional exit signs are removed from the luminaires and reinstalled onto the means of escape in appropriate locations such as at the changes of direction, to indicate the direction to the final exits on the ground floor.

<p>Assessors Observations:</p> <p>The directional fire exit signs have been removed from the walls in several locations and stuck on the emergency lighting luminaires, reducing the amount of illumination on the means of escape. in place within the premises.</p>
Date First Identified:	23/02/23	<p>Recommended Action:</p> <p>We recommend these directional exit signs are removed from the luminaires and reinstalled onto the means of escape in appropriate locations such as at the changes of direction, to indicate the direction to the final exits on the ground floor.</p>
Date of FRA	23/02/23	
Rectify Within: (months)	6	
Budget Cost:	No Cost

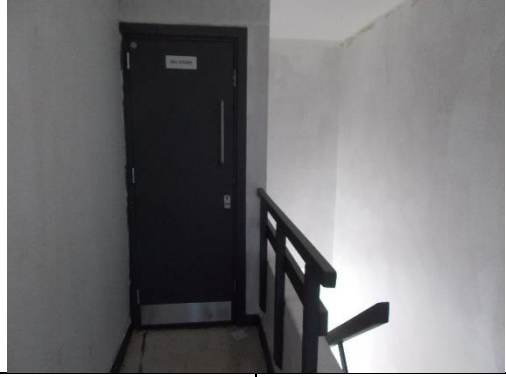
LOW		8

There is no signage on all landlord services doors to indicate the requirement to keep these doors locked. We recommend a "Fire Door Keep Locked" sign is attached to the facing side of all landlord services doors in the block.

Assessors Observations: There is no signage on all landlord services doors to indicate the requirement to keep these doors locked.
Date First Identified:	23/02/23	Recommended Action: We recommend a "Fire Door Keep Locked" sign is attached to the facing side of all landlord services doors in the block.
Date of FRA	23/02/23	
Rectify Within: (months)	12	
Budget Cost:	£30

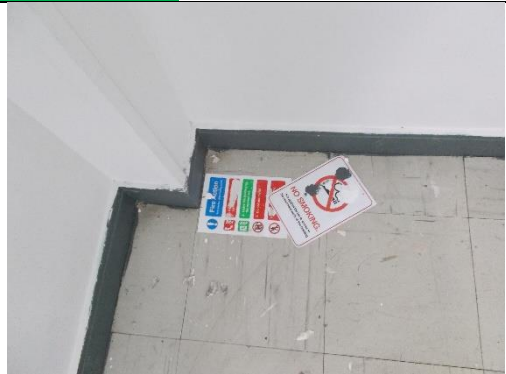
LOW		9

There are no "General Fire Action" notices or "No Smoking" notices displayed within the block. We recommend these notices are displayed in the entrances numbered 30 and 31 in a conspicuous location.

Assessors Observations: There are no "General Fire Action" notices or "No Smoking" notices displayed within the block.
Date First Identified:	23/02/23	Recommended Action: We recommend these notices are displayed in the entrances numbered 30 and 31 in a conspicuous location.
Date of FRA	23/02/23	
Rectify Within: (months)	12	
Budget Cost:	£40

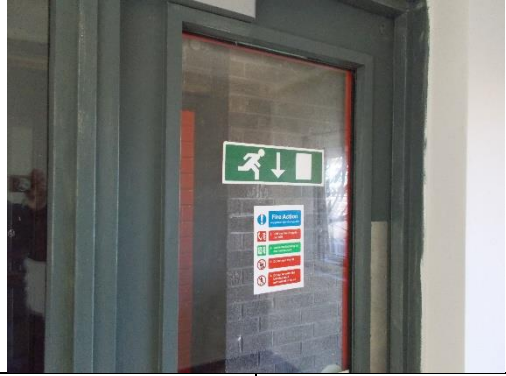
LOW		10

Both fire exit doors from the balcony walkway to the stairs have their fire exit sign attached to the door. We recommend these signs are displayed above the doors on the balcony side so that the sign is still visible when the door is opened.

<p>Assessors Observations:</p> <p>Both fire exit doors from the balcony walkway to the stairs have their fire exit sign attached to the door.</p>
Date First Identified:	23/02/23	<p>Recommended Action:</p> <p>We recommend these signs are displayed above the doors on the balcony side so that the sign is still visible when the door is opened.</p>
Date of FRA	23/02/23	
Rectify Within: (months)	12	
Budget Cost:	No Cost
