**FIRE RISK ASSESSMENT  
4-5 THE CHEVRON,  
NEWCASTLE UPON TYNE,  
TYNE AND WEAR, NE6 1RP.**

**FEBRUARY 2023**

**Reference:** 4180-04-22-JA

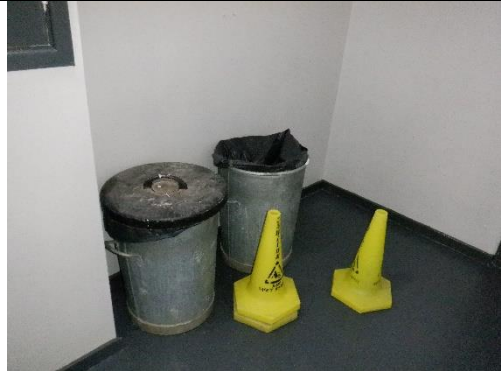
<b>MEDIUM</b>		<b>1</b>

We noted two old style garbage containers stored within the rear lobby and although empty on the day of the visit their presence may encourage waste disposal within them. We do not believe these would be emptied as part of the normal refuse collection. We recommend these are removed.

<p><b>Assessors Observations:</b></p> <p>We noted two old style garbage containers stored within the rear lobby and although empty on the day of the visit their presence may encourage waste disposal within them.</p>
<b>Date First Identified:</b>	20/02/23	<p><b>Recommended Action:</b></p> <p>We do not believe these would be emptied as part of the normal refuse collection. We recommend these are removed.</p>
<b>Date of FRA:</b>	20/02/23	
<b>Rectify Within: (months)</b>	6	
<b>Budget Cost:</b>	No Cost

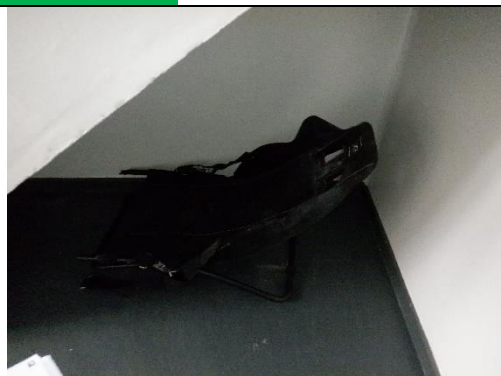
LOW		3

We noted a 'baby bouncer' chair located under the stairs of the ground floor. This may encourage further storage of equipment and obstruct the means of escape. We recommend the item is removed and residents advised accordingly to keep all means of escape clear from any potential obstructions.

<p><b>Assessors Observations:</b></p> <p>The escape routes should remain free from combustible items to reduce the risk of a fire starting in the communal areas and to ensure a clear escape route. We noted a 'baby bouncer' chair located under the stairs of the ground floor. This may encourage further storage of equipment and obstruct the means of escape.</p>
<b>Date First Identified:</b>	20/02/23	<p><b>Recommended Action:</b></p> <p>We recommend the item is removed and residents advised accordingly to keep all means of escape clear from any potential obstructions.</p>
<b>Date of FRA:</b>	20/02/23	
<b>Rectify Within: (months)</b>	12	
<b>Budget Cost:</b>	No Cost

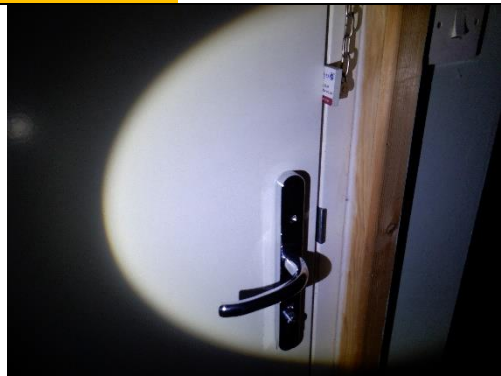
MEDIUM		4

We were able to access flat 5 and confirmed the entrance door is a notional FD60S fire door hung on 2 pair hinges fitted with combined intumescent and cold smoke seals and a self-closing device. The door has excessive gaps between the door and the frame which may allow cold smoke and the products of combustion to pass in a fire situation. We recommend the door is adjusted/rehung to ensure the gaps between the door and frame are  $3\text{mm} \pm 1\text{mm}$  and 3mm at the under door threshold for smoke control.

<p><b>Assessors Observations:</b></p> <p>We were able to access flat 5 and confirmed the entrance door is a notional FD60S fire door hung on 2 pair hinges fitted with combined intumescent and cold smoke seals and a self-closing device. The door has excessive gaps between the door and the frame which may allow cold smoke and the products of combustion to pass in a fire situation.</p>
<b>Date First Identified:</b>	20/02/23	<p><b>Recommended Action:</b></p> <p>We recommend the door is adjusted/rehung to ensure the gaps between the door and frame are 3mm ± 1mm and 3mm at the under door threshold for smoke control.</p>
<b>Date of FRA:</b>	20/02/23	
<b>Rectify Within: (months)</b>	6	
<b>Budget Cost:</b>	£35

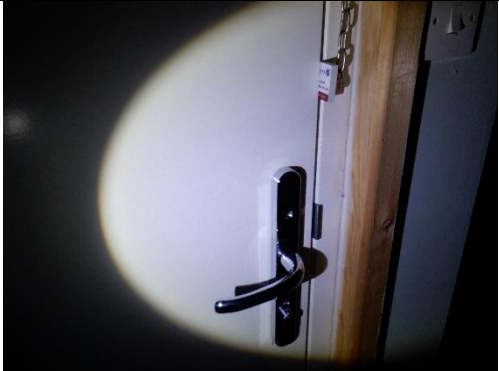
LOW		5

We noted flat 5 is fitted with a keyed locking mechanism internally to the flat entrance door. Guidance within the LACORS document states 'It is strongly recommended that the exit door from each unit of accommodation (bedsit or flat) is openable from the inside without the use of a removable key' (LACORS 16.2). We recommend the client follows this guidance and ensures all opening devices on the means of escape, including flat entrance doors are openable without a key to mitigate against misplaced or lost keys delaying or preventing egress during an emergency evacuation requirement.

<b>Assessors Observations:</b> We noted flat 5 is fitted with a keyed locking mechanism internally to the flat entrance door. Guidance within the LACORS document states 'It is strongly recommended that the exit door from each unit of accommodation (bedsit or flat) is openable from the inside without the use of a removable key' (LACORS 16.2).	
<b>Date First Identified:</b>	20/02/23	<b>Recommended Action:</b> We recommend the client follows this guidance and ensures all opening devices on the means of escape, including flat entrance doors are openable without a key to mitigate against misplaced or lost keys delaying or preventing egress during an emergency evacuation requirement.	
<b>Date of FRA:</b>	20/02/23		
<b>Rectify Within: (months)</b>	12		
<b>Budget Cost:</b>	£20

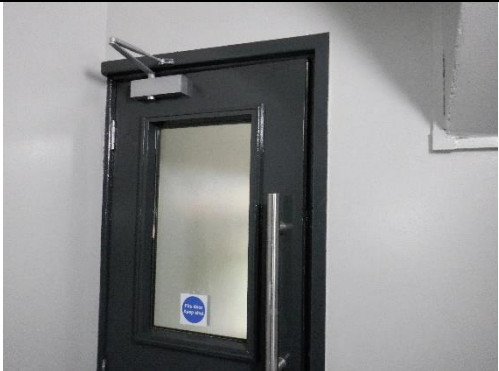
MEDIUM		6

The rear lobby door is fitted with an FD60S fire door with overhead self-closing device and intumescent and cold smoke seals. It was noted the door does not fully close to its rebate unaided. We recommend the self-closing device is adjusted to ensure the door closes fully, unaided to its rebate to ensure compartmentation is maintained to this area as and when required.

<b>Assessors Observations:</b> The rear lobby door is fitted with an FD60S fire door with overhead self-closing device and intumescent and cold smoke seals. It was noted the door does not fully close to its rebate unaided.	
<b>Date First Identified:</b>	20/02/23	<b>Recommended Action:</b> We recommend the self-closing device is adjusted to ensure the door closes fully, unaided to its rebate to ensure compartmentation is maintained to this area as and when required.	
<b>Date of FRA:</b>	20/02/23		
<b>Rectify Within: (months)</b>	6		
<b>Budget Cost:</b>	£35

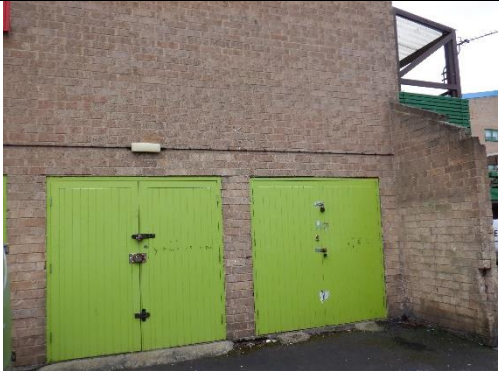
<b>LOW</b>		<b>7</b>

We were unable to access what we believe to be two garages belonging to residents accessed to the west elevation of the building. We would advise the client to arrange access to have these checked to ensure there are no compartmentation breaches between the garages and properties above or behind.

<b>Assessors Observations:</b> We were unable to access what we believe to be two garages belonging to residents accessed to the west elevation of the building.	
<b>Date First Identified:</b>	20/02/23	<b>Recommended Action:</b> We would advise the client to arrange access to have these checked to ensure there are no compartmentation breaches between the garages and properties above or behind.	
<b>Date of FRA:</b>	20/02/23		
<b>Rectify Within: (months)</b>	12		
<b>Budget Cost:</b>	No Cost

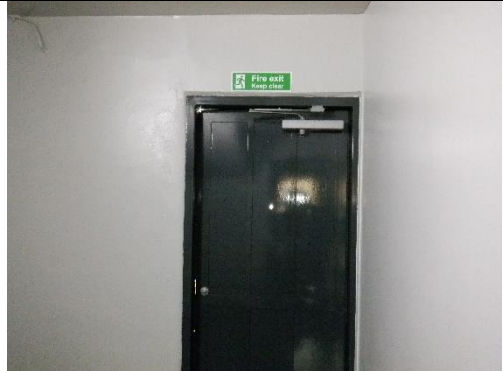
<b>LOW</b>		<b>9</b>

All final exits, which are fitted with a thumb turn opening device should also have an appropriate accompanying directional 'turn to open' sign fitted beside the opening device. We recommend appropriate signage is fitted beside the door opening mechanism where required.

<b>Assessors Observations:</b> All final exits, which are fitted with a thumb turn opening device should also have an appropriate accompanying directional 'turn to open' sign fitted beside the opening device.	
<b>Date First Identified:</b>	20/02/23	<b>Recommended Action:</b> We recommend appropriate signage is fitted beside the door opening mechanism where required.	
<b>Date of FRA:</b>	20/02/23		
<b>Rectify Within: (months)</b>	12		
<b>Budget Cost:</b>	£20

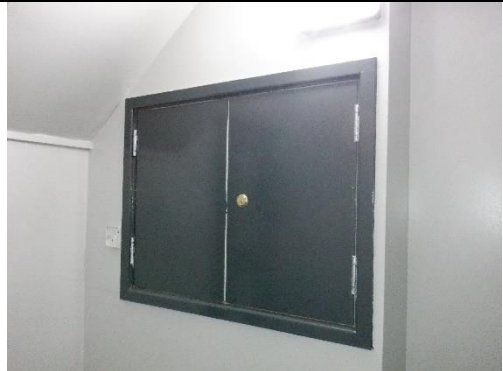
<b>LOW</b>		<b>10</b>

General access communal fire doors have appropriate fire door keep shut signage as required. Although the electrical distribution cupboards were locked on the day of the visit, they should also be fitted with fire door keep locked signage. We recommend appropriate fire door keep locked signage is fitted to the doors.

<b>Assessors Observations:</b> Although the electrical distribution cupboards were locked on the day of the visit, they should also be fitted with fire door keep locked signage.	
<b>Date First Identified:</b>	20/02/23	<b>Recommended Action:</b> We recommend appropriate fire door keep locked signage is fitted to the doors.	
<b>Date of FRA:</b>	20/02/23		
<b>Rectify Within: (months)</b>	12		
<b>Budget Cost:</b>	£20
