**FIRE RISK ASSESSMENT
6-15 & 20-31 & 36-55 SHIPLEY RISE,
BYKER,
NEWCASTLE UPON TYNE. NE6 2DF**

FEBRUARY 2023

Reference: SR/16/02/23/IC

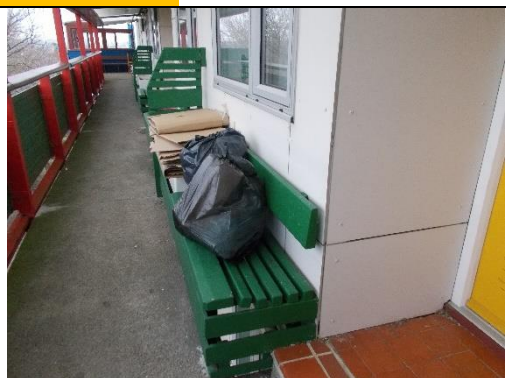
MEDIUM		1

It was noted there is bagged waste and cardboard packaging outside of flats 31 and 43. We recommend these items are removed and residents reminded to dispose of personal waste materials responsibly, to keep the means of escape routes free of unnecessary combustibles.

<p>Assessors Observations:</p> <p>There is bagged waste and cardboard packaging outside of flats 31 and 43.</p>
Date First Identified:	16/02/23	<p>Recommended Action:</p> <p>We recommend these items are removed and residents reminded to dispose of personal waste materials responsibly, to keep the means of escape routes free of unnecessary combustibles.</p>
Date of FRA	16/02/23	
Rectify Within: (months)	6	
Budget Cost:	No Cost

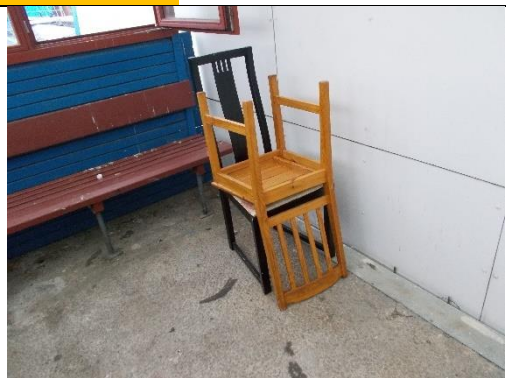
MEDIUM		2

It was noted timber chairs have been discarded outside of the fire exit adjacent to flat 39. We recommend these items are removed and residents reminded to dispose of personal waste materials responsibly, to keep the means of escape routes free of unnecessary combustibles.

<p>Assessors Observations:</p> <p>Timber chairs have been discarded outside of the fire exit adjacent to flat 39.</p>
Date First Identified:	16/02/23	<p>Recommended Action:</p> <p>We recommend these items are removed and residents reminded to dispose of personal waste materials responsibly, to keep the means of escape routes free of unnecessary combustibles.</p>
Date of FRA	16/02/23	
Rectify Within: (months)	6	
Budget Cost:	No Cost

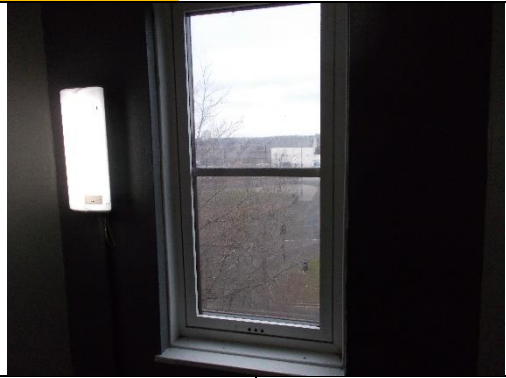
MEDIUM		3

3.3 Sources of Oxygen Natural airflow through doors and windows. It was noted the handle for the window on the protected stair adjacent to flat 23 is missing. We recommend this is reinstated to allow the stair to be ventilated if required by the fire and rescue service.

Assessors Observations: The handle for the window on the protected stair adjacent to flat 23 is missing.
Date First Identified:	16/02/23	Recommended Action: We recommend this is reinstated to allow the stair to be ventilated if required by the fire and rescue service.
Date of FRA	16/02/23	
Rectify Within: (months)	6	
Budget Cost:	£30

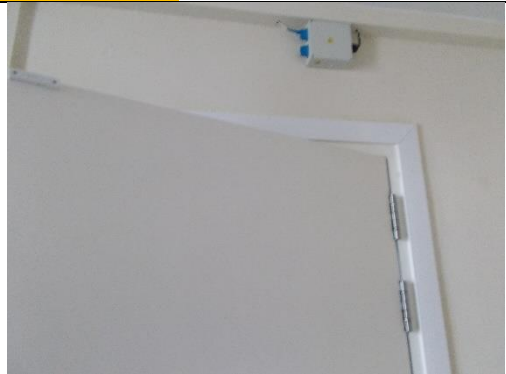
MEDIUM		4

Notwithstanding the above, we were able to gain access to flats 6, 9, 15, 21, 22 and 24 in order to check the specification and action of the flat entrance doors. The flat entrance doors to numbers 6 and 22 are FD60S doors but do not have self-closing devices attached. As flat 22 is located on the stair, we recommend a self-closing device is attached to this door to ensure it can close fully against its rebate unaided and under its own weight, and protect the means of escape for others.

Assessors Observations: The flat entrance doors to numbers 6 and 22 are FD60S doors but do not have self-closing devices attached.
Date First Identified:	16/02/23	Recommended Action: As flat 22 is located on the stair, we recommend a self-closing device is attached to this door to ensure it can close fully against its rebate unaided and under its own weight, and protect the means of escape for others.
Date of FRA	16/02/23	
Rectify Within: (months)	6	
Budget Cost:	£125

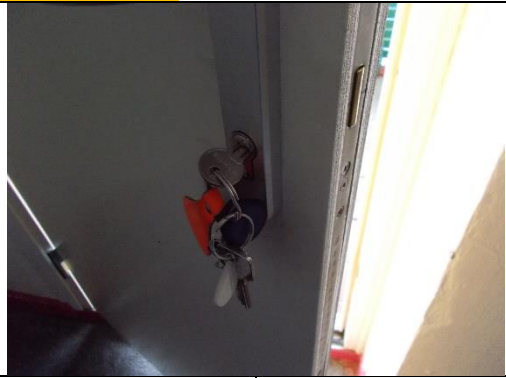
MEDIUM		5

In addition, it was noted the entrance doors to flats 6, 9 and 22 are secured via keys. We recommend the locking mechanism is changed to a thumb turn device to ensure a speedy evacuation in an emergency without the need to search for keys.

Assessors Observations: The entrance doors to flats 6, 9 and 22 are secured via keys.	
Date First Identified:	16/02/23	Recommended Action: We recommend the locking mechanism is changed to a thumb turn device to ensure a speedy evacuation in an emergency without the need to search for keys.	
Date of FRA	16/02/23		
Rectify Within: (months)	6		
Budget Cost:	£50

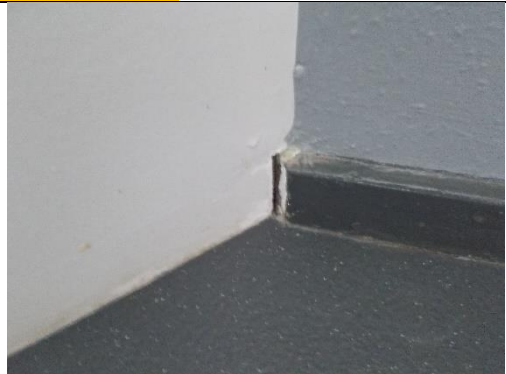
MEDIUM		6

There is a breach at floor level above flat 20 on the landing which we believe to house services for the building. We recommend this breach is addressed using the same materials surrounding it, in order to provide a minimum 60 minutes fire resistance.

Assessors Observations: There is a breach at floor level above flat 20 on the landing which we believe to house services for the building.	
Date First Identified:	16/02/23	Recommended Action: We recommend this breach is addressed using the same materials surrounding it, in order to provide a minimum 60 minutes fire resistance.	
Date of FRA	16/02/23		
Rectify Within: (months)	6		
Budget Cost:	£30

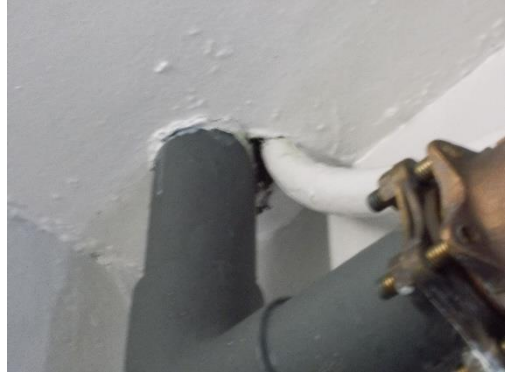
MEDIUM		7

There is a breach above the landlord services cupboard 14 / 5.1, opposite flat 23 on the stair, where pipes penetrate the ceiling. We recommend this breach is addressed using the same materials surrounding it, in order to provide a minimum 60 minutes fire resistance.

Assessors Observations: There is a breach above the landlord services cupboard 14 / 5.1, opposite flat 23 on the stair, where pipes penetrate the ceiling.
Date First Identified:	16/02/23	Recommended Action: We recommend this breach is addressed using the same materials surrounding it, in order to provide a minimum 60 minutes fire resistance.
Date of FRA	16/02/23	
Rectify Within: (months)	6	
Budget Cost:	£30

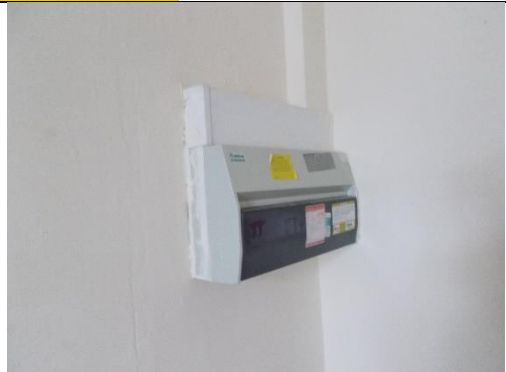
MEDIUM		8

It was noted within flat 22, the residents electrical consumer unit is immediately adjacent to the front entrance door. Should a fault occur which leads to a fire within the unit, this may compromise the residents escape. We recommend the electrical consumer unit is enclosed in fire resisting construction (minimum 30 minutes) to enable the resident enough time to evacuate.

Assessors Observations: Within flat 22, the residents electrical consumer unit is immediately adjacent to the front entrance door. Should a fault occur which leads to a fire within the unit, this may compromise the residents escape.
Date First Identified:	16/02/23	Recommended Action: We recommend the electrical consumer unit is enclosed in fire resisting construction (minimum 30 minutes) to enable the resident enough time to evacuate.
Date of FRA	16/02/23	
Rectify Within: (months)	6	
Budget Cost:	£100

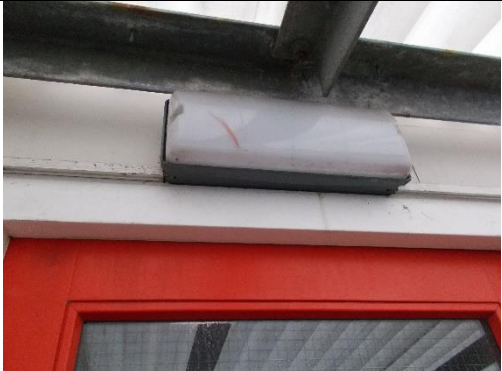
LOW		9

It was noted the emergency light fitting above the fire exit door adjacent to flat 15 does not appear to be working. We recommend this defect is rectified.

<p>Assessors Observations:</p> <p>The emergency light fitting above the fire exit door adjacent to flat 15 does not appear to be working.</p>	
		<p>Date First Identified:</p> <p>16/02/23</p>	<p>Recommended Action:</p> <p>We recommend this defect is rectified.</p>
		<p>Date of FRA</p> <p>16/02/23</p>	
		<p>Rectify Within: (months)</p> <p>12</p>	
		<p>Budget Cost:</p> <p>No Cost</p>

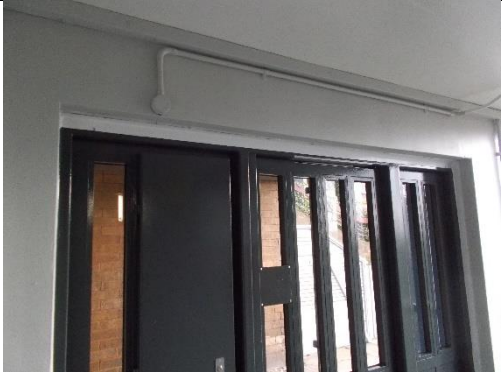
LOW		10

There is no "Fire Exit" sign above the final exit door within the lobby of entrance 14. We recommend one such sign is affixed above this door.

<p>Assessors Observations:</p> <p>There is no "Fire Exit" sign above the final exit door within the lobby of entrance 14.</p>	
		<p>Date First Identified:</p> <p>16/02/23</p>	<p>Recommended Action:</p> <p>We recommend one such sign is affixed above this door.</p>
		<p>Date of FRA</p> <p>16/02/23</p>	
		<p>Rectify Within: (months)</p> <p>12</p>	
		<p>Budget Cost:</p> <p>£10</p>

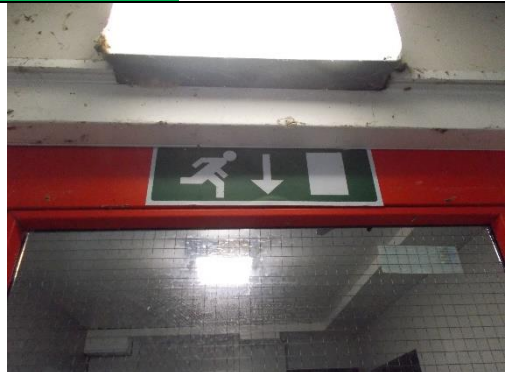
LOW		11

Generally, it was noted several directional fire exit signs are either not in place, or are affixed directly to the part glazed FD30S SC fire doors from the balcony walkways (for example door 14 / 3.3). We recommend any signage attached to the doors is removed and affixed above them, so they are still visible when the door is opened. Directional exit signage should be installed above those doors from the balconies where there is none (for example adjacent flat 6).

<p>Assessors Observations:</p> <p>Several directional fire exit signs are either not in place, or are affixed directly to the part glazed FD30S SC fire doors from the balcony walkways (for example door 14 / 3.3).</p>
Date First Identified:	16/02/23	<p>Recommended Action:</p> <p>We recommend any signage attached to the doors is removed and affixed above them, so they are still visible when the door is opened. Directional exit signage should be installed above those doors from the balconies where there is none (for example adjacent flat 6).</p>
Date of FRA	16/02/23	
Rectify Within: (months)	12	
Budget Cost:	£80

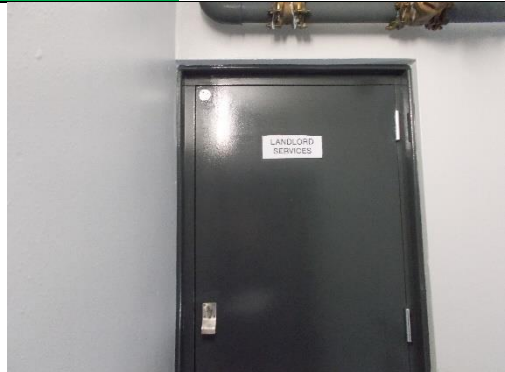
LOW		12

The landlord services room on the stair above flat 38 (door 13 / 4.4) requires a "Fire Door Keep Locked" sign to be attached to the facing side of the door.

<p>Assessors Observations:</p> <p>The landlord services room on the stair above flat 38 (door 13 / 4.4) requires a "Fire Door Keep Locked" sign to be attached to the facing side of the door.</p>
Date First Identified:	16/02/23	<p>Recommended Action:</p> <p>As above.</p>
Date of FRA	16/02/23	
Rectify Within: (months)	12	
Budget Cost:	£10
