**FIRE RISK ASSESSMENT
64-70 WOLSELEY HOUSE,
DUNN TERRACE, BYKER,
NEWCASTLE UPON TYNE NE6 1DA**

FEBRUARY 2023

Reference: WH/16/02/23/IC

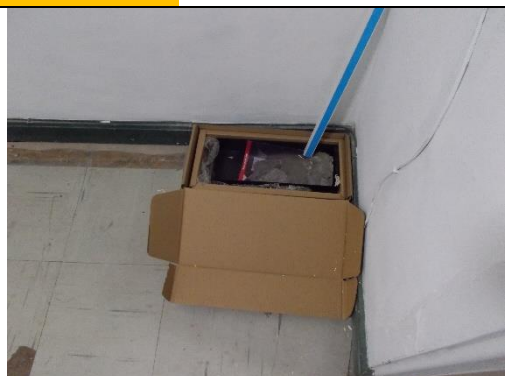
MEDIUM		1

It was noted there are combustibles within the landlord services room (door 25 / 2.2) such as plastic trunking and card board boxes left over from previous works undertaken within. We recommend these items are removed and this compartment kept sterile.

<p>Assessors Observations:</p> <p>There are combustibles within the landlord services room (door 25 / 2.2) such as plastic trunking and card board boxes left over from previous works undertaken within</p>
Date First Identified:	16/02/23	<p>Recommended Action:</p> <p>We recommend these items are removed and this compartment kept sterile.</p>
Date of FRA	16/02/23	
Rectify Within: (months)	6	
Budget Cost:	No Cost

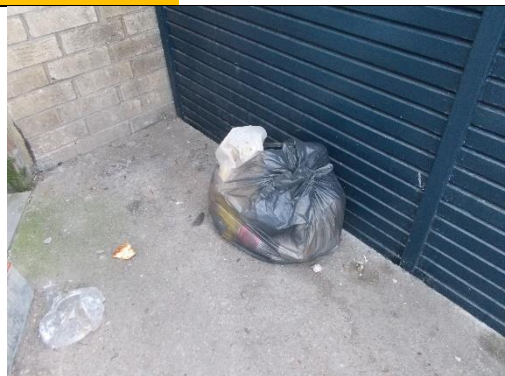
MEDIUM		2

It was noted there is bagged waste and general refuse outside of flats 65 and 70. We recommend these items are removed and residents reminded to dispose of personal waste materials responsibly, to keep the means of escape routes free of unnecessary combustibles.

<p>Assessors Observations:</p> <p>There is bagged waste and general refuse outside of flats 65 and 70.</p>
Date First Identified:	16/02/23	<p>Recommended Action:</p> <p>We recommend these items are removed and residents reminded to dispose of personal waste materials responsibly, to keep the means of escape routes free of unnecessary combustibles.</p>
Date of FRA	16/02/23	
Rectify Within: (months)	6	
Budget Cost:	No Cost

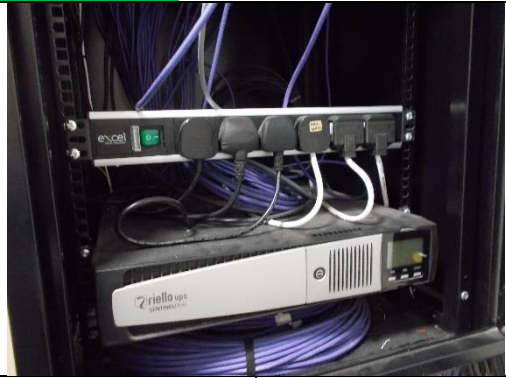
LOW		3

The servers/CCTV equipment within the landlord services room are connected via standard electrical plugs. We recommend the client confirms these are subject to inspection and test (PAT) by a competent person on an annual basis.

Assessors Observations: The servers/CCTV equipment within the landlord services room are connected via standard electrical plugs.
Date First Identified:	16/02/23	Recommended Action: We recommend the client confirms these are subject to inspection and test (PAT) by a competent person on an annual basis.
Date of FRA	16/02/23	
Rectify Within: (months)	12	
Budget Cost:	No Cost

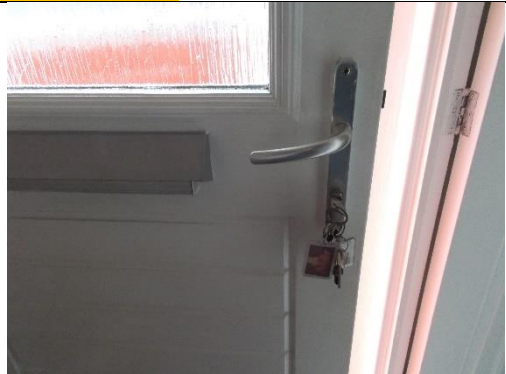
MEDIUM		4

It was noted however, the entrance door to flat 66 is secured via keys. We recommend the locking mechanism is changed to a thumb turn device to ensure a speedy evacuation in an emergency without the need to search for keys.

Assessors Observations: The entrance door to flat 66 is secured via keys.
Date First Identified:	16/02/23	Recommended Action: We recommend the locking mechanism is changed to a thumb turn device to ensure a speedy evacuation in an emergency without the need to search for keys.
Date of FRA	16/02/23	
Rectify Within: (months)	6	
Budget Cost:	£25

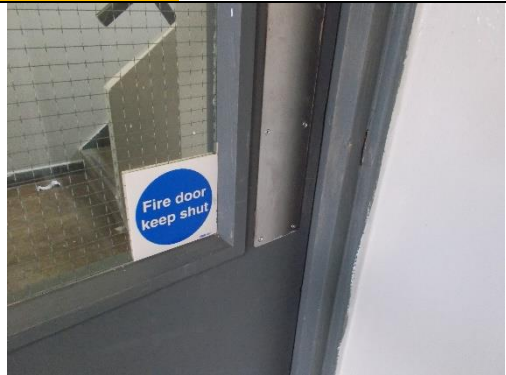
MEDIUM		5

The FD60S SC door leading to the stair adjacent to flat 64 (door 25 / G.2) does not close fully against its rebate. We recommend the self-closing device for this door is adjusted to allow it to close fully against its rebate unaided and under its weight.

Assessors Observations: The FD60S SC door leading to the stair adjacent to flat 64 (door 25 / G.2) does not close fully against its rebate.
Date First Identified:	16/02/23	Recommended Action: We recommend the self-closing device for this door is adjusted to allow it to close fully against its rebate unaided and under its weight.
Date of FRA	16/02/23	
Rectify Within: (months)	6	
Budget Cost:	£30

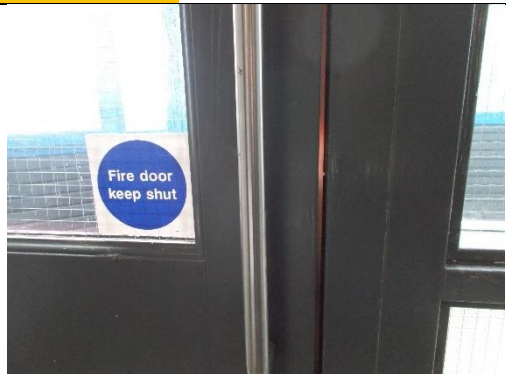
MEDIUM		6

The FD60S SC door leading to the balcony adjacent to flat 70 (door 25 / 3.3) does not close fully against its rebate. We recommend the self-closing device for this door is adjusted to allow it to close fully against its rebate unaided and under its weight.

Assessors Observations: The FD60S SC door leading to the balcony adjacent to flat 70 (door 25 / 3.3) does not close fully against its rebate.
Date First Identified:	16/02/23	Recommended Action: We recommend the self-closing device for this door is adjusted to allow it to close fully against its rebate unaided and under its weight.
Date of FRA	16/02/23	
Rectify Within: (months)	6	
Budget Cost:	£30

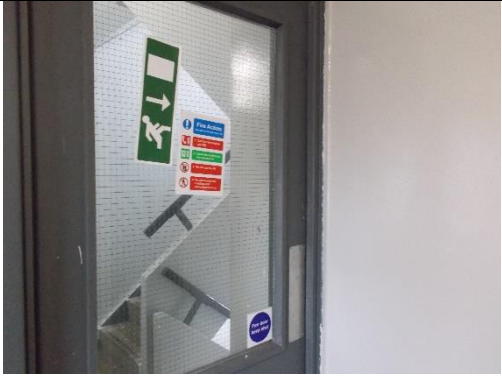
MEDIUM		7
Assessors Observations:

It should be noted, at the time of the assessment, contractors were in attendance carrying out a programme of decorating works within the common areas. Therefore, numerous signs had been removed on a temporary basis for the painting works to be carried out.

- General Fire Action notices and "No Smoking" notices are required on each floor.
- All FD30S doors in the common areas require "Fire Door Keep Shut" signage affixed to both sides of each door.

- Directional exit signage is required above the fire door leading from the balcony adjacent to flat 70, and to the stair adjacent to flat 68.
- Landlord services cupboard doors marked 25 / 3.2 and 25 / 2.2 require a "fire door keep locked" sign to be attached to the facing side of the door.

<p>At the time of the assessment, contractors were in attendance carrying out a programme of decorating works within the common areas. Therefore, numerous signs had been removed on a temporary basis for the painting works to be carried out.</p> <p>Amongst the signs which are missing/requiring to be reinstated are:</p> <ul style="list-style-type: none"> • General Fire Action notices and “No Smoking” notices are required on each floor. • All FD30S doors in the common areas require “Fire Door Keep Shut” signage affixed to both sides of each door. • Directional exit signage is required above the fire door leading from the balcony adjacent to flat 70, and to the stair adjacent to flat 68. • Landlord services cupboard doors marked 25 / 3.2 and 25 / 2.2 require a “fire door keep locked” sign to be attached to the facing side of the door. 		
Date First Identified:	16/02/23	Recommended Action:

Date of FRA	16/02/23	We recommend a full signage survey is undertaken following the completion of any decorative work on the estate to ensure residents and visitors can be guided to safety in an emergency.
Rectify Within: (months)	6	
Budget Cost:	£500
