FIRE RISK ASSESSMENT REVIEW
67-71 RABY STREET,
NEWCASTLE UPON TYNE,
TYNE AND WEAR, NE6 2FA.

JANUARY 2023

Reference: 4180-04-22-JA

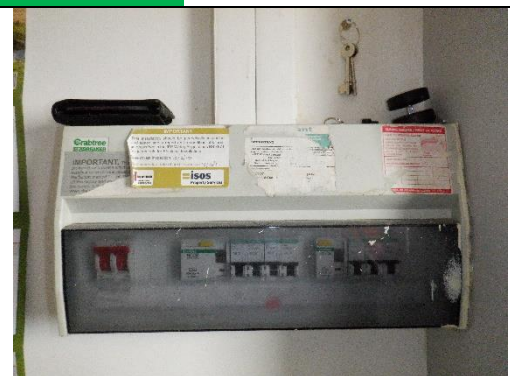
LOW		1

2.2.5 The electrical distribution board within flat 69 was noted to have been last inspected and tested on 10/04/17, beyond the required 5 year duration. We recommend a periodic test and inspection of the electrical installation is carried out as soon as practicable. All rented dwellings should be tested and inspected every 5 years.

<p>Assessors Observations:</p> <p>The electrical distribution board within flat 69 was noted to have been last inspected and tested on 10/04/17, beyond the required 5 year duration.</p>
Ref:	2.2.5	<p>Recommended Action:</p> <p>We recommend a periodic test and inspection of the electrical installation is carried out as soon as practicable. All rented dwellings should be tested and inspected every 5 years.</p>
Date First Identified:	21/02/23	
Date of FRA Review:	21/02/23	
Rectify Within: (months)	12	
Budget Cost:	No Cost

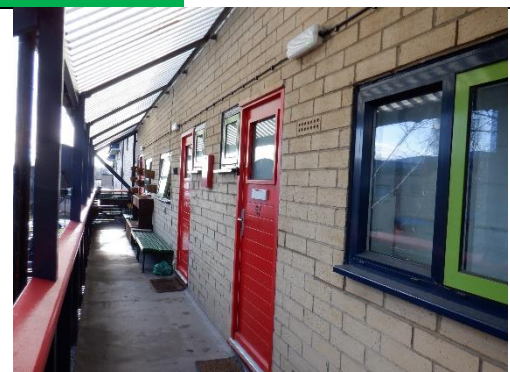
LOW		2

2.2.7 The external communal areas (stairs and walkways) of the property are no smoking areas, however we did not note any 'No Smoking' signage. We recommend no smoking signage is installed in appropriate locations.

<p>Assessors Observations:</p> <p>The external communal areas (stairs and walkways) of the property are no smoking areas, however we did not note any 'No Smoking' signage.</p>
Ref:	2.2.7	<p>Recommended Action:</p> <p>We recommend no smoking signage is installed in appropriate locations.</p>
Date First Identified:	21/02/23	
Date of FRA Review:	21/02/23	
Rectify Within: (months)	12	
Budget Cost:	£20
