**FIRE RISK ASSESSMENT
9-14 THE CHEVRON,
NEWCASTLE UPON TYNE,
TYNE AND WEAR, NE6 1RP.**

FEBRUARY 2023

STORM TEMPEST
PROPERTY CONSULTANCY

Reference: 4180-04-22-JA

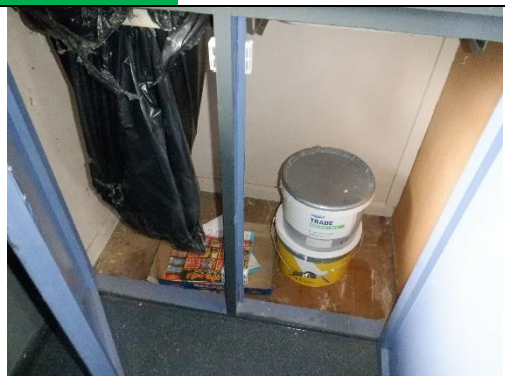
LOW		1

It was noted, within the unlocked cupboard in the ground floor lobby, combustible items are being stored including a rubbish bag and plastic paint pots. We recommend these items are removed and this cupboard kept sterile and locked shut.

Assessors Observations: It was noted, within the unlocked cupboard in the ground floor lobby, combustible items are being stored including a rubbish bag and plastic paint pots.	
Date First Identified:	20/02/23	Recommended Action: We recommend these items are removed and this cupboard kept sterile and locked shut.	
Date of FRA:	20/02/23		
Rectify Within: (months)	12		
Budget Cost:	No Cost

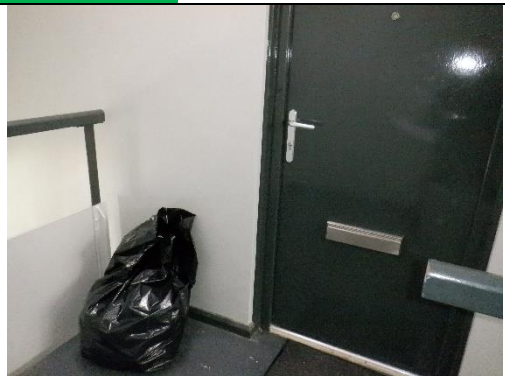
LOW		2

A bin bag has been left outside of a flat entrance door (no. 11) within the common stairwell. All means of escape should be kept clear of any additional fuel sources or obstructions. We recommend the bag is disposed of and residents advised of the requirement to keep all means of escape routes clear.

Assessors Observations: A bin bag has been left outside of a flat entrance door (no. 11) within the common stairwell. All means of escape should be kept clear of any additional fuel sources or obstructions.	
Date First Identified:	20/02/23	Recommended Action: We recommend the bag is disposed of and residents advised of the requirement to keep all means of escape routes clear.	
Date of FRA:	20/02/23		
Rectify Within: (months)	12		
Budget Cost:	No Cost

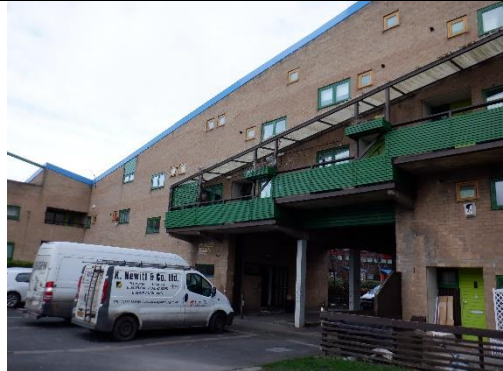
LOW		3

On the day of the visit we noted contractors vans parked in close proximity to the building under the communal walkway within 1m of the timber balustrade of the communal walkway. If the vehicle was to develop an electrical fault, the resultant fire would spread to the balcony and the building, making this means of escape unusable. Although this is considered as a low risk occurrence, the client should consider restricting parking in this location.

Assessors Observations: On the day of the visit we noted contractors vans parked in close proximity to the building under the communal walkway within 1m of the timber balustrade of the communal walkway. If the vehicle was to develop an electrical fault, the resultant fire would spread to the balcony and the building, making this means of escape unusable.	
Date First Identified:	20/02/23	Recommended Action: Although this is considered as a low risk occurrence, the client should consider restricting parking in this location.	
Date of FRA:	20/02/23		
Rectify Within: (months)	12		
Budget Cost:	No Cost

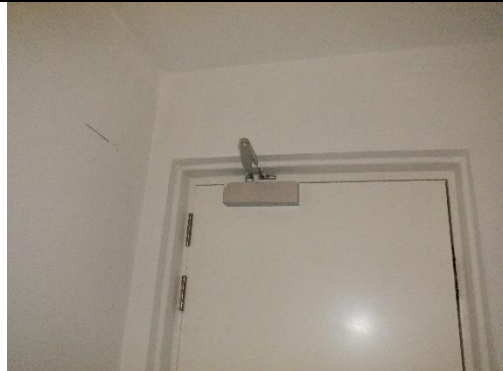
MEDIUM		4

We were able to access flat 10, accessed from the common stairwell on the day of the visit. The flat entrance door is a solid timber FD60S fire door fitted with overhead self-closing device, with 2x 10mm intumescent seals and Batwing cold smoke seals fitted and hung on 2 pair of fire rated hinges. We noted the door has excessive gaps between the door and frame which may allow the products of combustion to pass in a fire situation. We recommend the door is adjusted/rehung to ensure the gaps between the door and frame are 3mm ± 1mm and 3mm at the under door threshold for smoke control.

Assessors Observations: We were able to access flat 10, accessed from the common stairwell on the day of the visit. We noted the entrance door has excessive gaps between the door and frame which may allow the products of combustion to pass in a fire situation.	
Date First Identified:	20/02/23	Recommended Action: We recommend the door is adjusted/rehung to ensure the gaps between the door and frame are 3mm ± 1mm and 3mm at the under door threshold for smoke control.	
Date of FRA:	20/02/23		
Rectify Within: (months)	6		
Budget Cost:	£35

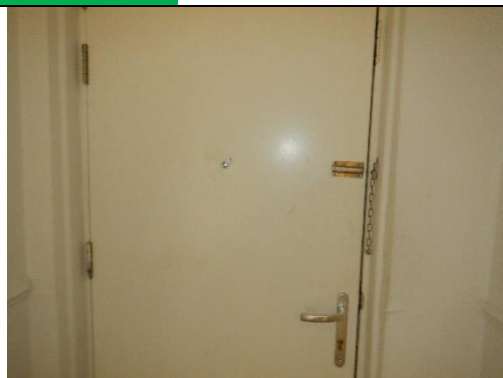
LOW		5

We noted flat 10 is fitted with a keyed locking mechanism internally to the flat entrance door. Guidance within the LACORS document states 'It is strongly recommended that the exit door from each unit of accommodation (bedsit or flat) is openable from the inside without the use of a removable key' (LACORS 16.2). We recommend the client follows this guidance and ensures all opening devices on

Assessors Observations: We noted flat 10 is fitted with a keyed locking mechanism internally to the flat entrance door. Guidance within the LACORS document states 'It is strongly recommended that the exit door from each unit of accommodation (bedsit or flat) is openable from the inside without the use of a removable key' (LACORS 16.2).	
Date First Identified:	20/02/23	Recommended Action: We recommend the client follows this guidance and ensures all opening devices on the means of escape, including flat entrance doors are openable without a key to mitigate against misplaced or lost keys delaying or preventing egress during an emergency evacuation requirement.	
Date of FRA:	20/02/23		
Rectify Within: (months)	12		
Budget Cost:	£20

the means of escape, including flat entrance doors are openable without a key to mitigate against misplaced or lost keys delaying or preventing egress during an emergency evacuation requirement.

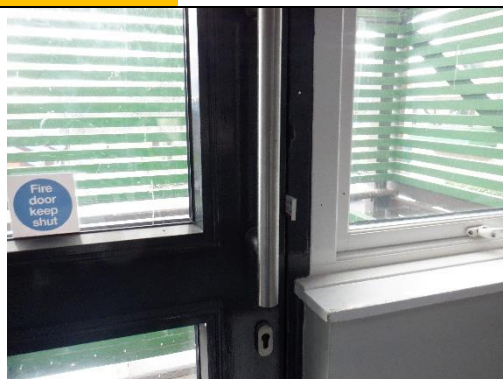
MEDIUM		6

The doors located on the common means of escape accessing the communal walkway off the first floor and balcony off the second floor are FD60S fire doors fitted with overhead self-closing device, with 2x 10mm intumescent seals and Batwing cold smoke seals fitted and hung on 2 pair of fire rated hinges. We noted the door on the 1st floor has excessive gaps between the door and frame and does not close fully to its rebate unaided, compromising the fire rated integrity of the fire door. We recommend the door is adjusted/rehung to ensure the gaps between the door and frame are $3\text{mm} \pm 1\text{mm}$ and 3mm at the under door threshold for smoke control, and the self-closing device is adjusted to ensure the door closes fully unaided to its rebate.

Assessors Observations: The doors located on the common means of escape accessing the communal walkway off the first floor and balcony off the second floor are FD60S fire doors. We noted the door on the 1st floor has excessive gaps between the door and frame and does not close fully to its rebate unaided, compromising the fire rated integrity of the fire door.	
Date First Identified:	20/02/23	Recommended Action: We recommend the door is adjusted/rehung to ensure the gaps between the door and frame are 3mm ± 1mm and 3mm at the under door threshold for smoke control, and the self-closing device is adjusted to ensure the door closes fully unaided to its rebate.	
Date of FRA:	20/02/23		
Rectify Within: (months)	6		
Budget Cost:	£35

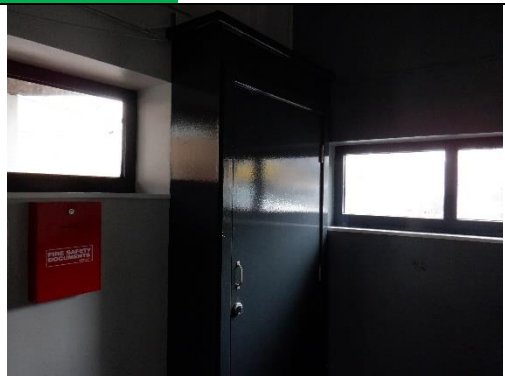
LOW		8

General access communal fire doors have appropriate fire door keep shut signage as required. Although the electrical distribution cupboard was locked on the day of the visit, it should also be fitted with fire door keep locked signage. We recommend appropriate fire door keep locked signage is fitted to the door.

Assessors Observations: Although the electrical distribution cupboard was locked on the day of the visit, it should also be fitted with fire door keep locked signage.
		Recommended Action: We recommend appropriate fire door keep locked signage is fitted to the door.
Date First Identified:	20/02/23	
Date of FRA:	20/02/23	
Rectify Within: (months)	12	
Budget Cost:	£20
