**FIRE RISK ASSESSMENT
9-16 GRAHAM HOUSE, BYKER,
NEWCASTLE UPON TYNE.
NE6 1AT**

FEBRUARY 2023

Reference: GH/23/02/23/IC

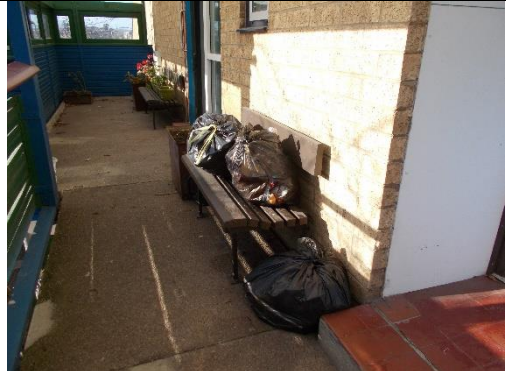
MEDIUM		1

It was noted there is bagged waste on the balcony walkway outside of flat 12. We recommend this is removed and residents are reminded to dispose of household rubbish responsibly to mitigate the risk of fires occurring on the means of escape.

Adjacent to the fire exit to the stair (door 27A / 2.1), there are discarded toys, books and twigs on the balcony walkway. We recommend these are removed and residents reminded to dispose of household items responsibly.

<p>Assessors Observations:</p> <p>There is bagged waste on the balcony walkway outside of flat 12 as well as discarded toys, books and twigs adjacent to the fire exit to the stair (door 27A / 2.1).</p>
Date First Identified:	23/02/23	<p>Recommended Action:</p> <p>We recommend these items are removed and residents are reminded to dispose of household waste items responsibly to mitigate the risk of fires occurring on the means of escape.</p>
Date of FRA	23/02/23	
Rectify Within: (months)	6	
Budget Cost:	No Cost

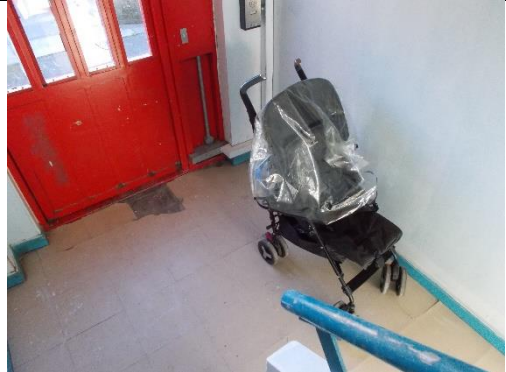
MEDIUM		2

It was noted there is a pushchair in the ground floor entrance hallway. We are unsure if this is being stored or has been discarded. We recommend the client investigates this matter and reminds

<p>Assessors Observations:</p> <p>There is a pushchair in the ground floor entrance hallway. We are unsure if this is being stored or has been discarded.</p>
Date First Identified:	23/02/23	<p>Recommended Action:</p> <p>We recommend the client investigates this matter and reminds residents to keep the means of escape free of obstructions so it can be safely used by all.</p>
Date of FRA	23/02/23	
Rectify Within: (months)	6	
Budget Cost:	No Cost

residents to keep the means of escape free of obstructions so it can be safely used by all.

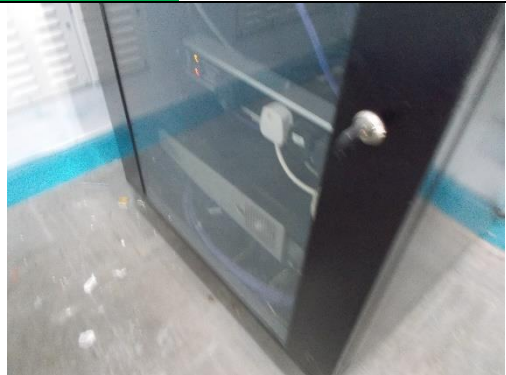
LOW		3

The servers/CCTV equipment within the landlord services room are connected via standard electrical plugs. We recommend the client

Assessors Observations: The servers/CCTV equipment within the landlord services room are connected via standard electrical plugs.	
Date First Identified:	23/02/23	Recommended Action: We recommend the client confirms these are subject to inspection and test (PAT) by a competent person on an annual basis.	
Date of FRA	23/02/23		
Rectify Within: (months)	12		
Budget Cost:	No Cost

confirms these are subject to inspection and test (PAT) by a competent person on an annual basis.

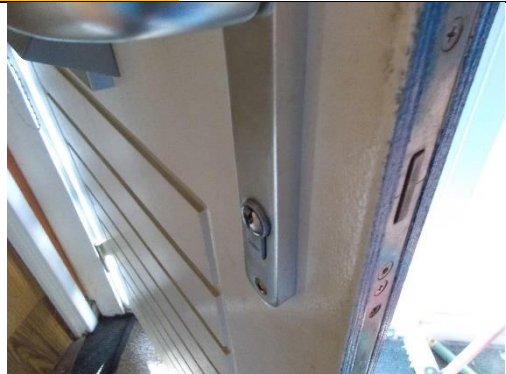
MEDIUM		4

We were able to gain access to flat 13 which is located on the balcony walkway. It was noted this particular door does not have a self-closing device attached to the door and is secured internally via a key. We recommend a self-closing device is attached to this door in order to contain any fire within the flat following any evacuation. In addition, we recommend the locking mechanism is replaced with a thumb turn device internally. This will allow the

Assessors Observations: The flat entrance door to number 13 does not have a self-closing device attached to the door and is secured internally via a key.	
Date First Identified:	23/02/23	Recommended Action: We recommend a self-closing device is attached to this door in order to contain any fire within the flat following any evacuation. In addition, we recommend the locking mechanism is replaced with a thumb turn device internally. This will allow the occupants to evacuate the dwelling speedily without the need to search for keys to unlock the door.	
Date of FRA	23/02/23		
Rectify Within: (months)	6		
Budget Cost:	£150

occupants to evacuate the dwelling speedily without the need to search for keys to unlock the door.

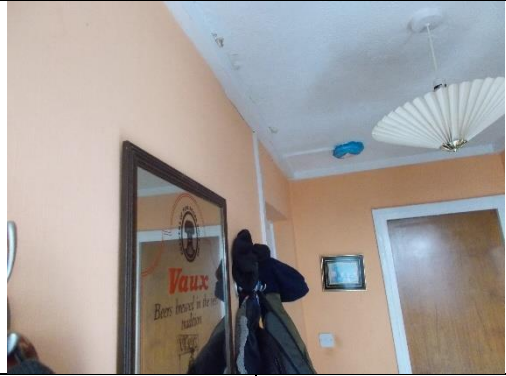
MEDIUM		5

It was noted, within flat 13, the resident has put a plastic cover over the detector head in the hall. On questioning the resident stated it was too sensitive and has suffered repeated false alarms when cooking. We advised the resident to remove the cover. We recommend the client investigates this matter with a view to changing the smoke detector head if it is defective, or repositioning it with a view to ensuring a working smoke detector in the hall and also preventing false alarms occurring.

Assessors Observations: Within flat 13, the resident has put a plastic cover over the detector head in the hall. On questioning the resident stated it was too sensitive and has suffered repeated false alarms when cooking.	
Date First Identified:	23/02/23	Recommended Action: We recommend the client investigates this matter with a view to changing the smoke detector head if it is defective, or repositioning it with a view to ensuring a working smoke detector in the hall and also preventing false alarms occurring.	
Date of FRA	23/02/23		
Rectify Within: (months)	6		
Budget Cost:	No Cost

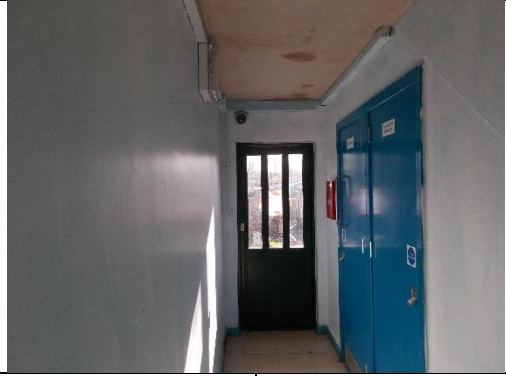
LOW		6

There is no "Fire Exit" sign above both final exit doors within the ground floor entrance hall. We recommend one such sign is affixed above each of these doors.

Assessors Observations: There is no "Fire Exit" sign above both final exit doors within the ground floor entrance hall.	
Date First Identified:	23/02/23	Recommended Action: We recommend one such sign is affixed above each of these doors.	
Date of FRA	23/02/23		
Rectify Within: (months)	12		
Budget Cost:	£20

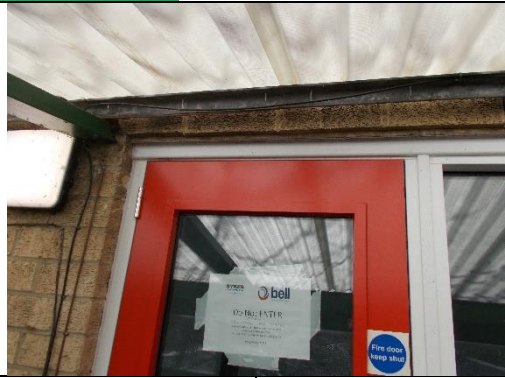
LOW		7

It was noted there are no directional fire exit signs in place within the premises. We recommend directional exit signage is installed above the door from the balcony walkway (door 27A/2.1). In

Assessors Observations: There are no directional fire exit signs in place within the premises.
Date First Identified:	23/02/23	Recommended Action: We recommend directional exit signage is installed above the door from the balcony walkway (door 27A/2.1). In addition, the directional signage temporarily removed on the means of escape on the stair, from flat 11 downwards, should be reinstated onto the wall at the changes of direction, to indicate the direction to the final exits on the ground floor.
Date of FRA	23/02/23	
Rectify Within: (months)	12	
Budget Cost:	£40

addition, the directional signage temporarily removed on the means of escape on the stair, from flat 11 downwards, should be reinstated onto the wall at the changes of direction, to indicate the direction to the final exits on the ground floor.

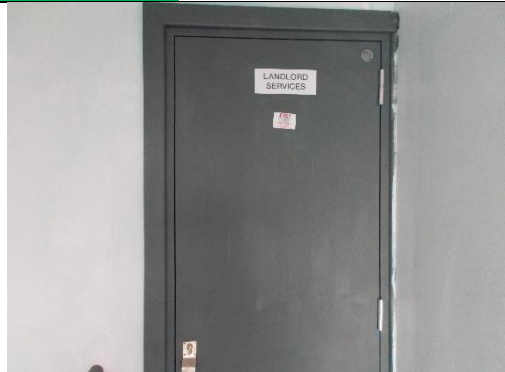
LOW		8

There is no signage on the landlord services door adjacent to flat 11 (door 27/2.2) to indicate the requirement to keep this door locked. We recommend a "Fire Door Keep Locked" sign is attached to the facing side of this door.

Assessors Observations: There is no signage on the landlord services door adjacent to flat 11 (door 27/2.2) to indicate the requirement to keep this door locked.
Date First Identified:	23/02/23	Recommended Action: We recommend a "Fire Door Keep Locked" sign is attached to the facing side of this door.
Date of FRA	23/02/23	
Rectify Within: (months)	12	
Budget Cost:	£10

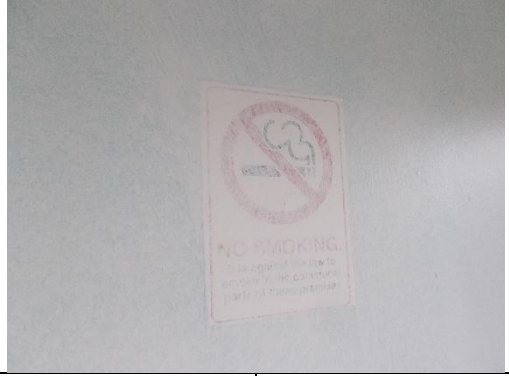
LOW		9

There are no "General Fire Action" notices or "No Smoking" notices displayed within the block, with one "No Smoking" sign painted over. We recommend these notices are displayed in the ground floor entrance hall area as well as in a conspicuous location outside of flat 11.

<p>Assessors Observations:</p> <p>There are no "General Fire Action" notices or "No Smoking" notices displayed within the block, with one "No Smoking" sign painted over.</p>
Date First Identified:	23/02/23	<p>Recommended Action:</p> <p>We recommend these notices are displayed in the ground floor entrance hall area as well as in a conspicuous location outside of flat 11.</p>
Date of FRA	23/02/23	
Rectify Within: (months)	12	
Budget Cost:	£60
