**FIRE RISK ASSESSMENT  
25-39 & 48-63 DUNN TERRACE, BYKER,  
NEWCASTLE UPON TYNE  
NE6 1AZ**

**FEBRUARY 2023**

**Reference:** DT/16/02/23/IC

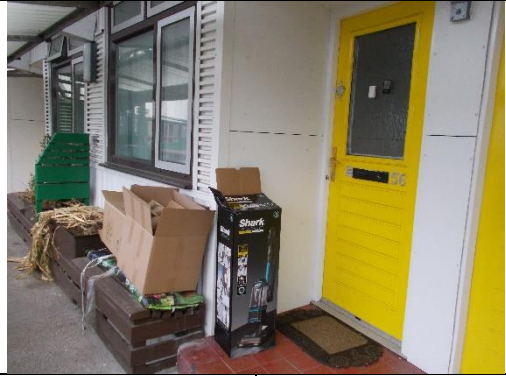
<b>MEDIUM</b>		<b>1</b>

It was noted that bagged waste as well as large amounts of cardboard packaging have been discarded on the communal walkway /balcony adjacent to flats 56 and 62. We recommend these items are removed and residents reminded to dispose of their unwanted items responsibly in order to protect the means of escape for all residents.

<p><b>Assessors Observations:</b></p> <p>Bagged waste as well as large amounts of cardboard packaging have been discarded on the communal walkway /balcony adjacent to flats 56 and 62.</p>
<b>Date First Identified:</b>	16/01/23	<p><b>Recommended Action:</b></p> <p>We recommend these items are removed and residents reminded to dispose of their unwanted items responsibly in order to protect the means of escape for all residents.</p>
<b>Date of FRA</b>	16/01/23	
<b>Rectify Within: (months)</b>	6	
<b>Budget Cost:</b>	No Cost

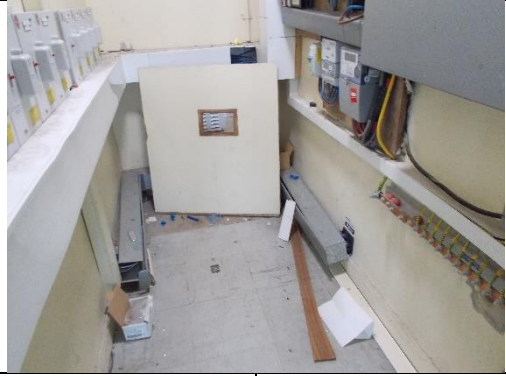
<b>MEDIUM</b>		<b>2</b>

It was noted there are discarded combustibles within the ground floor electrical meter room (door 26 G.2). We recommend these items are removed and this area kept sterile.

<p><b>Assessors Observations:</b></p> <p>There are discarded combustibles within the ground floor electrical meter room (door 26 G.2).</p>
<b>Date First Identified:</b>	16/01/23	<p><b>Recommended Action:</b></p> <p>We recommend these items are removed and this area kept sterile.</p>
<b>Date of FRA</b>	16/01/23	
<b>Rectify Within: (months)</b>	6	
<b>Budget Cost:</b>	No Cost

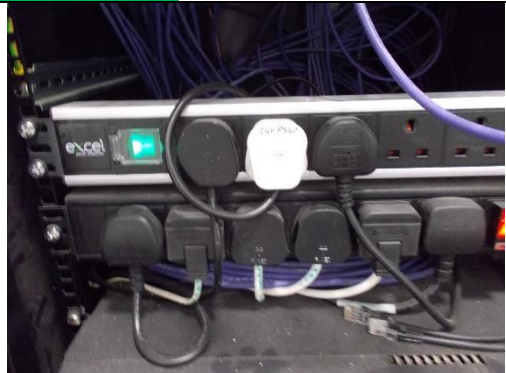
<b>LOW</b>		<b>3</b>

The servers/CCTV equipment within the landlord services room (door 26/G.2) are connected via standard electrical plugs. We recommend the client confirms these are subject to inspection and test (PAT) by a competent person on an annual basis.

<b>Assessors Observations:</b> The servers/CCTV equipment within the landlord services room (door 26/G.2) are connected via standard electrical plugs.
<b>Date First Identified:</b>	16/01/23	<b>Recommended Action:</b> We recommend the client confirms these are subject to inspection and test (PAT) by a competent person on an annual basis.
<b>Date of FRA</b>	16/01/23	
<b>Rectify Within: (months)</b>	12	
<b>Budget Cost:</b>	No Cost

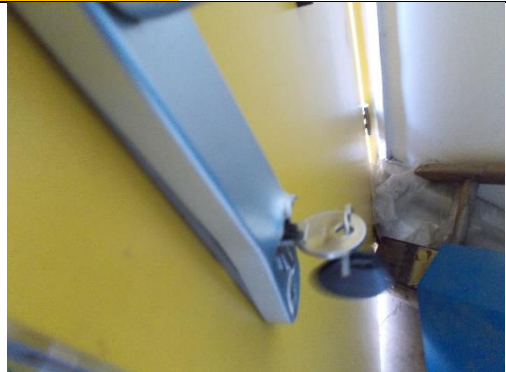
<b>MEDIUM</b>		<b>4</b>

It was noted the entrance doors to flats 32 and 57 are secured via keys. We recommend the locking mechanism is changed to a thumb turn device to ensure a speedy evacuation in an emergency without the need to search for keys.

<b>Assessors Observations:</b> The entrance doors to flats 32 and 57 are secured via keys.
<b>Date First Identified:</b>	16/01/23	<b>Recommended Action:</b> We recommend the locking mechanism is changed to a thumb turn device to ensure a speedy evacuation in an emergency without the need to search for keys.
<b>Date of FRA</b>	16/01/23	
<b>Rectify Within: (months)</b>	6	
<b>Budget Cost:</b>	£50

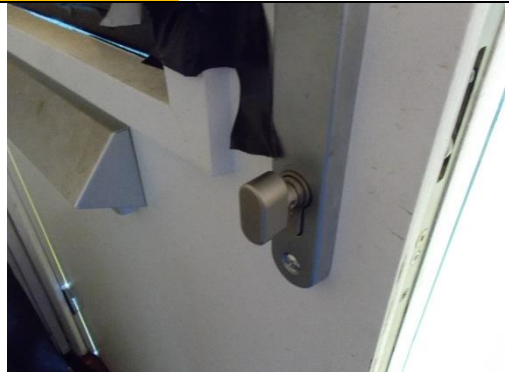
<b>MEDIUM</b>		<b>5</b>

The thumb turn device on the entrance door to flat 29 is defective with the resident complaining it is difficult to lock and unlock. We recommend the client investigates this issue to ensure the resident can escape quickly in an emergency.

<b>Assessors Observations:</b> The thumb turn device on the entrance door to flat 29 is defective with the resident complaining it is difficult to lock and unlock.
<b>Date First Identified:</b>	16/01/23	<b>Recommended Action:</b> We recommend the client investigates this issue to ensure the resident can escape quickly in an emergency.
<b>Date of FRA</b>	16/01/23	
<b>Rectify Within: (months)</b>	6	
<b>Budget Cost:</b>	No Cost

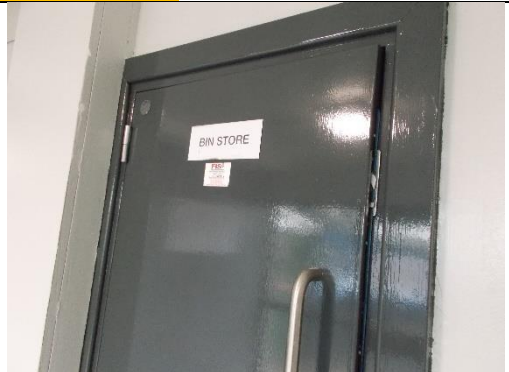
<b>MEDIUM</b>		<b>6</b>

It was noted the part glazed FD60S SC fire door protecting the bin store numbered 26/3.2 does not close fully against its rebate. We recommend the self-closing devices for this door is adjusted to ensure it can close fully against its rebate unaided and under its own weight.

<b>Assessors Observations:</b> The part glazed FD60S SC fire door protecting the bin store numbered 26/3.2 does not close fully against its rebate.
<b>Date First Identified:</b>	16/01/23	<b>Recommended Action:</b> We recommend the self-closing devices for this door is adjusted to ensure it can close fully against its rebate unaided and under its own weight.
<b>Date of FRA</b>	16/01/23	
<b>Rectify Within: (months)</b>	6	
<b>Budget Cost:</b>	£30

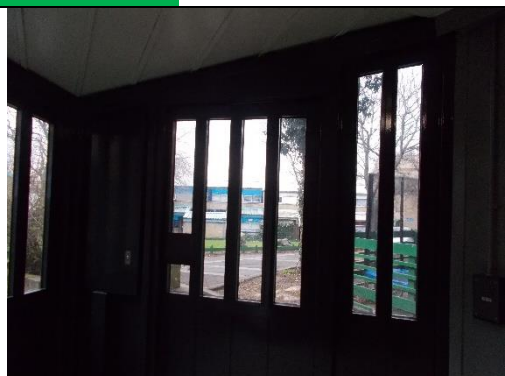
LOW		7

There is no "Fire Exit" sign above the final exit door within the lobby (27b). We recommend one such sign is affixed above this door.

<p><b>Assessors Observations:</b></p> <p>There is no "Fire Exit" sign above the final exit door within the lobby (27b).</p>
<b>Date First Identified:</b>	16/01/23	<p><b>Recommended Action:</b></p> <p>We recommend one such sign is affixed above this door.</p>
<b>Date of FRA</b>	16/01/23	
<b>Rectify Within: (months)</b>	12	
<b>Budget Cost:</b>	£10

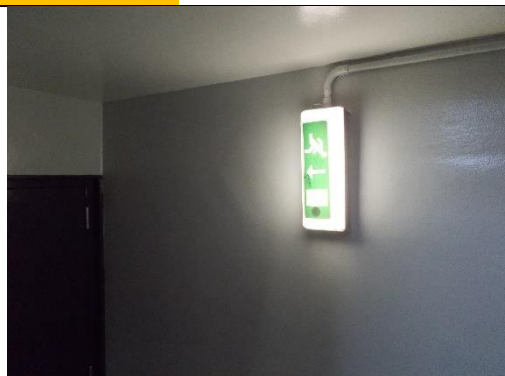
MEDIUM		8

Generally, it was noted numerous directional fire exit signs are either not in place, or are affixed directly to the part glazed FD30S SC fire doors from the balcony walkways or onto emergency light fittings on the stair, restricting the light given off. We recommend any signage attached to the doors is removed and affixed above them, so they are still visible when the door is opened. Directional exit signage should be installed above those doors from the balconies where there is none. In addition, the signage temporarily attached to the emergency light fittings on the stair should be reinstated onto the wall adjacent indicating the correct direction of escape.

<p><b>Assessors Observations:</b></p> <p>Generally, it was noted numerous directional fire exit signs are either not in place, or are affixed directly to the part glazed FD30S SC fire doors from the balcony walkways or onto emergency light fittings on the stair, restricting the light given off.</p>
<b>Date First Identified:</b>	16/01/23	<p><b>Recommended Action:</b></p> <p>We recommend any signage attached to the doors is removed and affixed above them, so they are still visible when the door is opened. Directional exit signage should be installed above those doors from the balconies where there is none. In addition, the signage temporarily attached to the emergency light fittings on the stair should be reinstated onto the wall adjacent indicating the correct direction of escape.</p>
<b>Date of FRA</b>	16/01/23	
<b>Rectify Within: (months)</b>	6	
<b>Budget Cost:</b>	£150

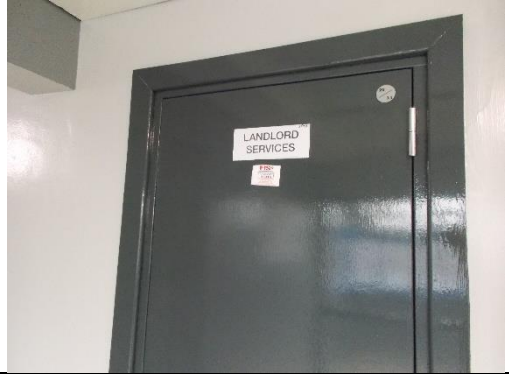
LOW		9

There is no signage on the landlord services doors to indicate the requirement to keep these doors locked. We recommend "Fire Door Keep Locked" signs are attached to the facing side of each landlord services door within the block.

<b>Assessors Observations:</b>	
		There is no signage on the landlord services doors to indicate the requirement to keep these doors locked.	
<b>Date First Identified:</b>	16/01/23	<b>Recommended Action:</b> We recommend "Fire Door Keep Locked" signs are attached to the facing side of each landlord services door within the block.	
<b>Date of FRA</b>	16/01/23		
<b>Rectify Within: (months)</b>	12		
<b>Budget Cost:</b>	£150
