**FIRE RISK ASSESSMENT REVIEW
76, 80-88 & 91 TOM COLLINS HOUSE,
DUNN TERRACE, BYKER,
NEWCASTLE UPON TYNE. NE6 1DB**

FEBRUARY 2023

Reference: TCH/16/02/23/IC
Prepared by:
Resilience Risk Management Services
Ltd
10 Westoe Drive
South Shields
Tyne and Wear
NE33 3EJ

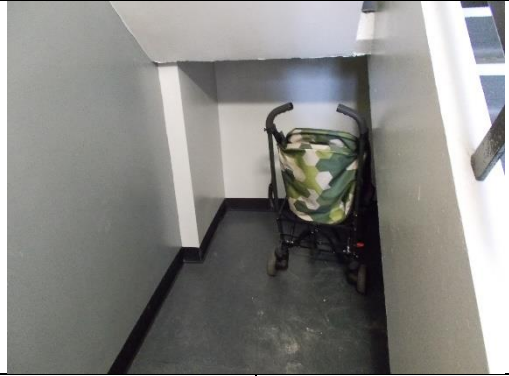
MEDIUM		1

2.2.1 It was noted there is a pushchair being stored on the means of escape outside of flat 76. We recommend the resident is contacted and requested to keep this item within the dwelling in order to keep the means of escape sterile and safe to use by all.

<p>Assessors Observations:</p> <p>There is a pushchair being stored on the means of escape outside of flat 76.</p>
Ref:	2.2.1	<p>Recommended Action:</p> <p>We recommend the resident is contacted and requested to keep this item within the dwelling in order to keep the means of escape sterile and safe to use by all.</p>
Date First Identified:	16/02/23	
Date of FRA Review:	16/02/23	
Rectify Within: (months)	6	
Budget Cost:	No Cost

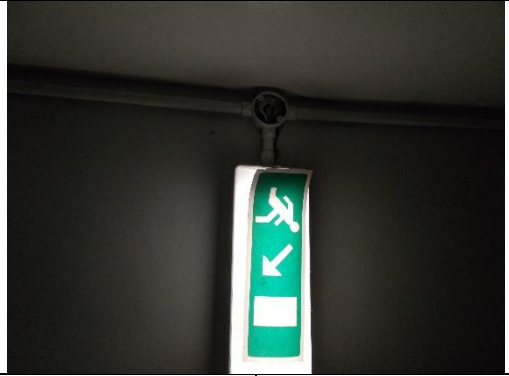
MEDIUM		2

2.2.2 On the landing up from flat 76, there is exposed wiring on the conduit supplying the emergency lighting unit on the stair. In addition, the directional exit sign has been stuck to the emergency light reducing its effectiveness and giving incorrect directions to the residents. We recommend the wiring defect is addressed and the directional exit sign removed from the emergency light and installed correctly on the wall adjacent to it.

<p>Assessors Observations:</p> <p>On the landing up from flat 76, there is exposed wiring on the conduit supplying the emergency lighting unit on the stair. In addition, the directional exit sign has been stuck to the emergency light reducing its effectiveness and giving incorrect directions to the residents.</p>
Ref:	2.2.2	<p>Recommended Action:</p> <p>We recommend the wiring defect is addressed and the directional exit sign removed from the emergency light and installed correctly on the wall adjacent to it.</p>
Date First Identified:	16/02/23	
Date of FRA Review:	16/02/23	
Rectify Within: (months)	6	
Budget Cost:	£100

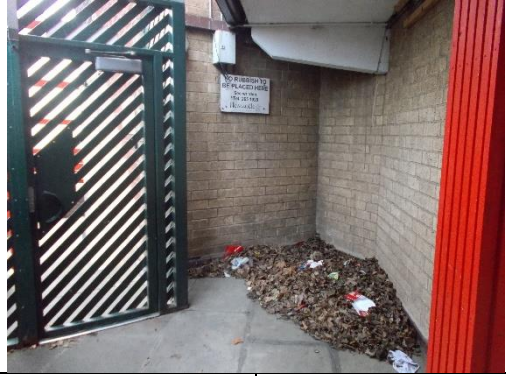
MEDIUM		3

2.2.3 There is an excessive build-up of dried leaves immediately adjacent to the fire exit from the balcony adjacent to flat 84. We recommend these are removed to keep the means of escape sterile.

Assessors Observations: There is an excessive build-up of dried leaves immediately adjacent to the fire exit from the balcony adjacent to flat 84.
Ref:	2.2.3	Recommended Action: We recommend these are removed to keep the means of escape sterile.
Date First Identified:	16/02/23	
Date of FRA Review:	16/02/23	
Rectify Within: (months)	6	
Budget Cost:	No Cost

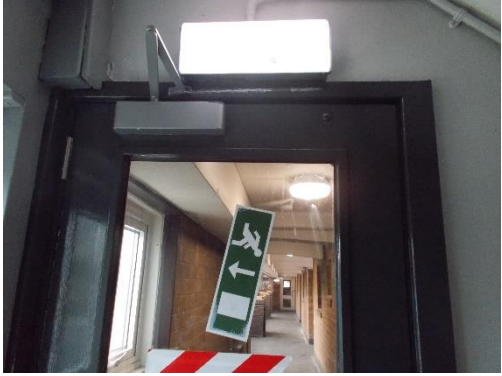
MEDIUM		5

2.3.5 It was noted there are numerous issues with the fire exit and directional signage on the means of escape. This is probably due to recent decorating works having been undertaken on the communal areas of the building, with signs removed but not yet reinstated. Amongst the signs which are missing/requiring to be reinstated are:

- General Fire Action notices are required on each floor.
- No directional exit signage on the stairwell outside of flat 80.
- Incorrect exit sign (old type) on the balcony adjacent to flat 80.
- Fire exit sign required above the exit door adjacent to flat 84.
- Landlord services door 25A / 4.1 requires a "fire door keep locked" sign to be attached to the facing side of the door.

<p>Assessors Observations:</p> <p>There are numerous issues with the fire exit and directional signage on the means of escape. This is probably due to recent decorating works having been undertaken on the communal areas of the building, with signs removed but not yet reinstated. Amongst the signs which are missing/requiring to be reinstated are:</p> <ul style="list-style-type: none">• General Fire Action notices are required on each floor.• No directional exit signage on the stairwell outside of flat 80.• Incorrect exit sign (old type) on the balcony adjacent to flat 80.• Fire exit sign required above the exit door adjacent to flat 84.• Landlord services door 25A / 4.1 requires a "fire door keep locked" sign to be attached to the facing side of the door.
Ref:	2.3.5	<p>Recommended Action:</p> <p>We recommend a full signage survey is undertaken following the completion of any decorative work on the estate to ensure residents and visitors can be guided to safety in an emergency.</p>

We recommend a full signage survey is undertaken following the completion of any decorative work on the estate to ensure residents and visitors can be guided to safety in an emergency.
