**FIRE RISK ASSESSMENT  
9-14 THE BROW, BYKER,  
NEWCASTLE UPON TYNE,  
NE6 2FL**

**MARCH 2022**

**STORM TEMPEST**  
PROPERTY CONSULTANCY

**Reference:** 4009-04-21-IC

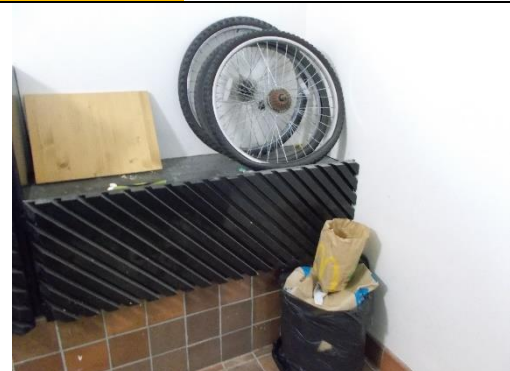
<b>MEDIUM</b>		<b>1</b>

It was noted, outside of flats 10 and 13, as well as flats 9 and 12, residents have left combustible items such as cardboard, timber, bicycle wheels and general refuse. We recommend residents are reminded to remove their unwanted items/refuse from the building to the wheeled bins outside and the means of escape should be kept sterile for the residents' safety.

<b>Assessors Observations:</b> Outside of flats 10 and 13, as well as flats 9 and 12, residents have left combustible items such as cardboard, timber, bicycle wheels and general refuse.
		<b>Recommended Action:</b> We recommend residents are reminded to remove their unwanted items/refuse from the building to the wheeled bins outside and the means of escape should be kept sterile for the residents safety.
<b>Date First Identified:</b>	29/03/2022	
<b>Date of FRA</b>	29/03/2022	
<b>Rectify Within: (months)</b>	6	
<b>Budget Cost:</b>	No Cost

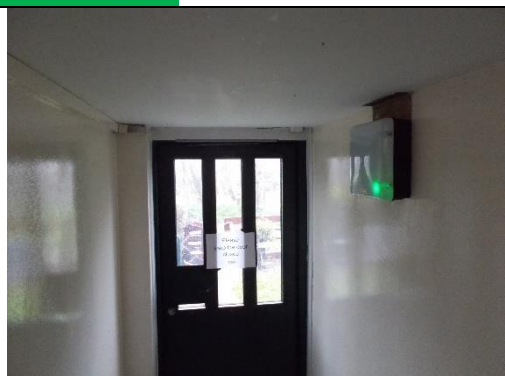
LOW		5

It was noted, there is no "Fire Exit" sign above the rear final exit door. Although this is a simple premises with residents familiar with the building, we recommend one such sign is provided.

<b>Assessors Observations:</b> There is no "Fire Exit" sign above the rear final exit door.
<b>Date First Identified:</b>	29/03/2022	<b>Recommended Action:</b> Although this is a simple premises with residents familiar with the building, we recommend one such sign is provided.
<b>Date of FRA</b>	29/03/2022	
<b>Rectify Within: (months)</b>	12	
<b>Budget Cost:</b>	£10

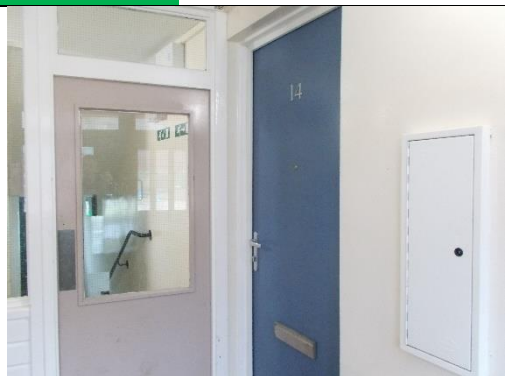
LOW		6

The FD30S SC VP fire doors adjacent to flat 14 and the lobby door adjacent to flats 10 and 13, require "Fire Door Keep Shut" signage to be attached to both sides of the doors.

<b>Assessors Observations:</b> The FD30S SC VP fire doors adjacent to flat 14 and the lobby door adjacent to flats 10 and 13, require "Fire Door Keep Shut signage to be attached to both sides of the doors.
<b>Date First Identified:</b>	29/03/2022	<b>Recommended Action:</b> As above
<b>Date of FRA</b>	29/03/2022	
<b>Rectify Within: (months)</b>	12	
<b>Budget Cost:</b>	£40
