**FIRE RISK ASSESSMENT  
1-6 RABY CRESCENT,  
BYKER,  
NEWCASTLE UPON TYNE NE6 2FD**

**FEBRUARY 2021**

**Reference:** PA-3888-02-21

**APPENDIX 1  
FIRE RISK ASSESSMENT**

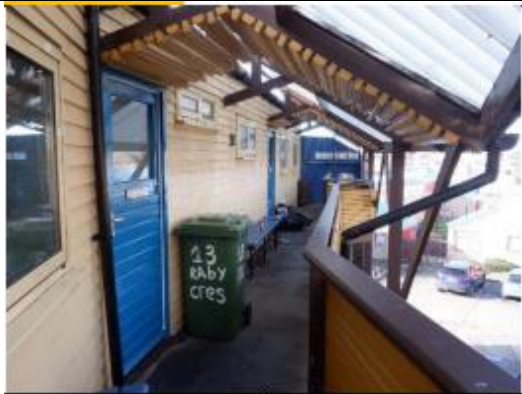
<b>MEDIUM</b>		<b>1</b>

We noted wheely bins on the balcony and positioned under openable windows on the ground floor. In order to ensure that the build-up of combustible materials does not continue to the point that a high fire load is created and/or the means of escape from the building are seriously obstructed it is strongly recommended that procedures, managerial checks, are put in place to monitor the area to ensure it remains free from combustible material and that the occupiers are advised not to store bins against the wall.

<b>Assessors Observations:</b> We noted wheely bins on the balcony and positioned under openable windows on the ground floor.	
<b>Date First Identified:</b>	26/02/2021	<b>Recommended Action:</b> In order to ensure that the build-up of combustible materials does not continue to the point that a high fire load is created and/or the means of escape from the building are seriously obstructed it is strongly recommended that procedures, managerial checks, are put in place to monitor the area to ensure it remains free from combustible material and that the occupiers are advised not to store bins against the wall.	
<b>Date of FRA:</b>	26/02/2021		
<b>Rectify Within: (months)</b>	6		
<b>Budget Cost:</b>	No cost

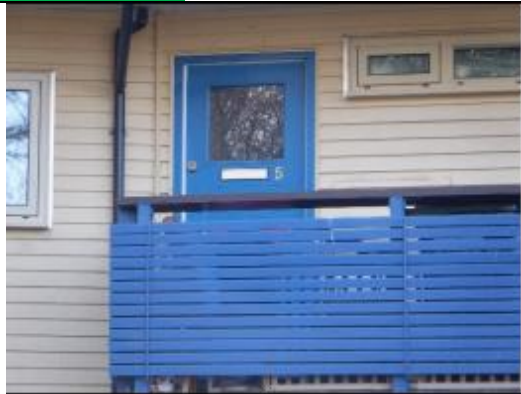
<b>LOW</b>		<b>4</b>

4.2 Fire Doors We were able to access number 5 to inspect the specification of the flat entrance door. The door is a solid door with glazed panel hung on 3 hinges and fitted with rim lock, security chain, mortice lock with no mechanical override and letter box aperture.

<p><b>Assessors Observations:</b></p> <p>We were able to access number 5 to inspect the specification of the flat entrance door. The door is a solid door with glazed panel hung on 3 hinges and fitted with rim lock, security chain, mortice lock with no mechanical override and letter box aperture.</p>
<b>Date First Identified:</b>	26/02/2021	<p><b>Recommended Action:</b></p> <p>We recommend the mortice locks on all doors are fitted with a mechanical override that negates the use of a key to operate the lock in an emergency.</p>
<b>Date of FRA:</b>	26/02/2021	
<b>Rectify Within: (months)</b>	12	
<b>Budget Cost:</b>	£100

We recommend the mortice locks on all doors are fitted with a mechanical override that negates the use of a key to operate the lock in an emergency.
